**Final
Phase II Remedial Investigation
Northeast Cape,
St. Lawrence Island, Alaska**

Volume 1: Report Body

August, 1999

Montgomery Watson
4100 Spenard Road
Anchorage, Alaska 99517

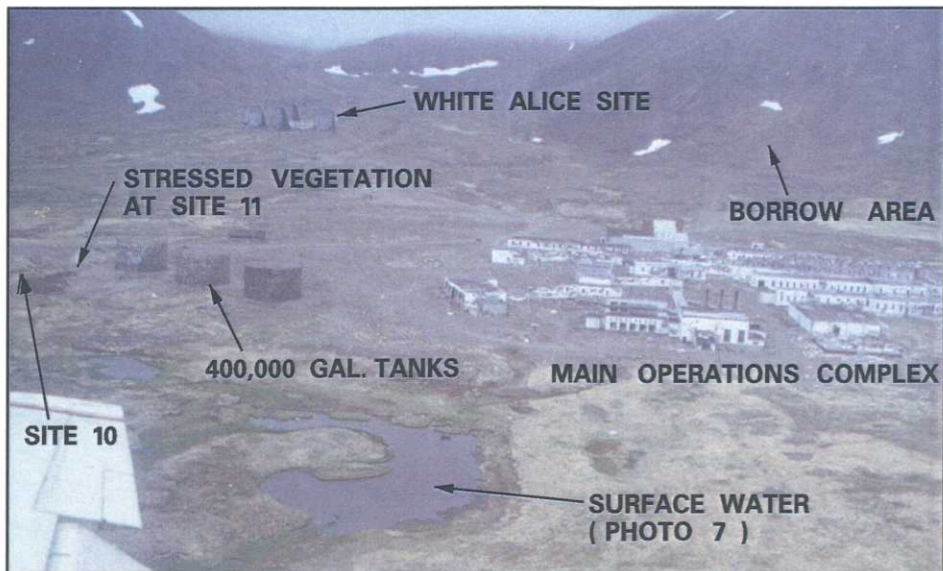
1 AERIAL VIEW - HEADWATERS OF DRAINAGE BASIN

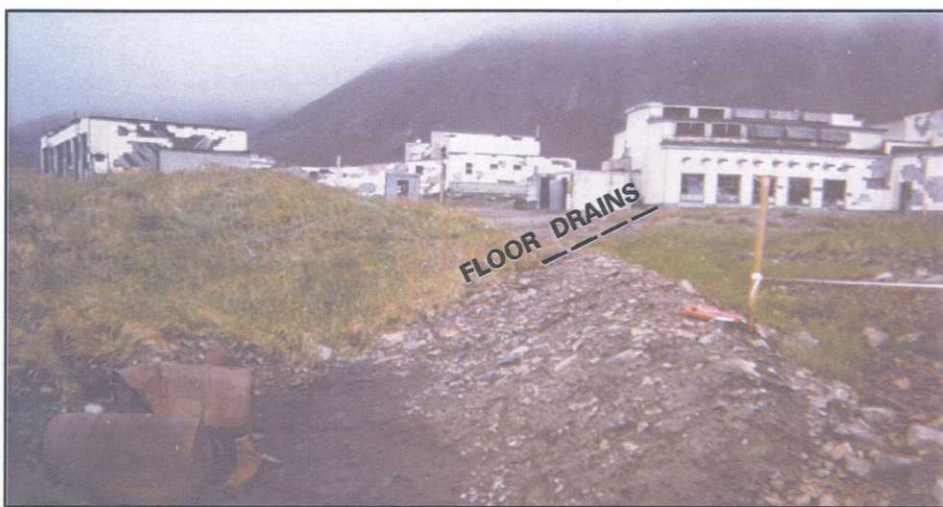
2 DRUMS AND STAINING AT SITE 13 HEADWATERS

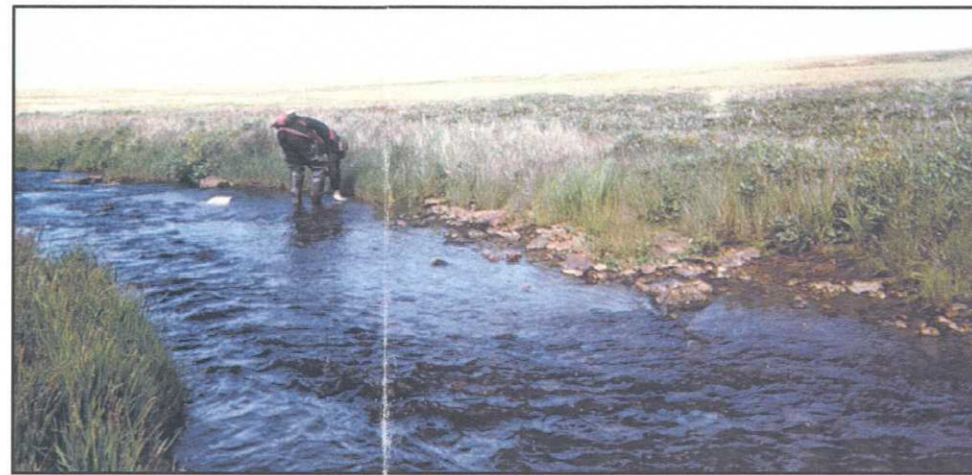
4 INSPECTION OF LOWER REACHES OF THE UNNAMED STREAM

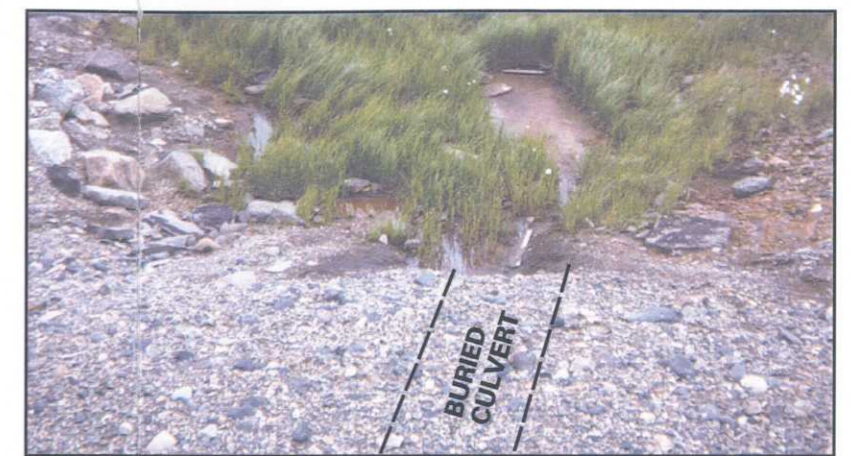
6 SITE 27 HEADWATERS AREA (CULVERT OUTLET FROM DIESEL PUMP ISLAND)

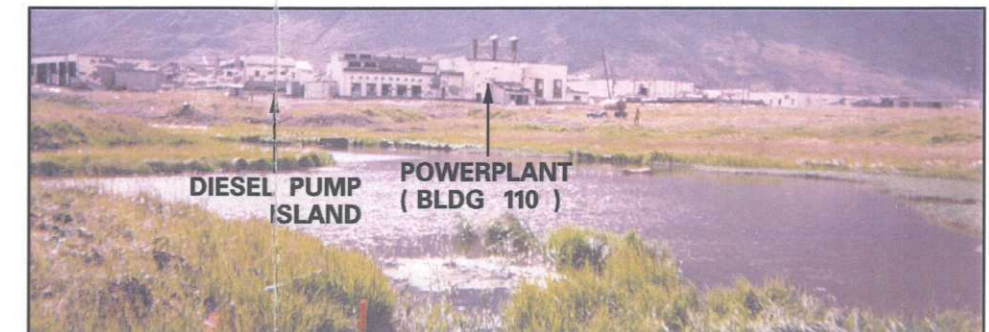
7 SURFACE WATER IN HEADWATERS OF DRAINAGE BASIN WHICH RECEIVES FLOW FROM SITES 10, 11, 13 & 27
