## **FIRST PERIODIC REVIEW REPORT**

### **SITE 7 CARGO BEACH ROAD LANDFILL NORTHEAST CAPE FUDS ST. LAWRENCE ISLAND, ALASKA**

**Formerly Used Defense Site No. F10AK0969-05**

**FINAL  
FEBRUARY 2015**

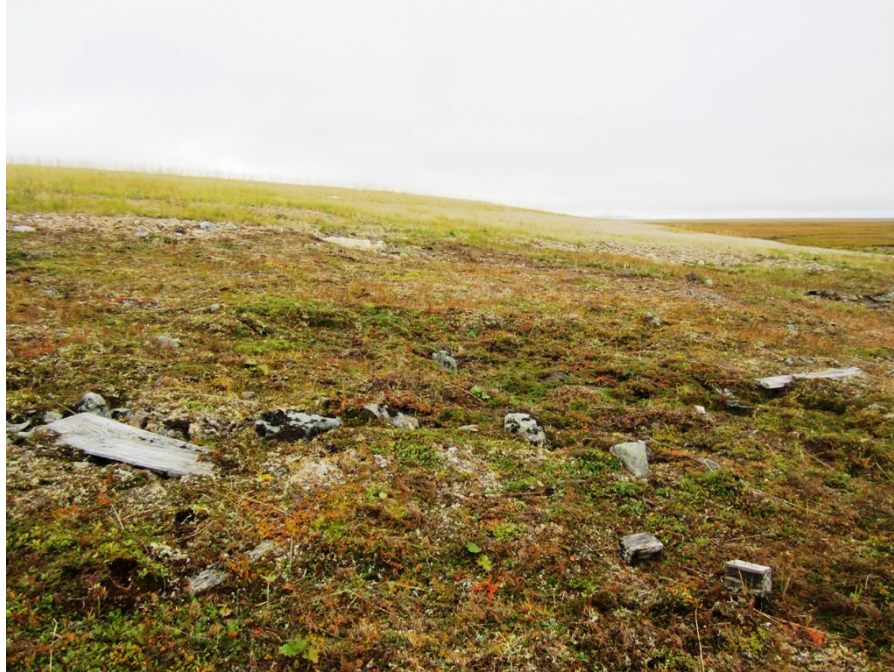
**Photo No. 7 – 13 September 2013  
Wood debris at Site 7. View facing north.**

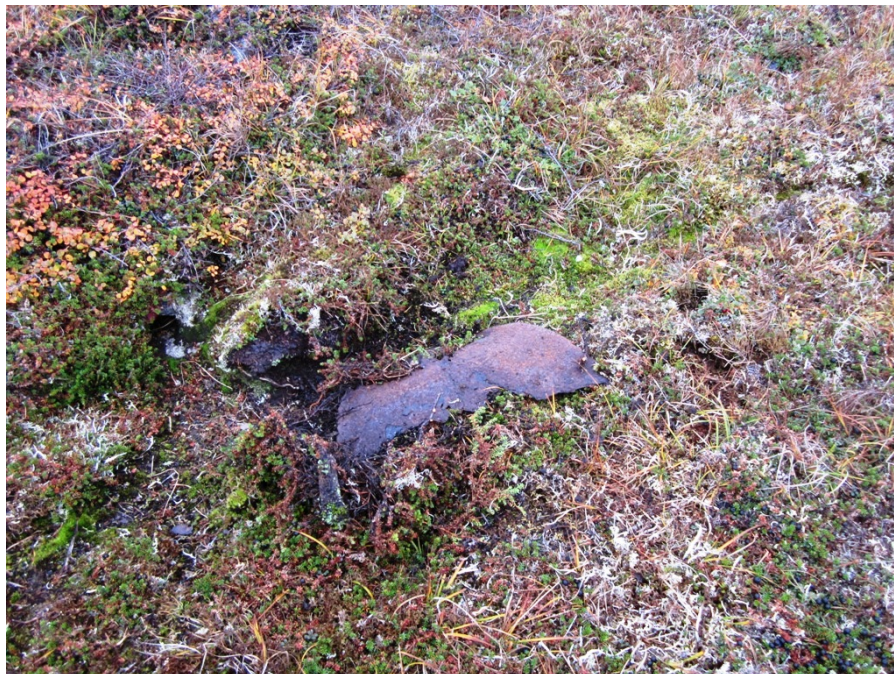
**Photo No. 8 – 13 September 2013  
Metal debris at Site 7.**

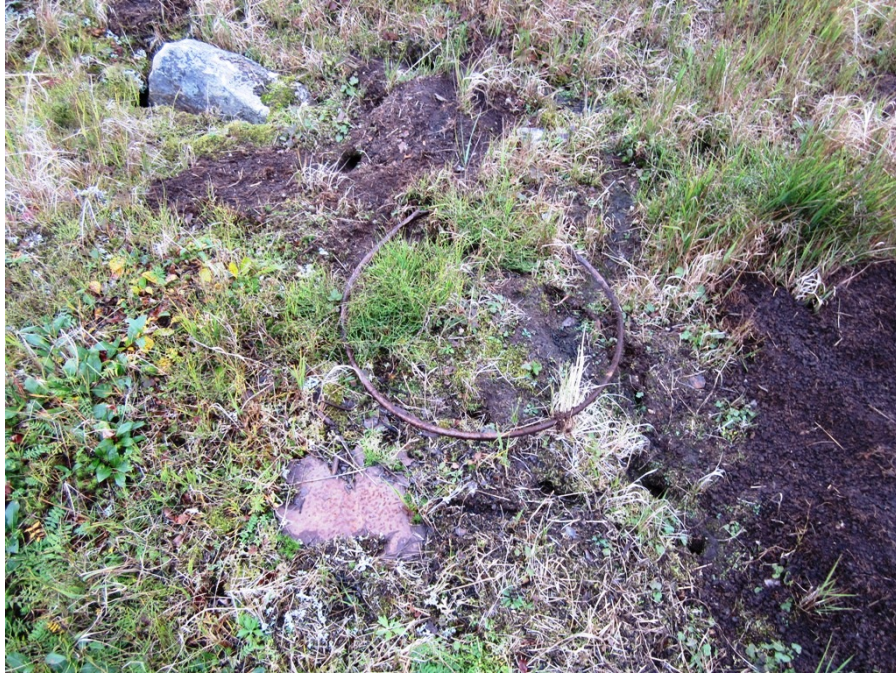
**Photo No. 9 – 13 September 2013  
Metal debris at Site 7.**

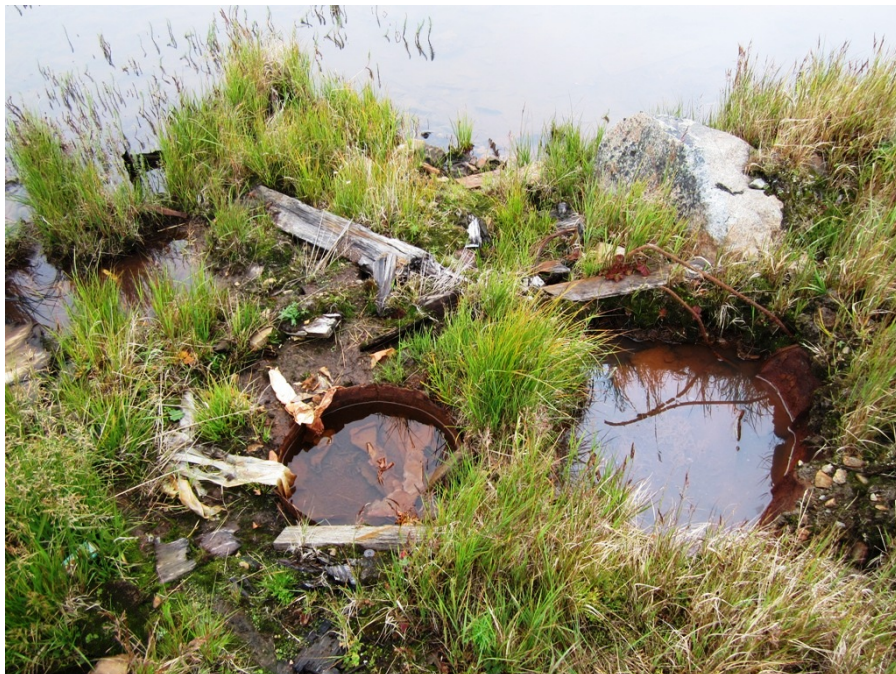
**Photo No. 10 – 13 September 2013  
Drum debris located near a pond at Site 7. View facing north.**

| | <b>Recommendation:</b> Remove debris identified in and around ponds adjacent to the landfill cap. | | | |

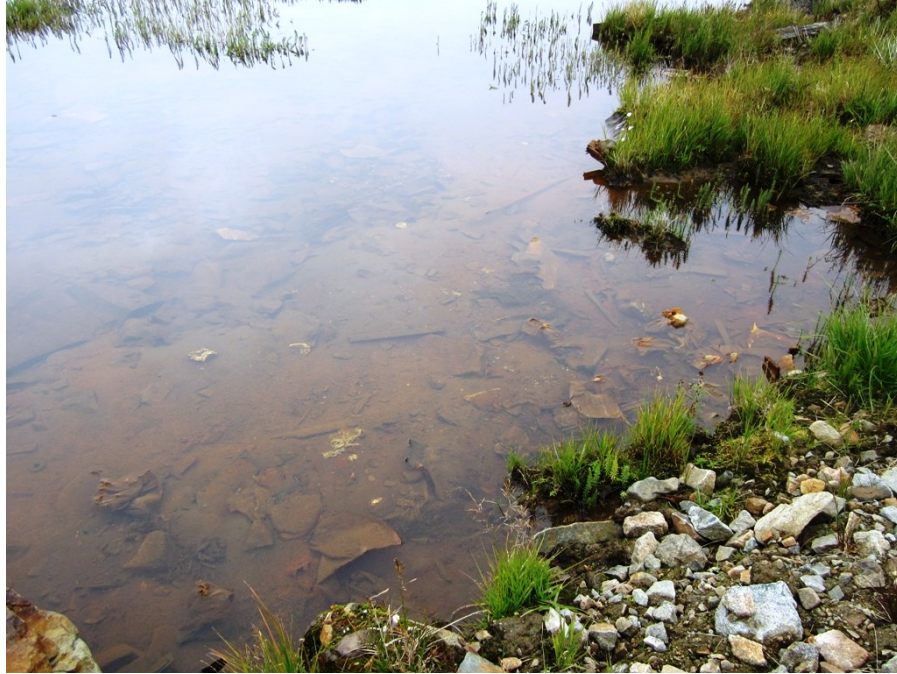
**Photo No. 11 – 13 September 2013  
Debris in pond located adjacent to landfill cap at Site 7. View facing north.**

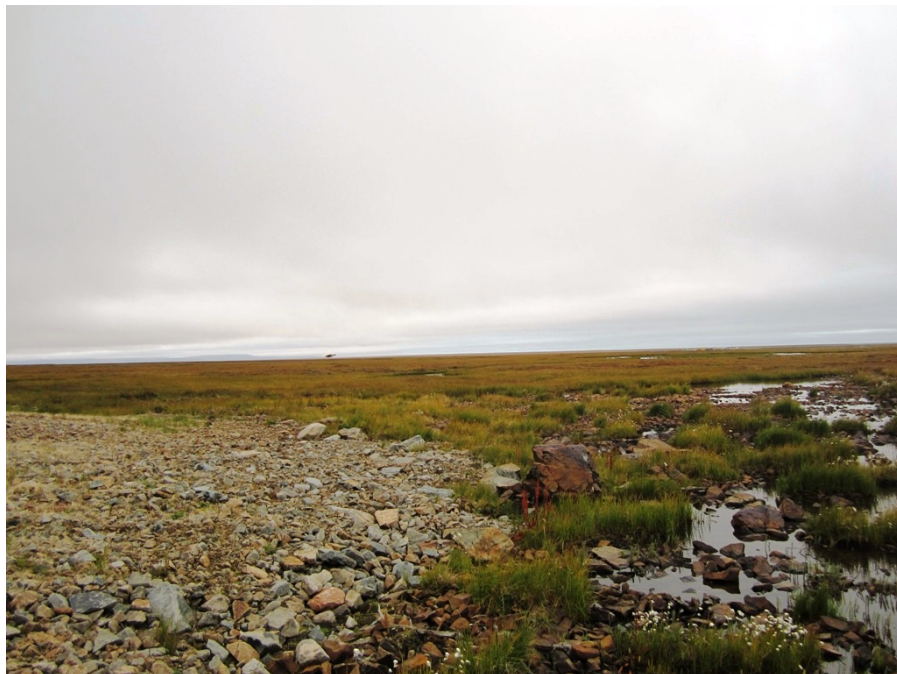
**Photo No. 12 – 13 September 2013  
Condition of northern edge of landfill cap at Site 7. View facing west.**

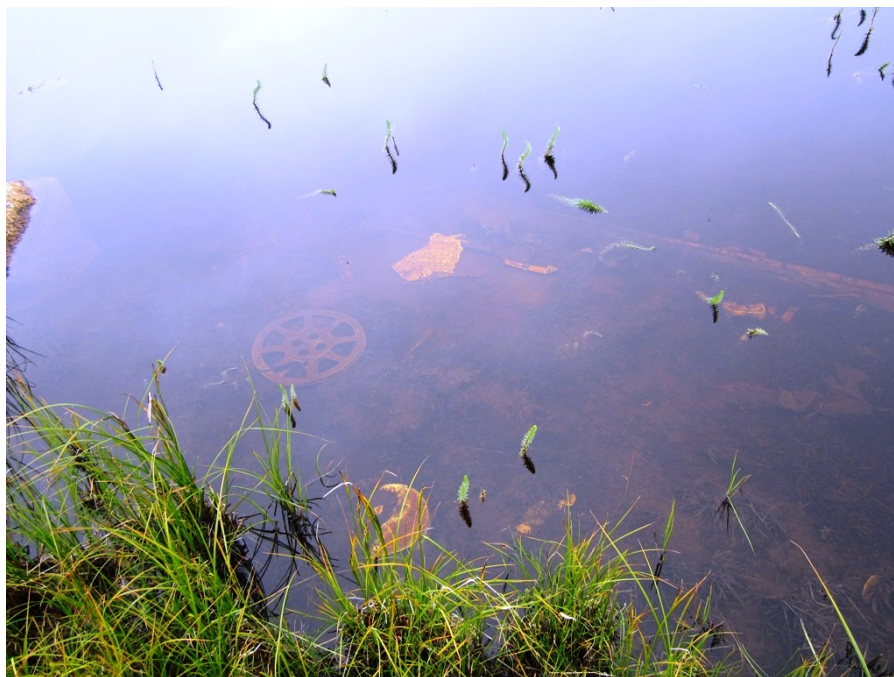
**Photo No. 13 – 13 September 2013  
Miscellaneous debris in pond adjacent to landfill cap at Site 7. View facing north.**

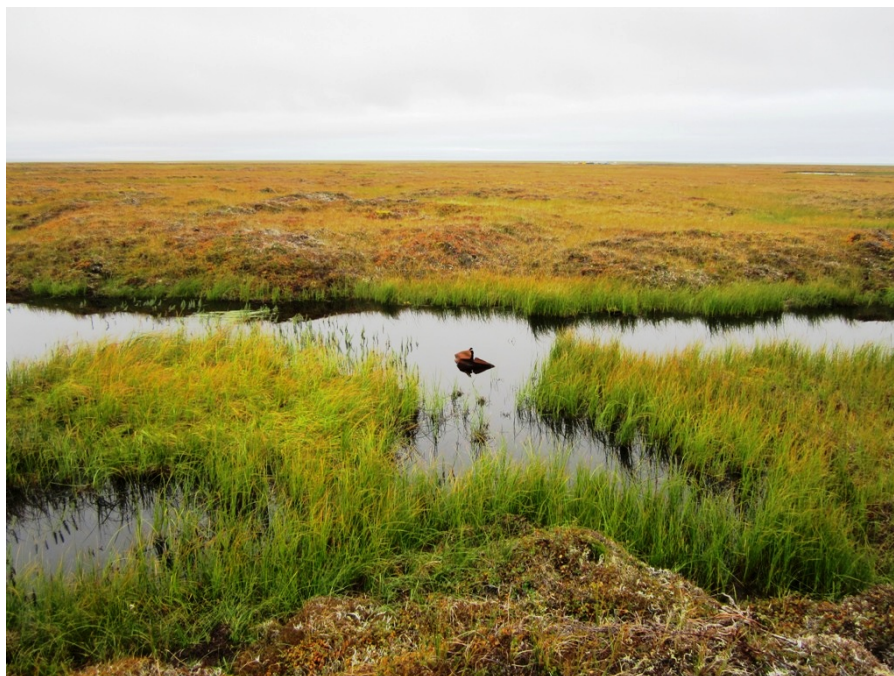
**Photo No. 14 – 13 September 2013  
Miscellaneous debris in pond near landfill cap at Site 7. View facing northwest.**

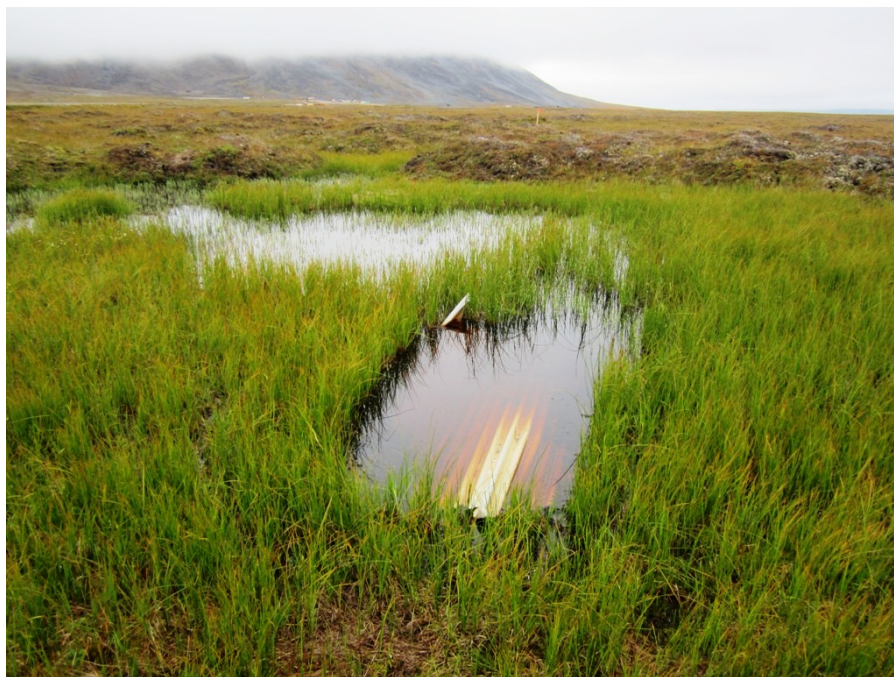
**Photo No. 15 – 13 September 2013  
Metal debris in pond adjacent to landfill cap at Site 7. View facing north.**

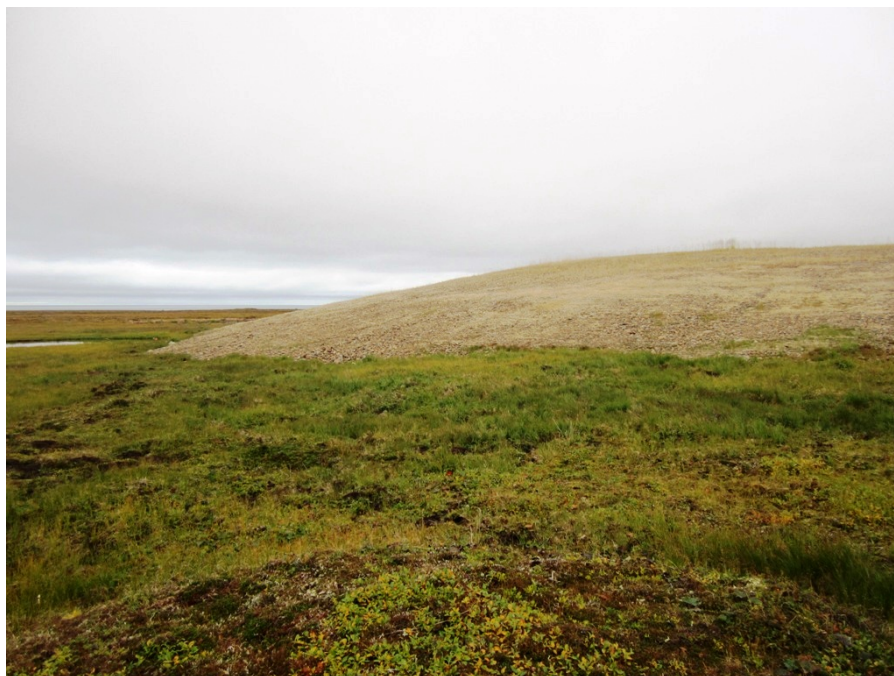
**Photo No. 16 – 13 September 2013  
Condition of northern edge of landfill cap at Site 7. View facing west.**

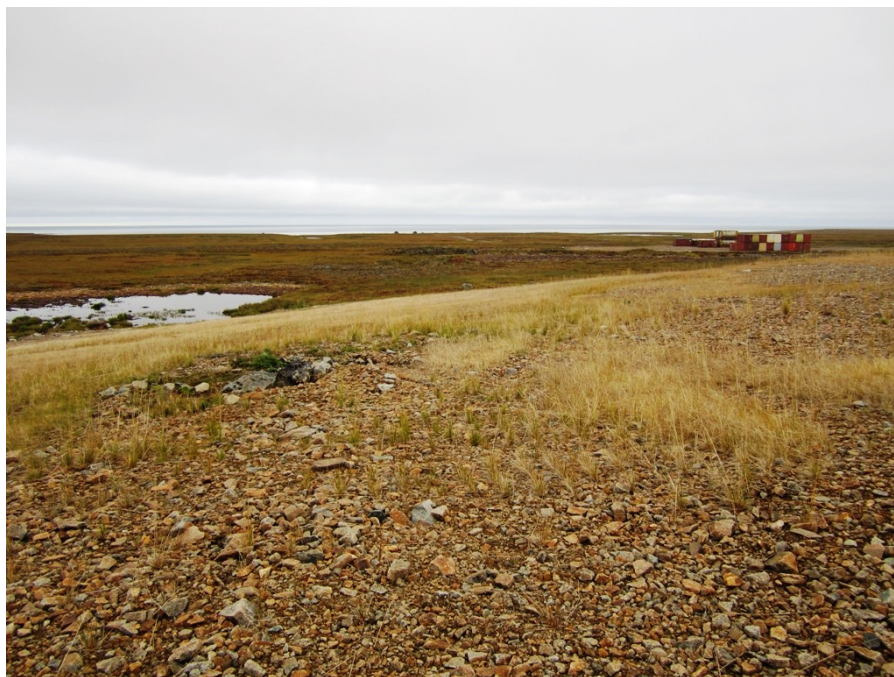
The landfill cap at Site 7 was observed in good condition with no apparent signs of erosion or cracking. The soil used for vegetative cover was observed to be very coarse, making vegetative growth difficult and sparse. There was a small amount of debris protruding from the cap on the southern side of the cap near the armored rock (Photo No. 15, Appendix D). Several metal items were observed in ponds located immediately north of the landfill cap (Photo Nos. 6, 7, 9, 10, 11, 18, and 19, Appendix D). A few rusted open drums were observed in ponds located to the north and southeast of the landfill cap (Photo Nos. 6 and 19, Appendix D). Bentonite was observed on the ground surface and thought to be an abandoned monitoring well southeast of the landfill cap (Photo No. 17, Appendix D).

**Photo No. 17 – 13 September 2013**  
**View standing on top of landfill cap at Site 7. View facing northwest.**

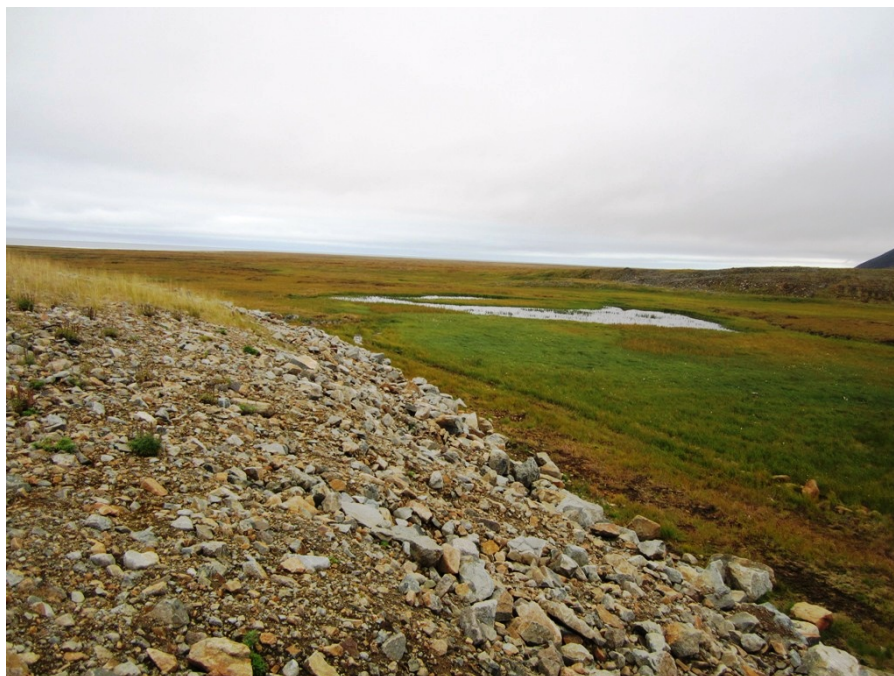
**Photo No. 18 – 13 September 2013**  
**Condition of armored rock on the southern border of landfill cap at Site 7. View facing east.**

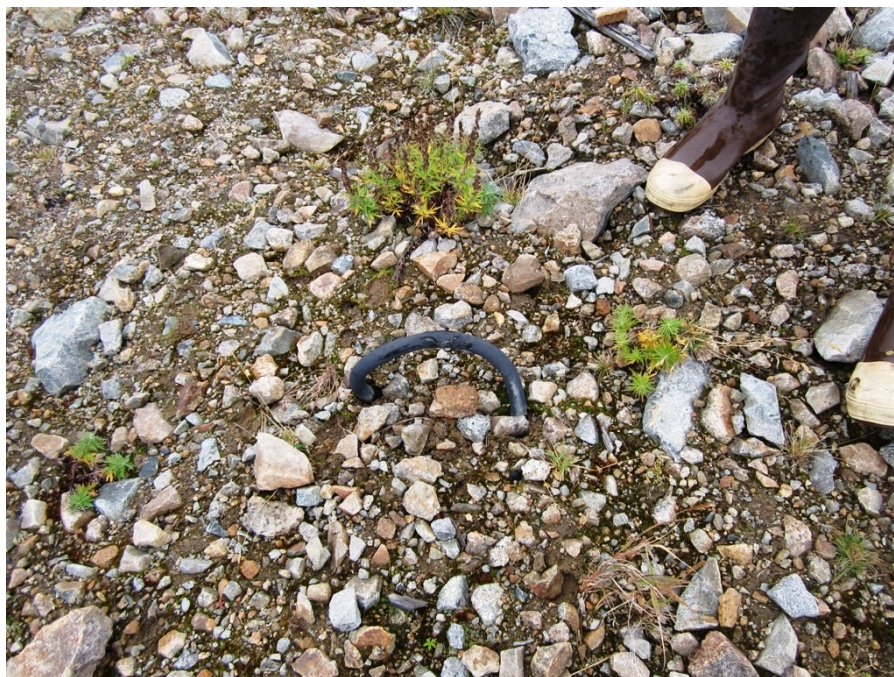
**Photo No. 19 – 13 September 2013  
Debris protruding through the southern side of landfill cap at Site 7.**

| | <b>Recommendation:</b> Remove debris protruding from the landfill cap. | | | |

An additional visual inspection event is recommended for the Site 7 landfill cap. The inspection is recommended to occur following the removal of the identified debris protruding through the surface of the southeastern edge of the landfill and implementation of LUCs. The second event is recommended to occur within five years of this review. Additional monitoring events should be documented within the second Periodic Review, at which time, the need for future reviews will be evaluated.

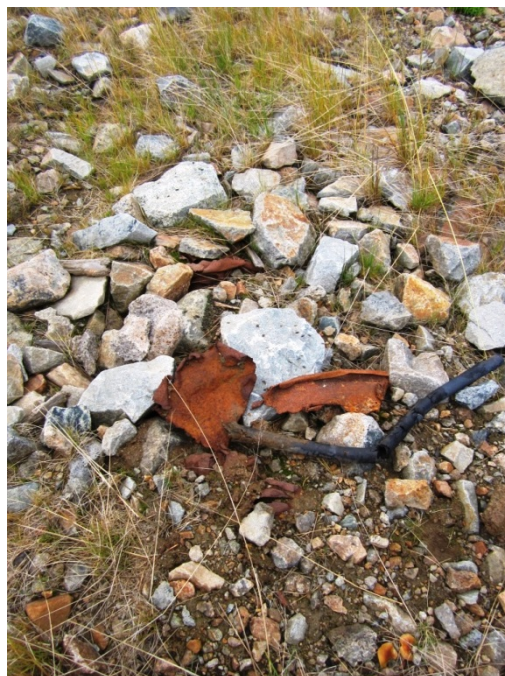
**Photo No. 20 – 13 September 2013  
Debris located with the armored rock at Site 7. View facing south.**

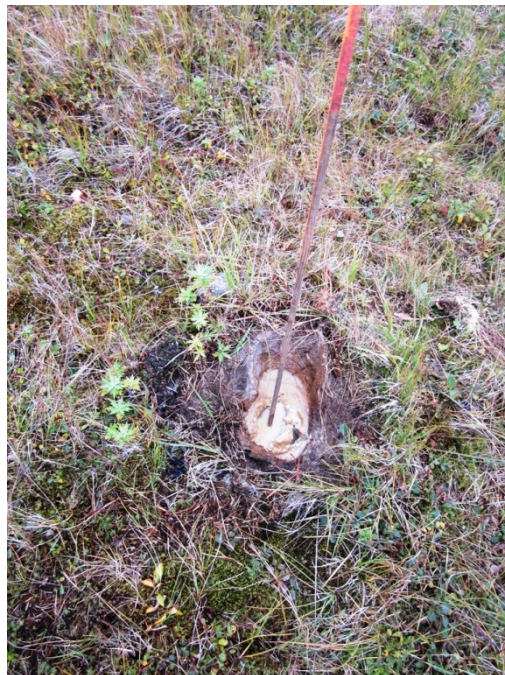
**Photo No. 21 – 13 September 2013  
Abandoned monitoring well filled with bentonite at Site 7.**

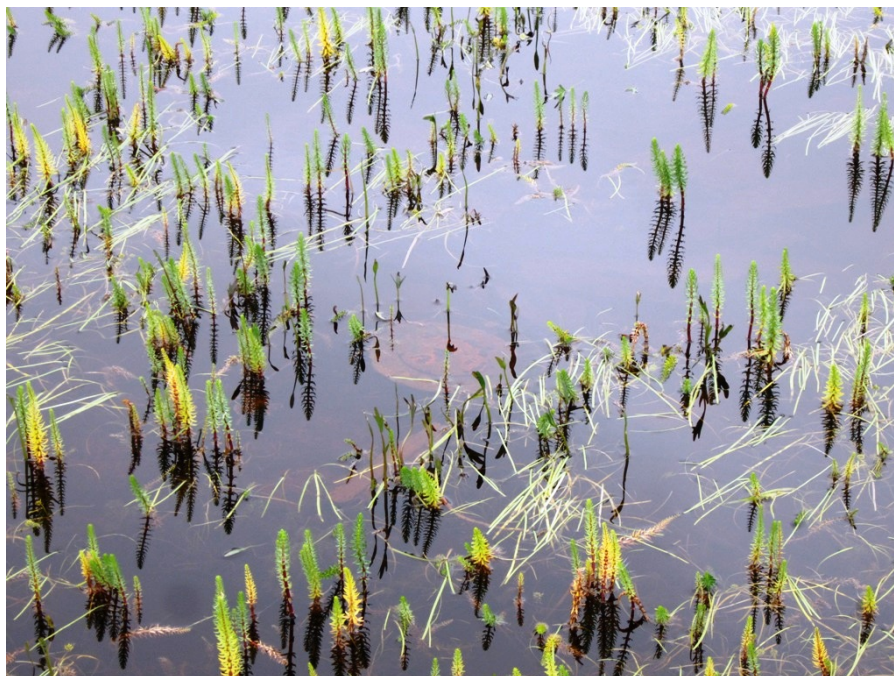
**Photo No. 22 – 13 September 2013  
Debris in pond south of landfill cap at Site 7. View facing south.**

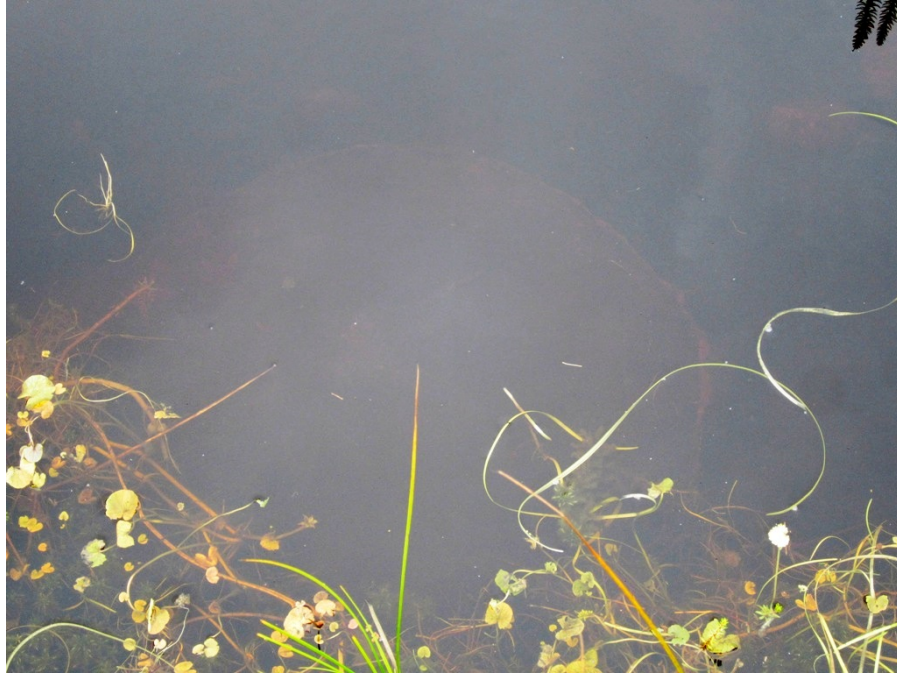
**Photo No. 23 – 13 September 2013  
Apparent drum located in pond south of landfill cap at Site 7.**
