**United States Army Corps of
Engineers, Alaska District**

**Phase II Remedial Investigation
Gambell,
St. Lawrence Island, Alaska**

Photographs - August, 1996

**Phase II Remedial Investigation
Northeast Cape,
St. Lawrence Island, Alaska**

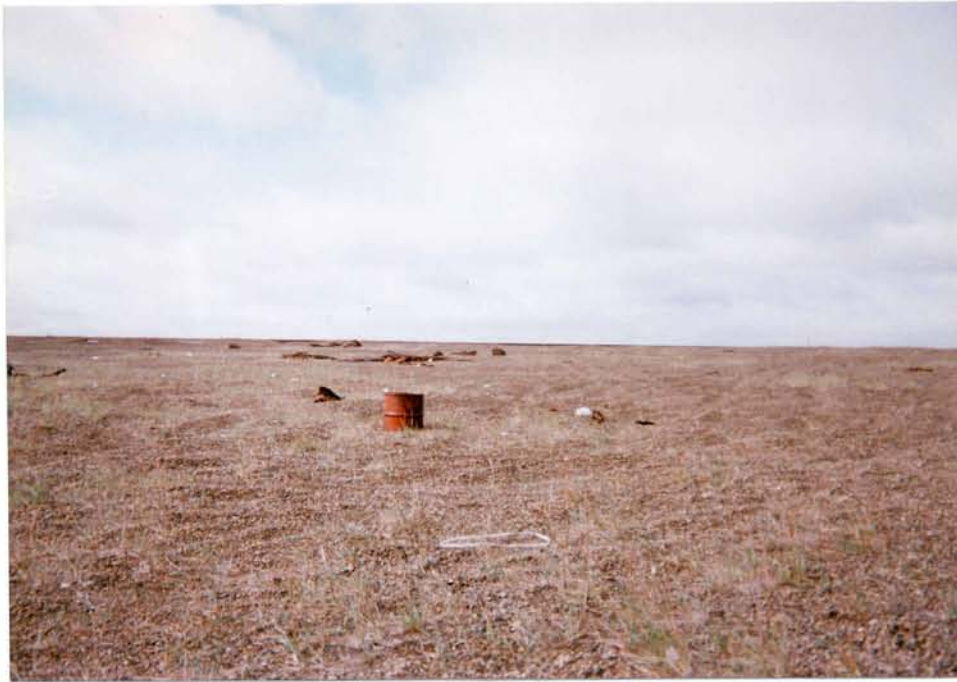
Debris found along ATV trail along Gambell runway

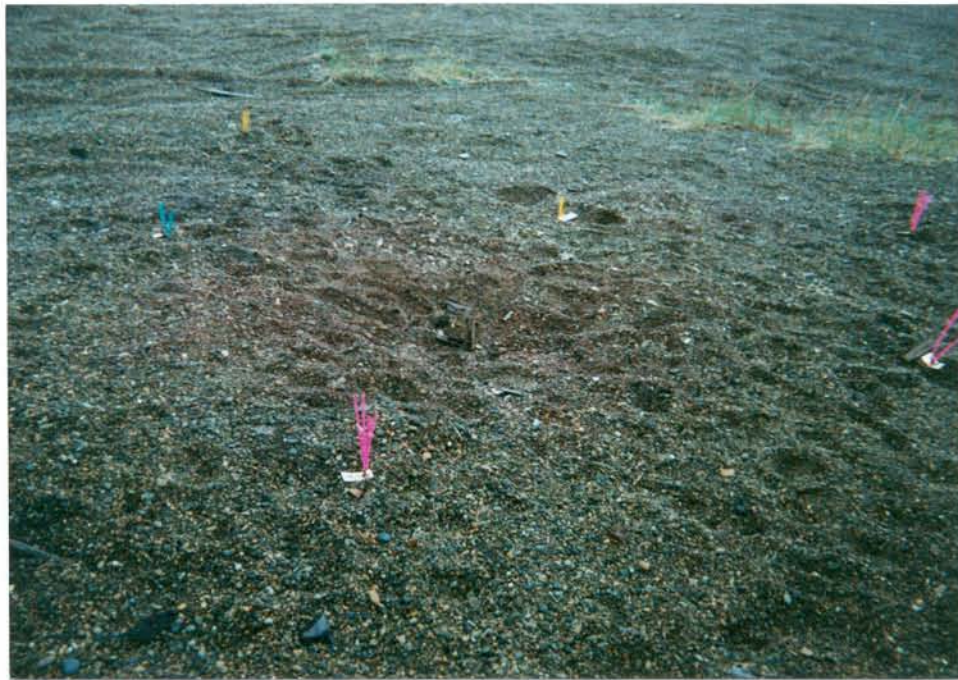
Stained soil at Site 2

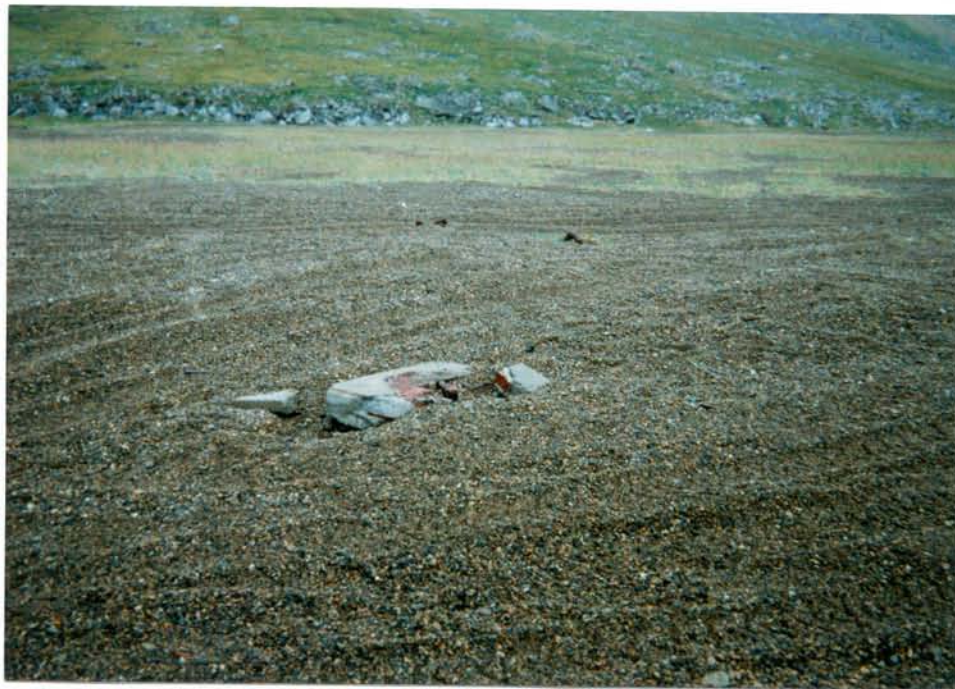
Exposed fireplace at Site 2

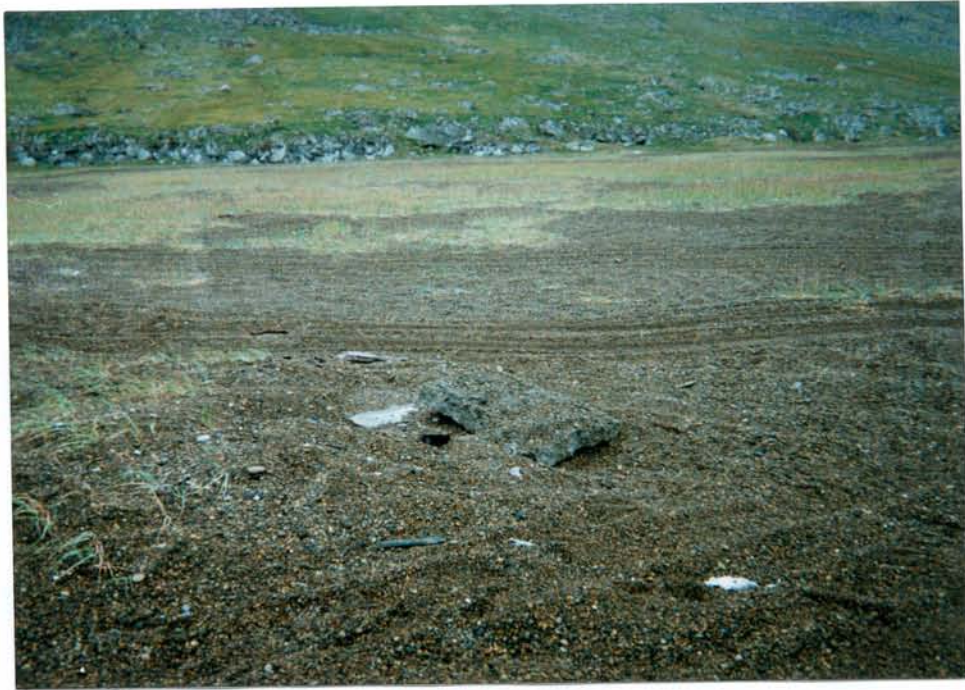
Exposed Concrete Slab at Site 2

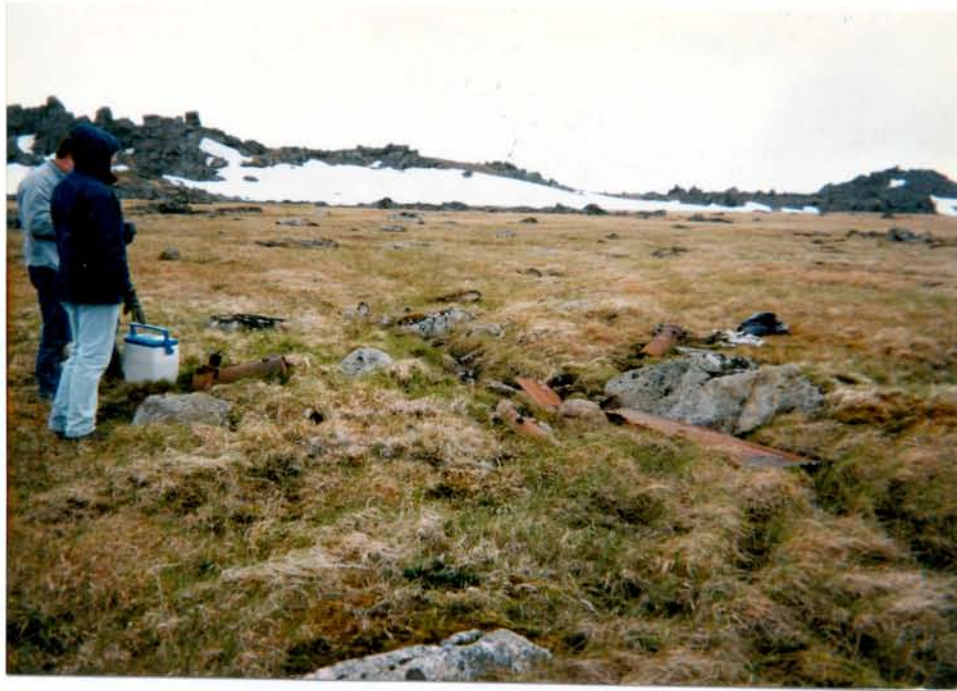
Transformers found in mountainside drainage during preliminary Phase II Investigation

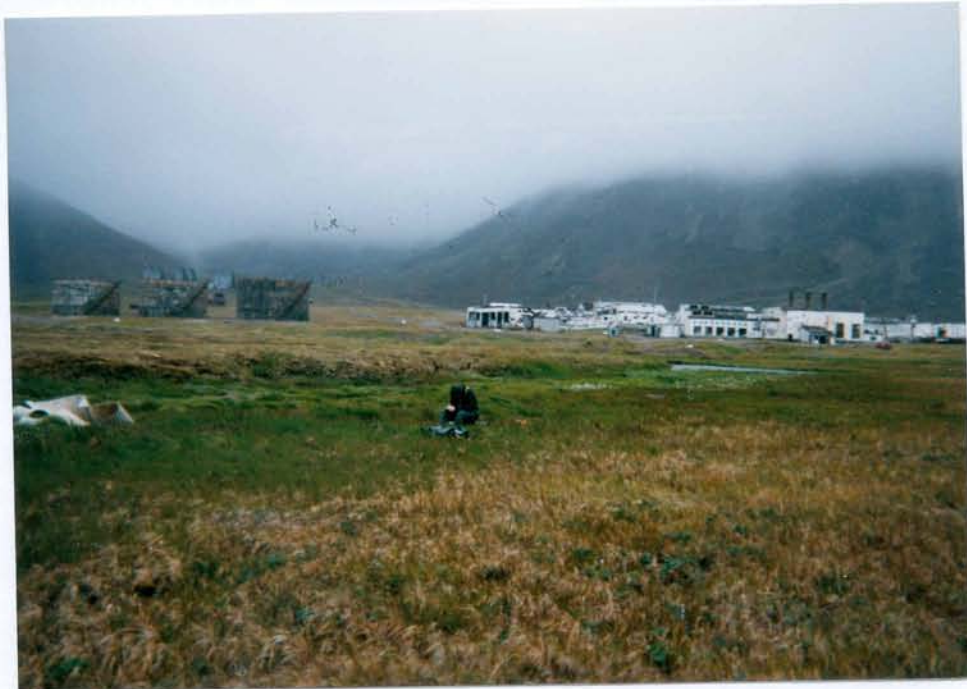
Drainage Basin, view from North, Main Site in right background, Site 11 and White Alice Station in left background. Note corrugated metal sheet & empty 55 gal drum

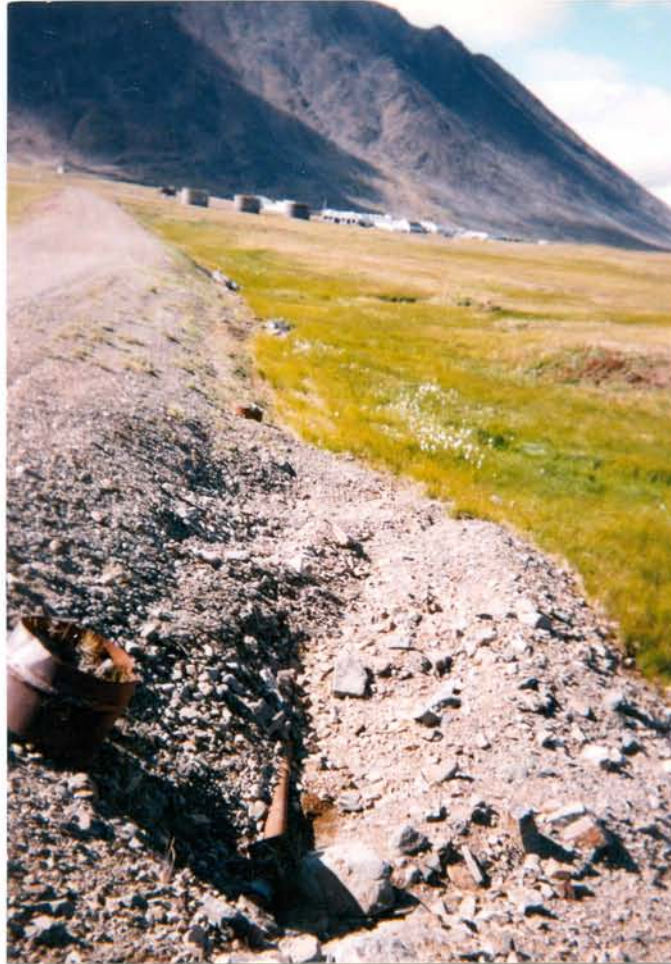
Site 8: Fuel Line Leak, looking Southwest toward Main
Complex

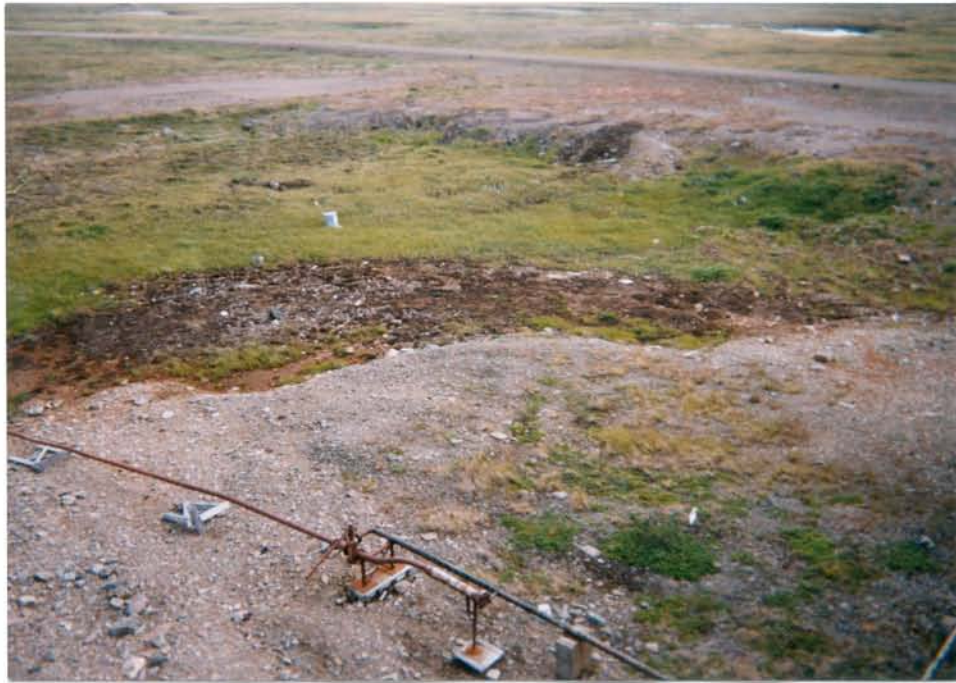
Site 10, looking Southeast. Note stained soil

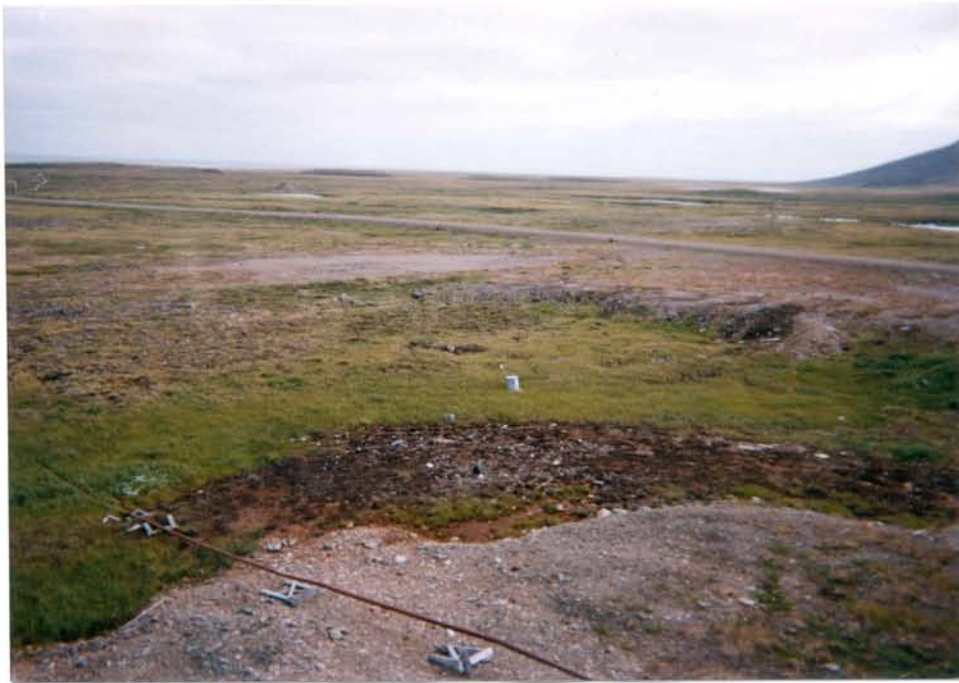
Site 10, looking Southeast. Note stained soil

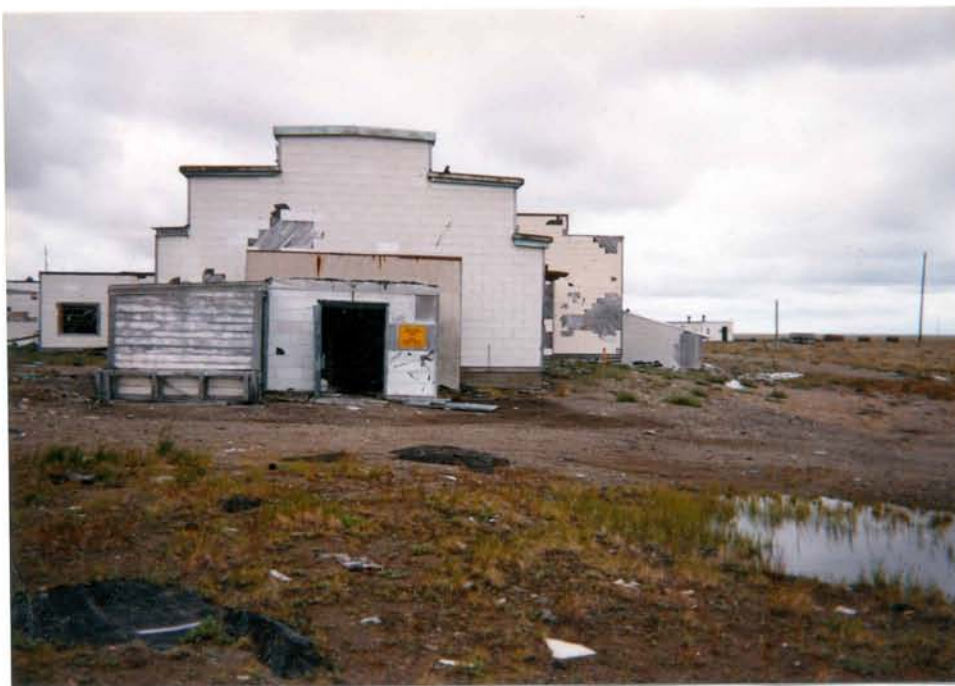
Site 13 Building 110-Note Stained Soils-Site 27 in Forground-View from East

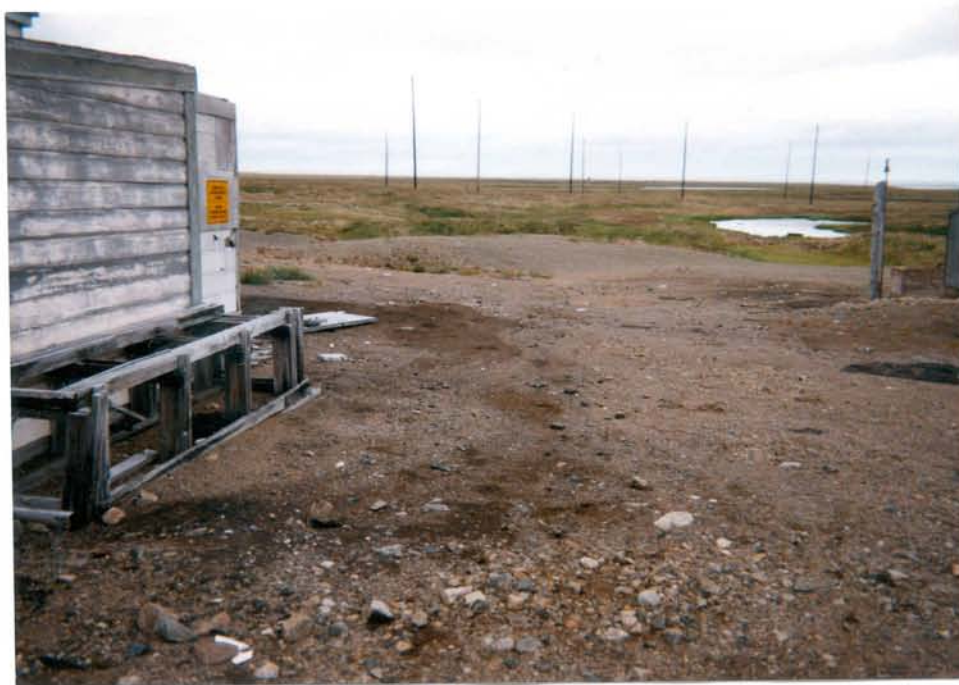
Site 13 Building 110 View from South. Southeast Corner-Note Stained Soil Around Building

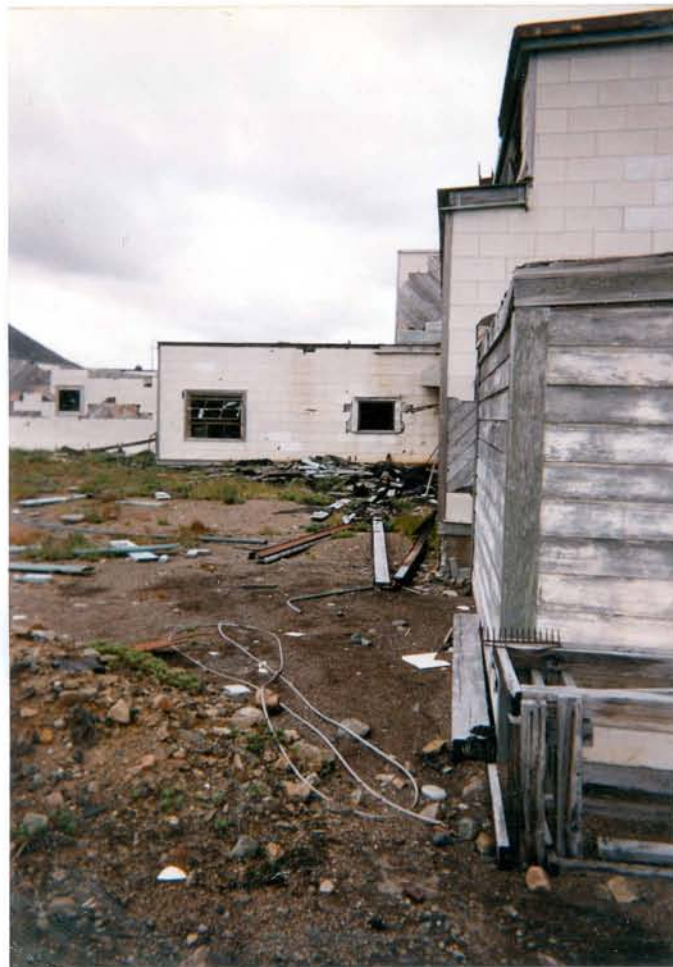
Site 13: South side of Building 110 East end, view from East
Note : Stained Surface Soil around building

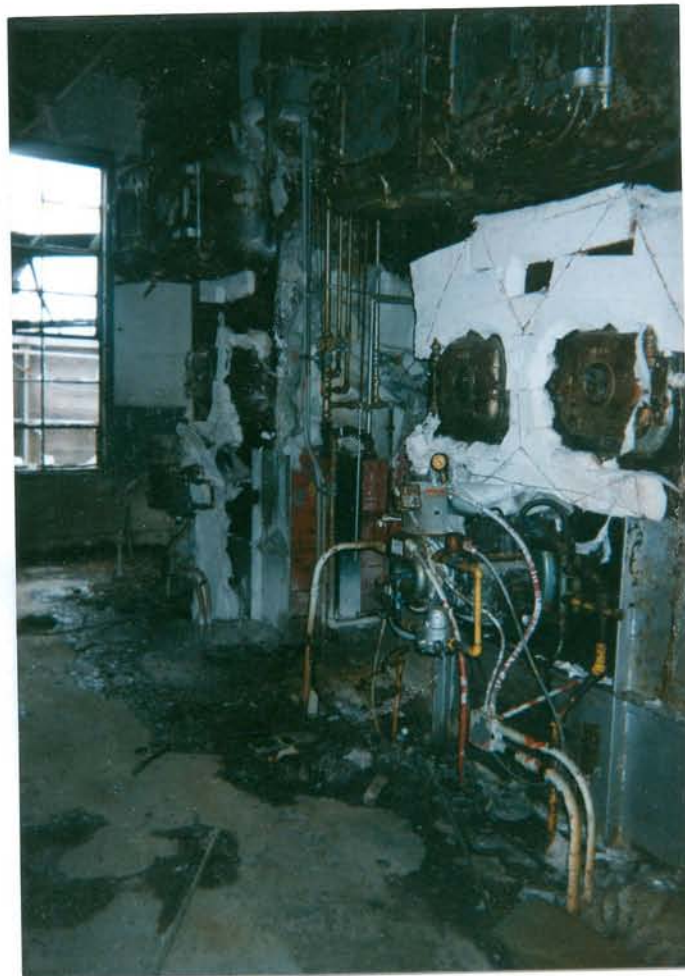
Site 13, Interior - Generator; Note: House PACM

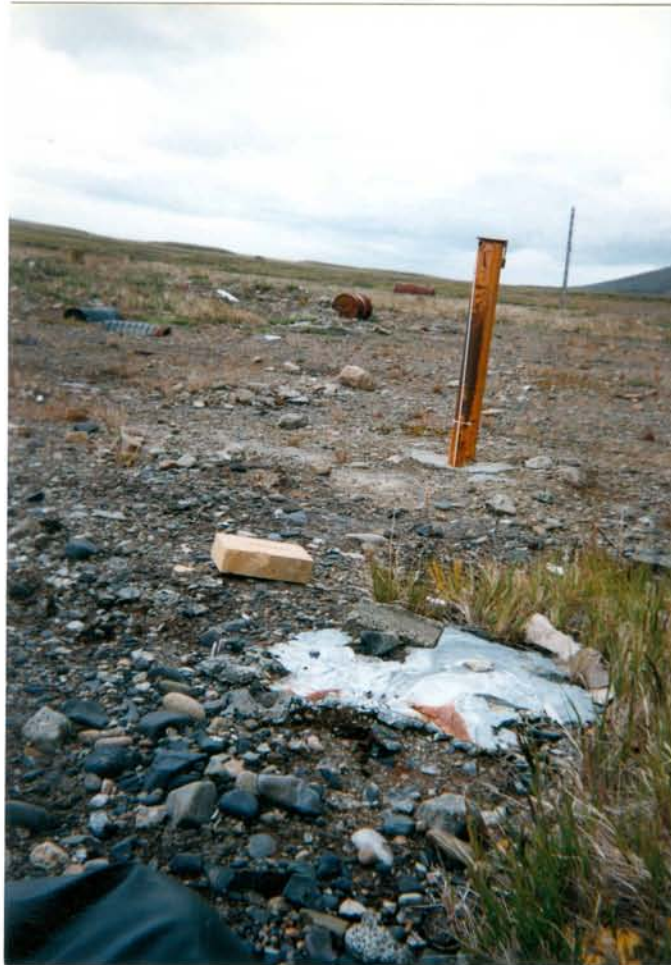
Site 16: Paint and Dope Storage Building, View from East side of
building. MW 16-1 in foreground
Note: Paint spill (solidified)

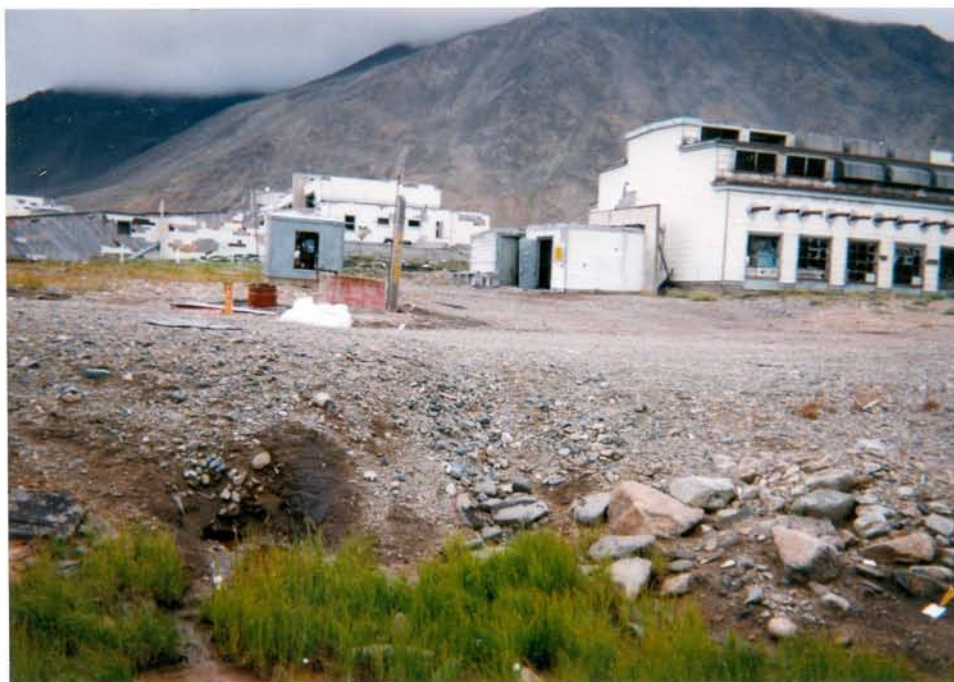
Looking South toward Site 27s' culvert to Drainage Basin. Note: staining near culvert

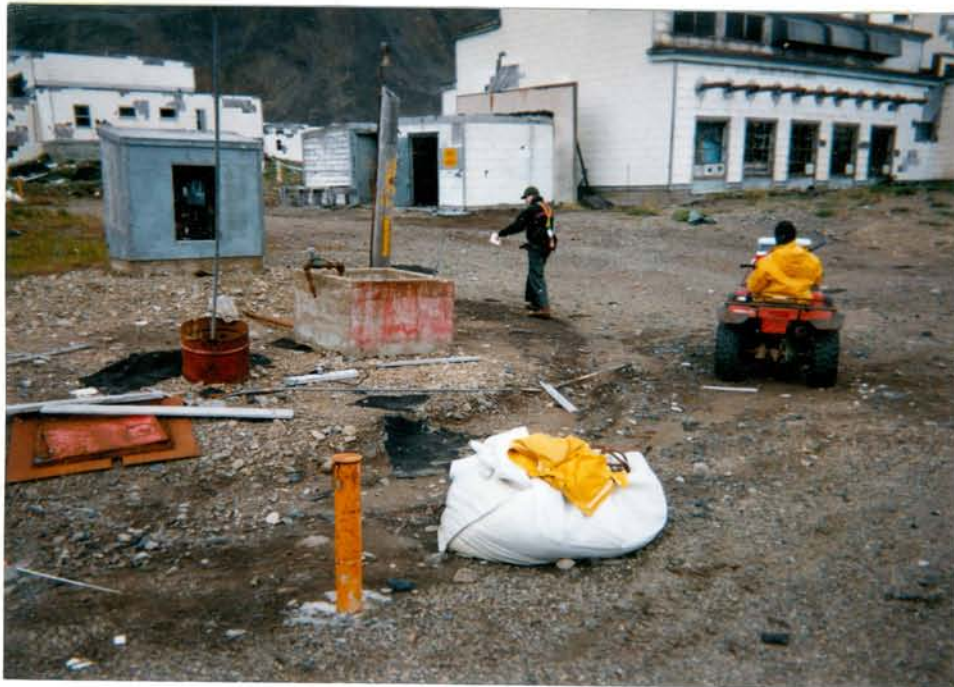
Site 27 looking South. Note: MW 27-1 and staining
