United States Army  
Corps of Engineers

# Trip Report

Gambell FUDS Site  
Gambell, Alaska  
21 – 22 July 2004

**Trip Report  
Gambell FUDS Site  
Gambell, Alaska  
21-22 July 2004**

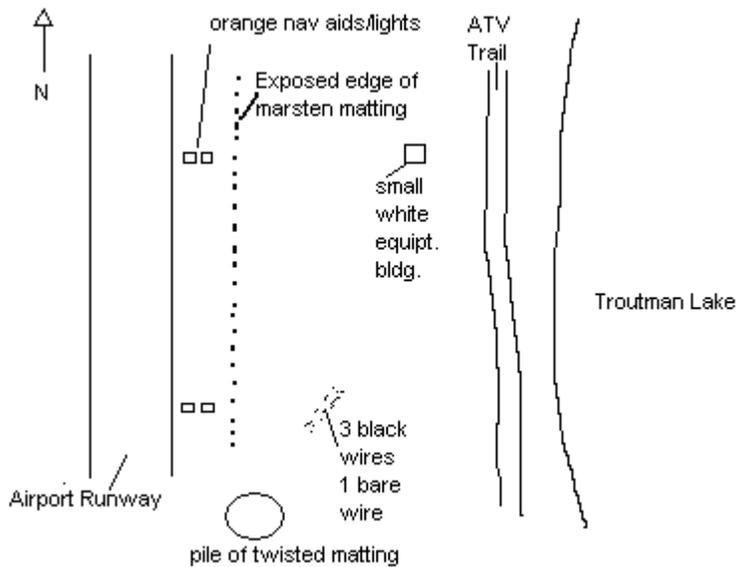
Figure 2 - Marsten matting along east side of airport runway (Site 8A)

At 10:00, Lisa Geist and Scott Kendall traveled to the airstrip to view the exposed marsten matting. At 10:30 am, the team encountered Bruce B., the local airport maintenance employee. Bruce mentioned that Pat Kellerer was the FAA/DOT contact in Nome. The exposed marsten matting is concentrated along the southern half of the eastern side of the runway. Towards the southern end of the runway, an exposed group of wires was observed (see photo log). According to Bruce, the power lines for the runway lights are buried underneath the asphalt runway. However, the FAA's navigation aids appear to be connected by wiring which runs east of the runway (see sketch).

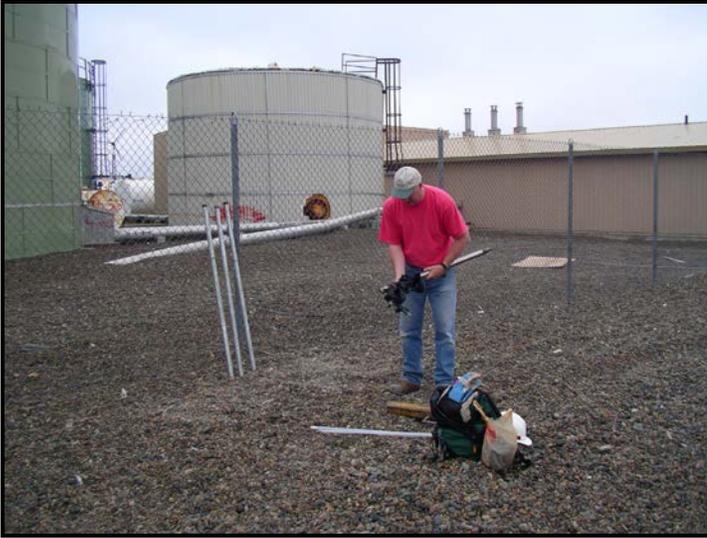
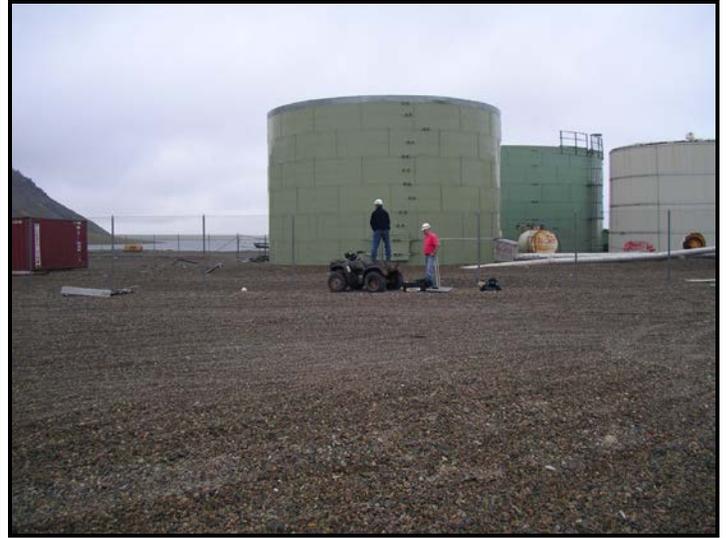
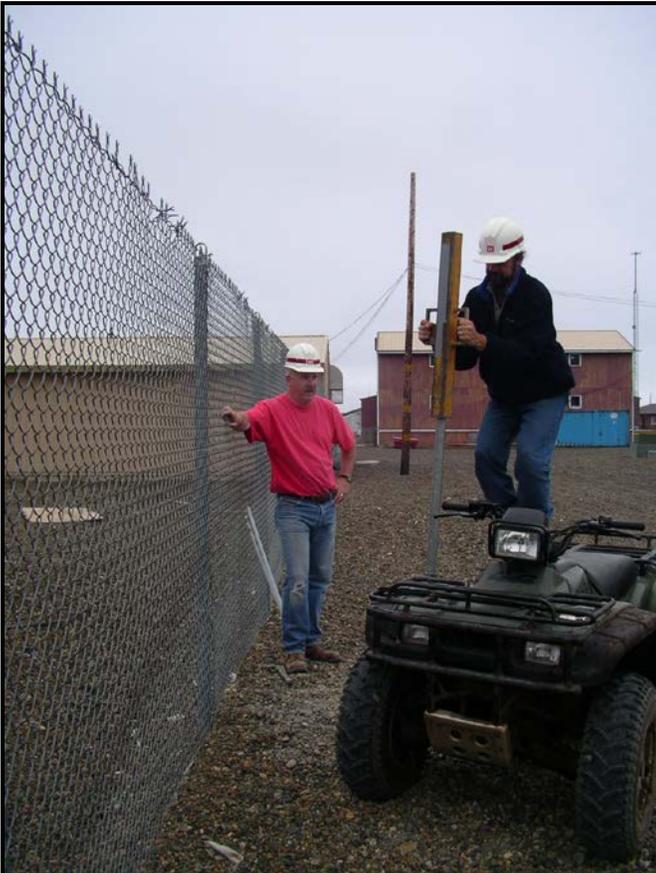
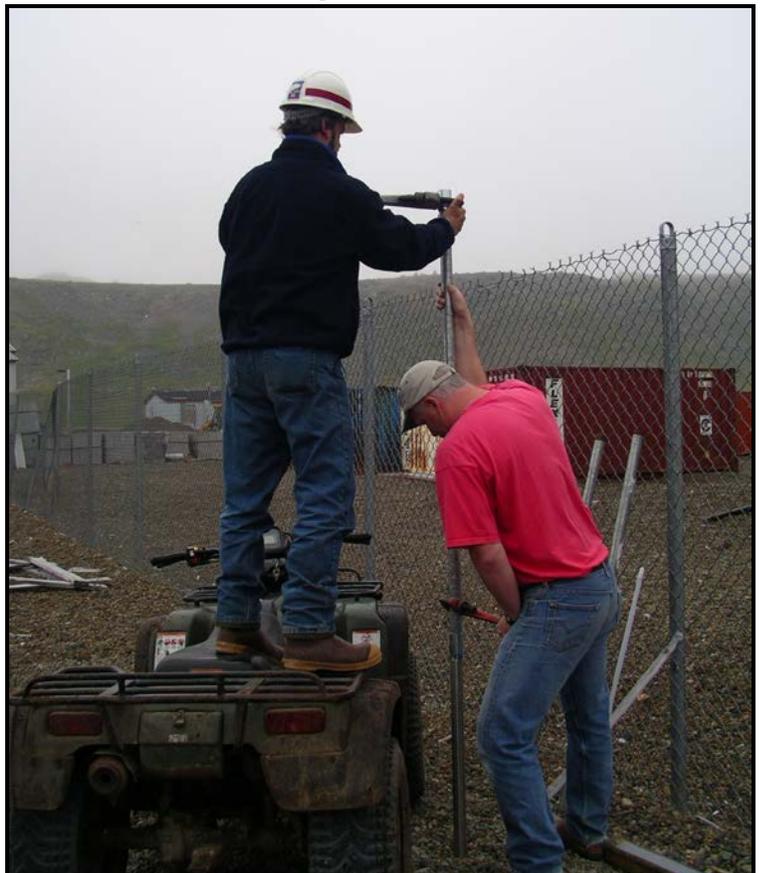
Photo 1- View southwest towards water treatment bldg    Photo 2 - View southeast towards tanks.

At 9:25 am, the well point was driven 14.5 feet below ground surface. The well point was tested for water using the bailer. The top of casing was measured at 45 inches. The water recovered in the bailer had a slight odor of fuel, with grey silty water. The well point was pounded in an additional 1.5 feet. At 9:45 am, the well point was completed. The final top of casing measurement was 31 inches above ground surface. The well point was

tested again for water. A strong fuel odor was present in the bailer. The well point was left to rest for several hours.

Photos 1-4: Well point installation at Site 18A, adjacent to fence along northern boundary of washeteria area.

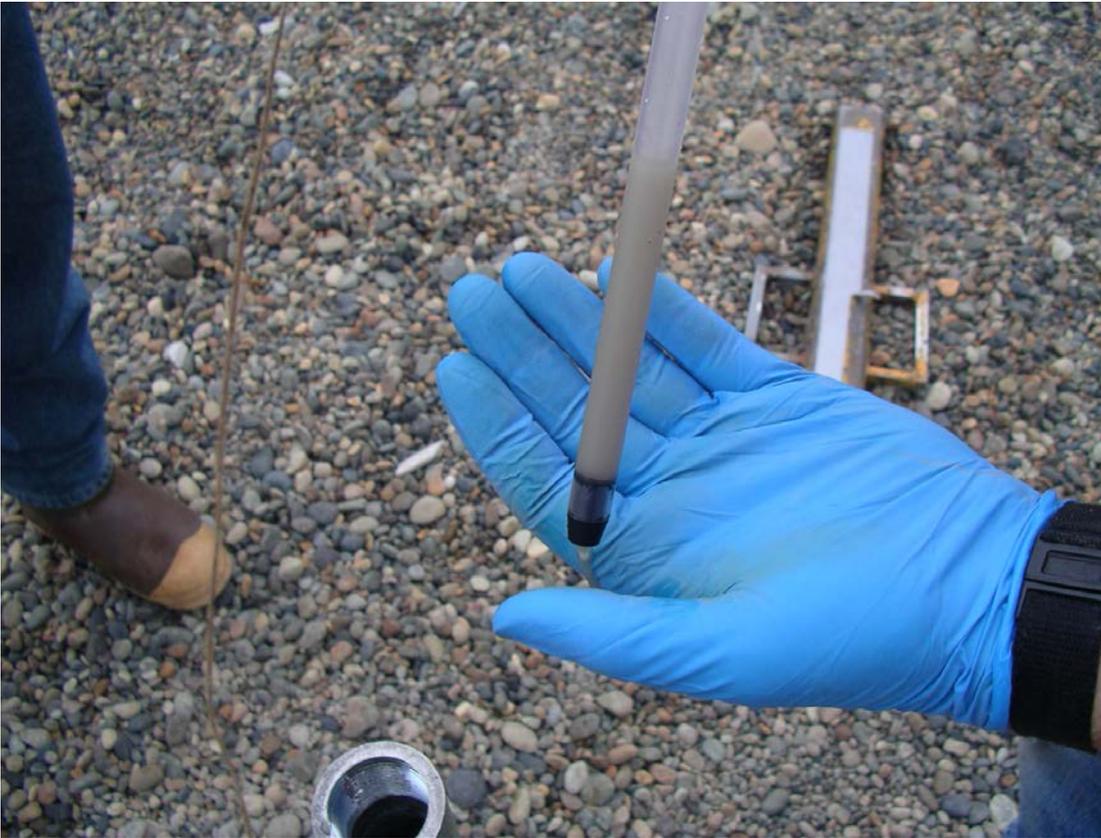
Photo 9: Sampling of well point 18A

At 1:45 pm, the field team returned to the well point at Site 18A to collect a groundwater sample. A slight sheen and fuel odor was observed from the water recovered from the bailer. The water was clear at the top of the bailer. Approximately 14 inches of water was recovered in the bailer. The total depth of the well point was 224 inches (to top of casing). The top of casing was 31 inches above ground surface. The total depth of the well point was 16 feet below ground surface. Water was encountered at approximately 14.5 feet below ground surface.

At 2:25 pm, the field team finished collecting enough water to completely fill two 50 ml amber sample jars, leaving no head space. The collected water had a definite sheen.

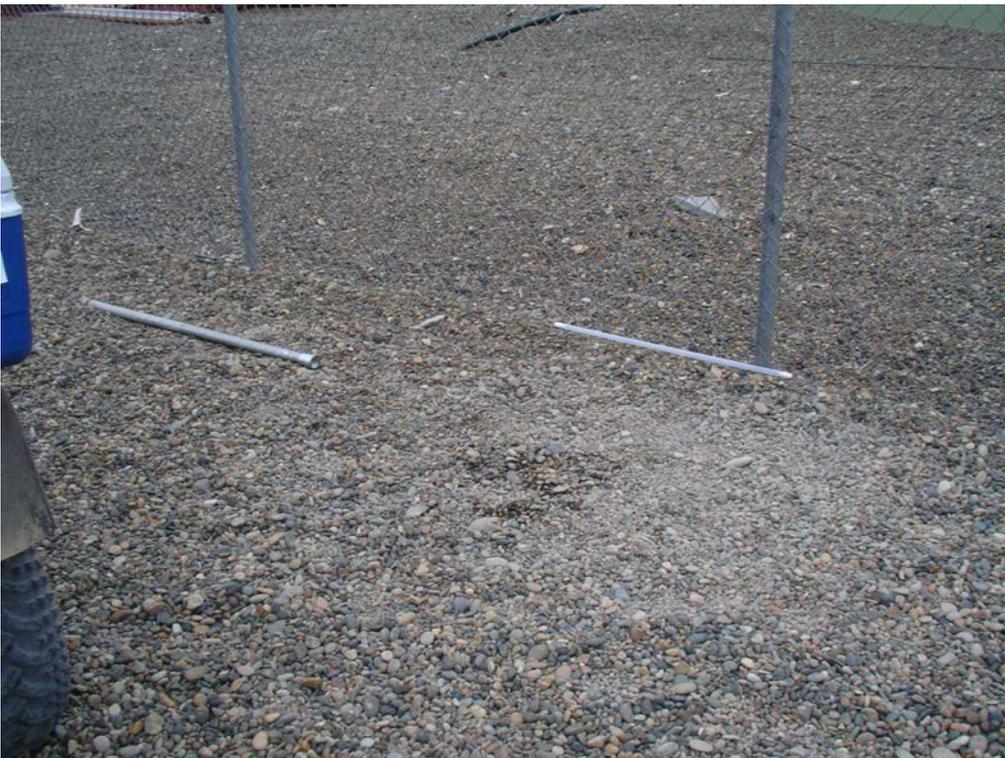
At 2:30 pm, the top 5 foot section of pipe was unscrewed and removed. The well point was abandoned in place by filling the remaining underground pipe with gravel.

Photo 10: Well point abandoned in place. Top 5 feet of casing removed.

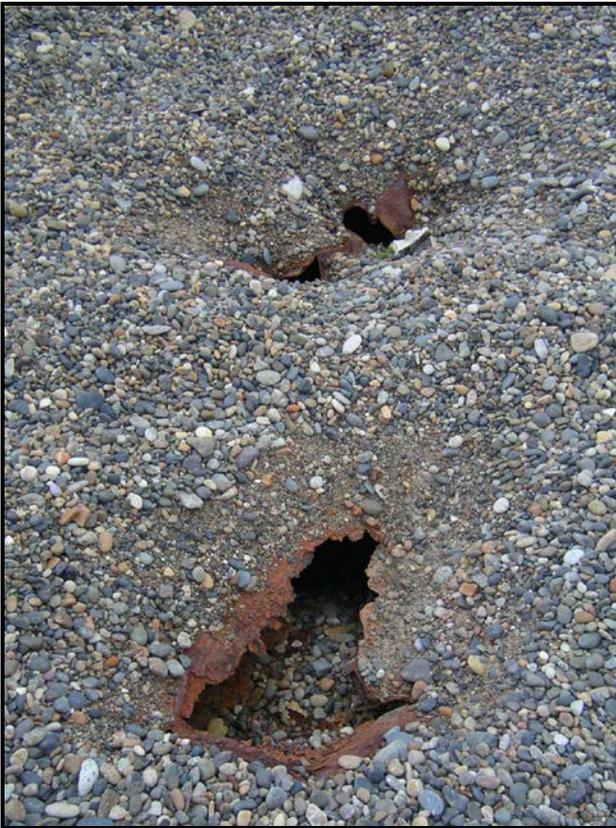
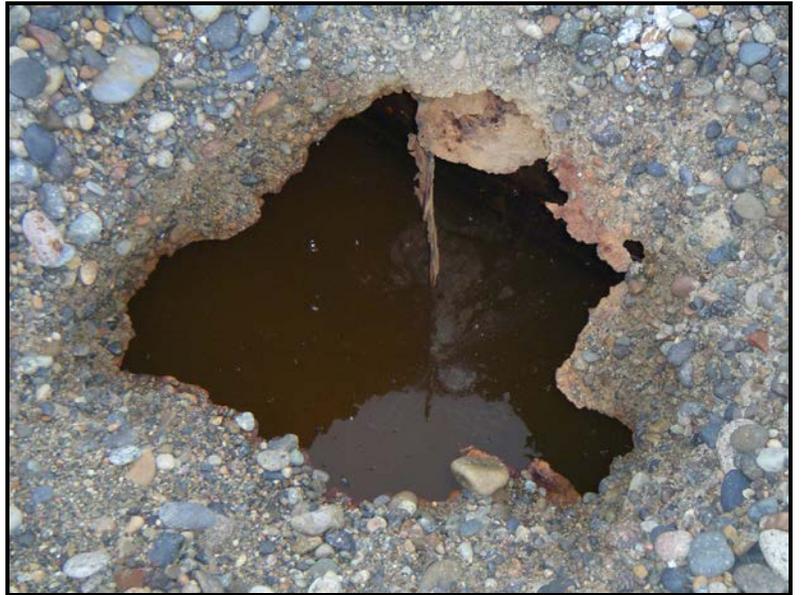
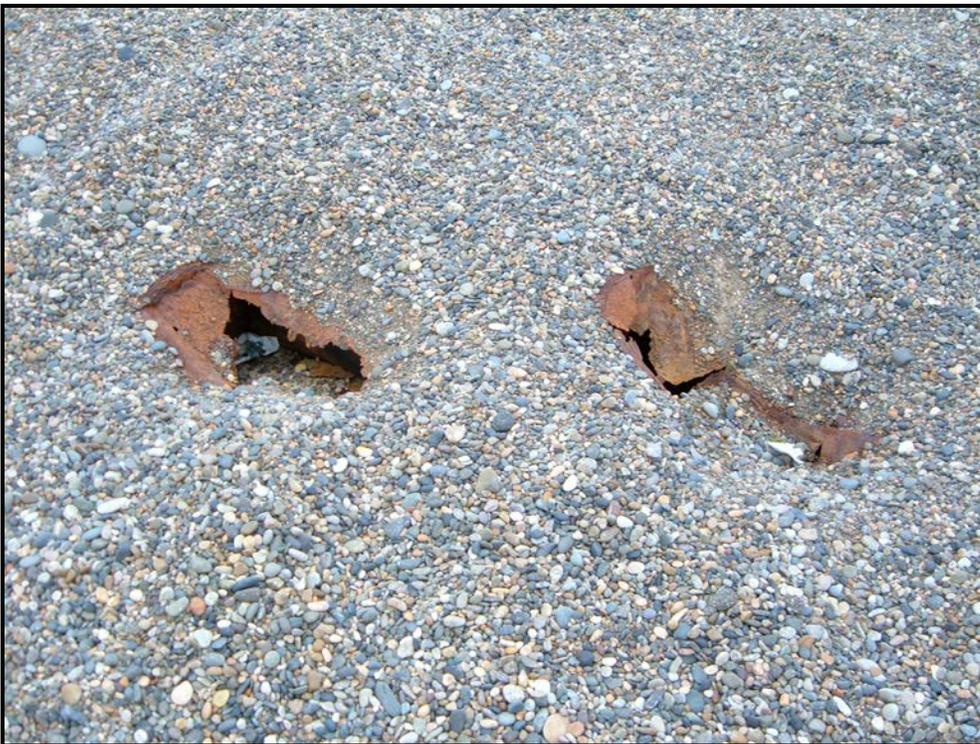
Photos 18 -20: Decaying drums at Site 8A, northern edge of exposed marsten matting area

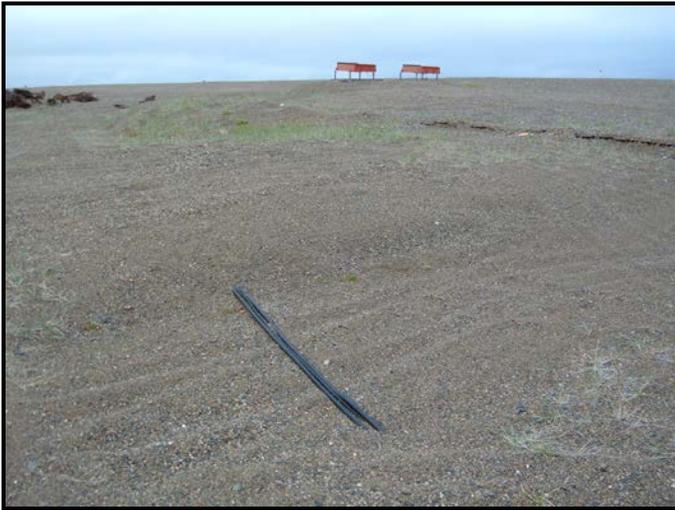
Photo 21: Exposed cables near southern end of airstrip. View southwest towards runway. Orange navigation aids / lights in background.

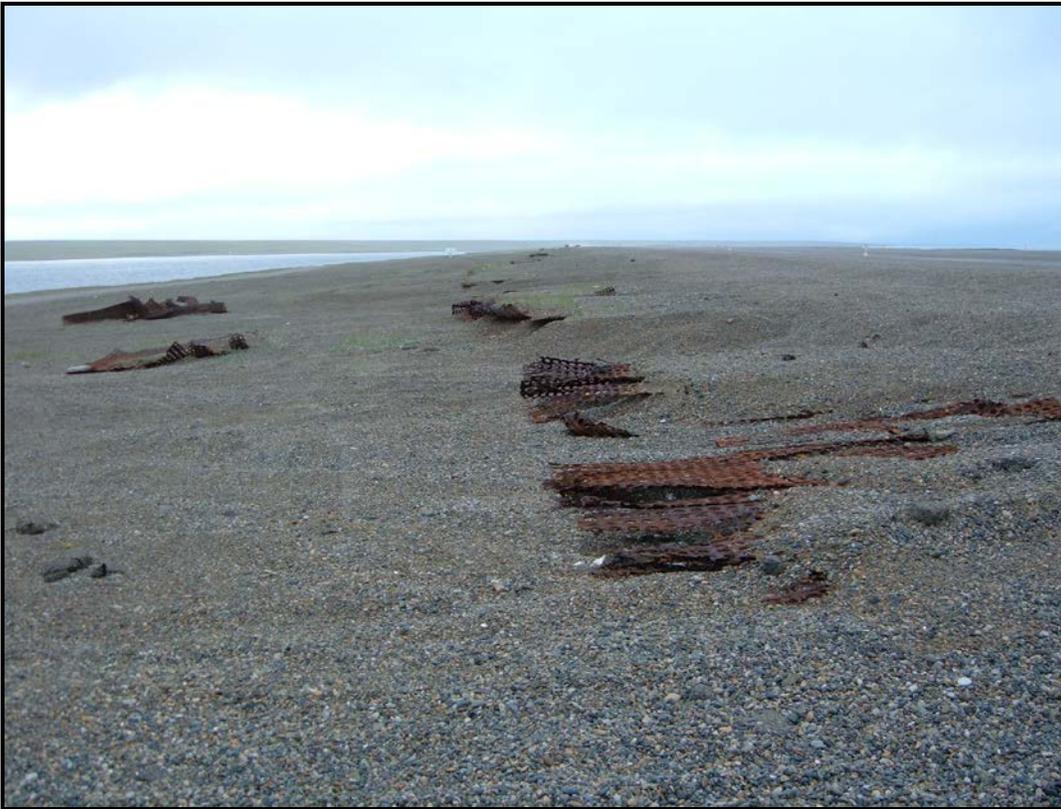
Photo 24: Exposed marsten matting along eastern edge of Airstrip, looking south (Site 8A)

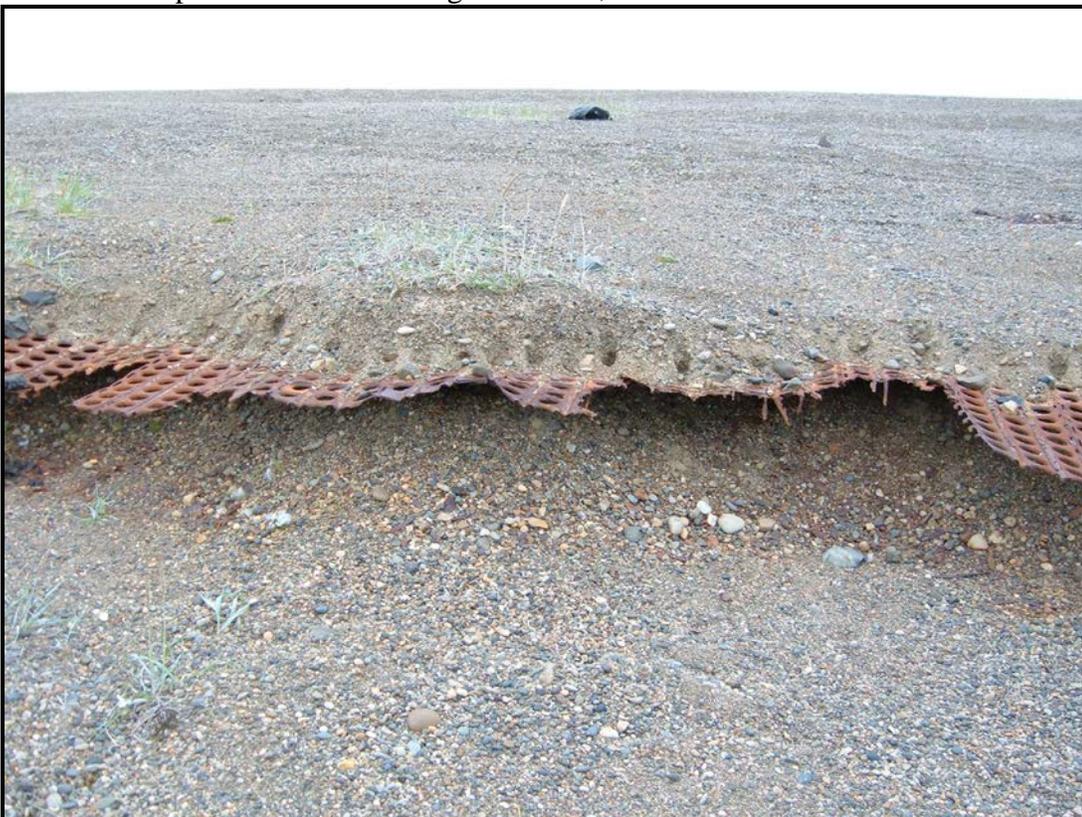
Photo 25: Exposed marsten matting at Site 8A, view west

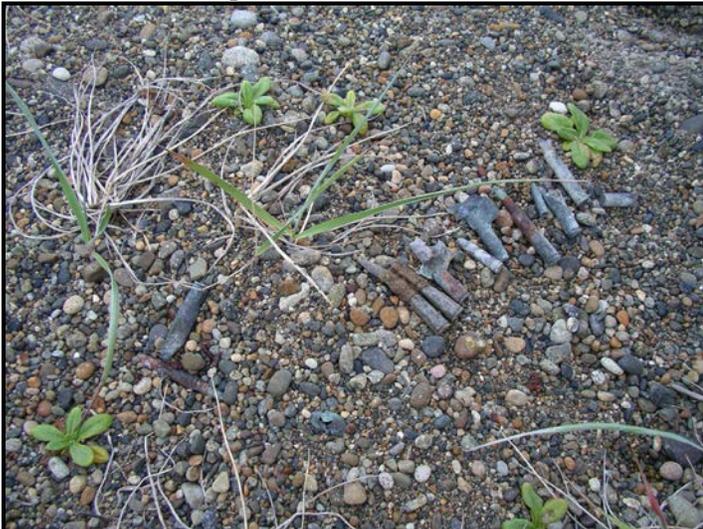
The field team continued to Site 12 and Site 8D to observe current conditions. The location of Site 12 is adjacent to a fork in ATV trails south of Troutman lake. Some remnants of debris/trash were observed, but the lead-contaminated soil is not visible to the eye. Site 8D, the beach ammunition burial pits were located due west of Site 12. Two kinds of ammunition were predominantly observed. The casings included both intact and previously ruptured shells.

Photo 33: close up of small arms ammunition

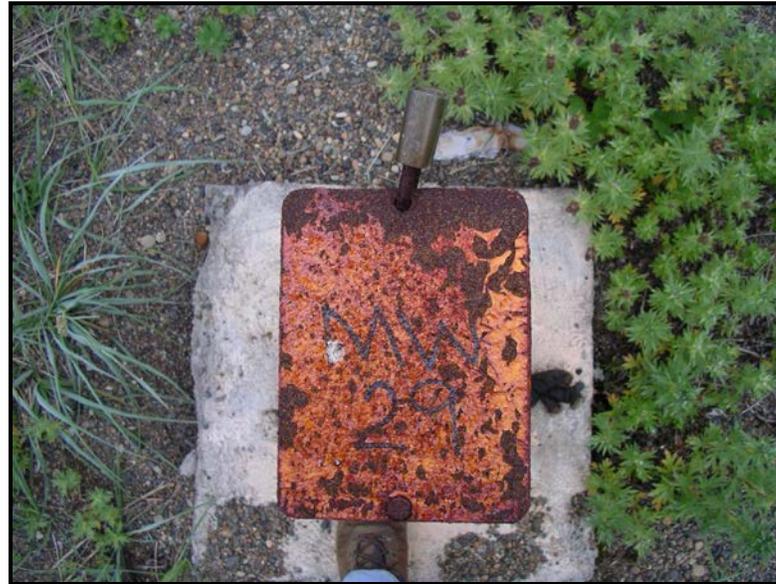
Photo 37: Top view of MW29

At 12:30 pm, the field team traveled to Site 5 to conduct an inventory the existing monitoring wells. MW28 was located southwest of the fenced Village water supply well building, and found filled with gravel. MW29 was located east of the ATV trail, and southeast of the water supply building. The well was locked, but would

require cutting of the lock to be opened. Slight frost jacking was observed. MW 32 was located due southeast of the water supply building. The top of the well was resting on the casing, no lock was present. Otherwise, the well seemed in good condition. MW 15 was located northeast of the water supply building. This well is an older vintage. No lock was present on the outer casing, but the interior well was capped with a white plastic PVC cap. MW30 was located northwest of the water supply building. The well was locked, but weathered in place and would require cutting. Another monitoring well not related to previous remedial investigations was documented due north of the water supply building. MW 14 was located further north from MW15. A plastic tie secured the top of the protective casing, the lock had been previously removed. The protective casing of MW14 was also loose.

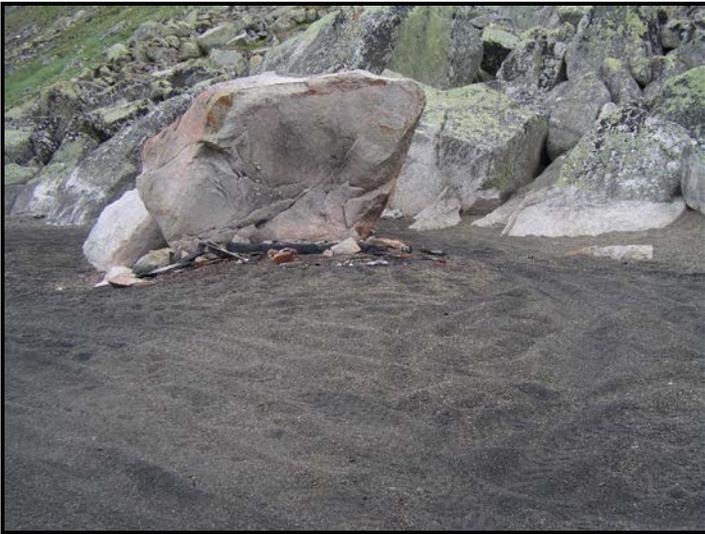
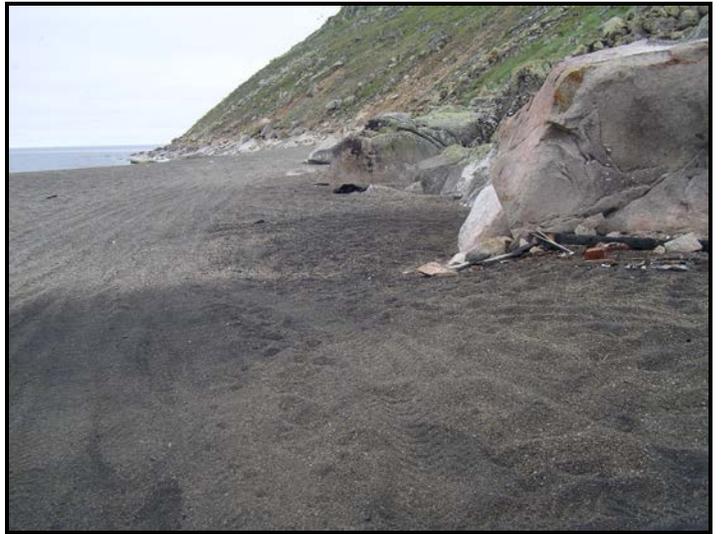
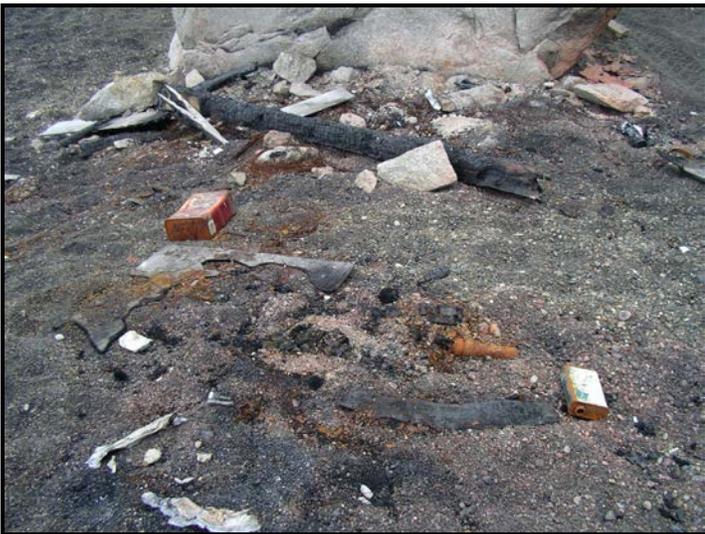
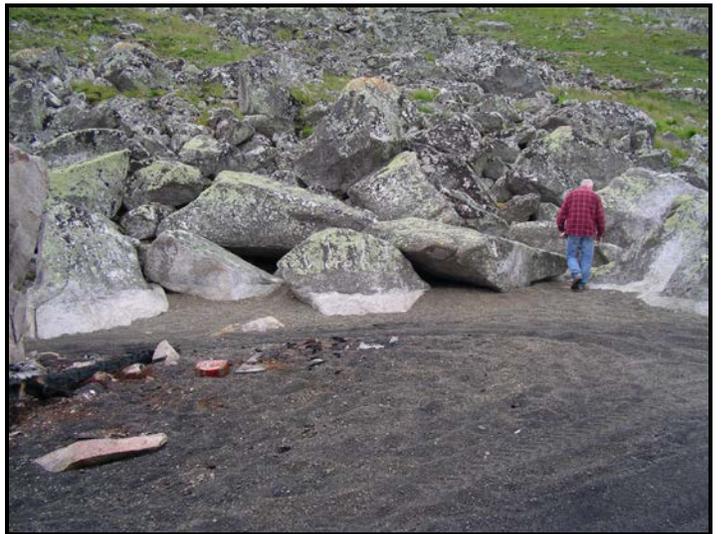
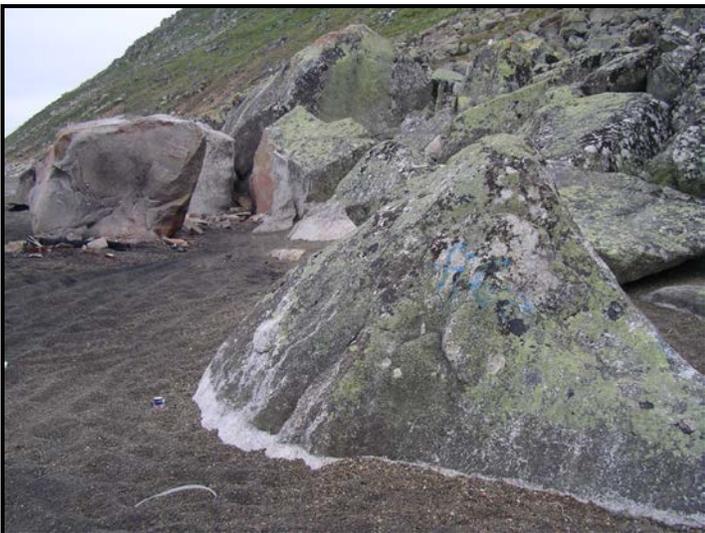
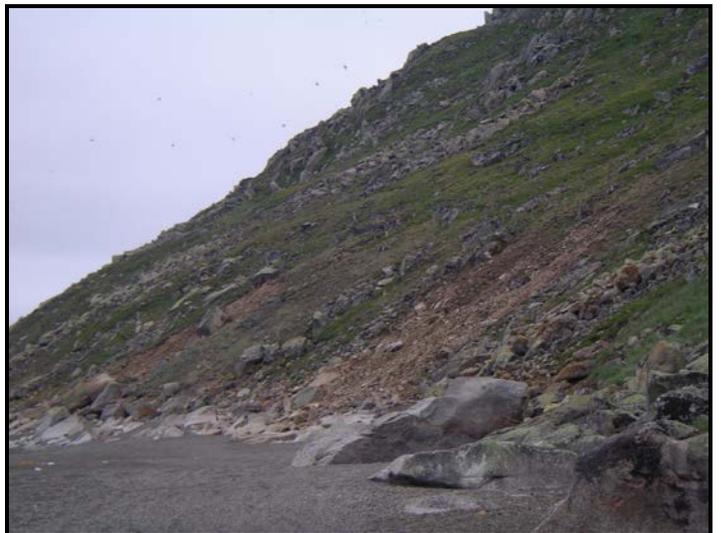
Five additional older vintage monitoring wells were observed north of Site 5 in the vicinity of Sites 2 and 3. The previous location of the POL-contaminated soil excavation at Site 2 was approximately located and photographed. The area appeared discolored from campfire burning (ash), other local trash was visible. Just north of this area near rocks at the base of Sevuokuk Mountain, more local trash was observed, including metal rims from discarded ATV wheels (see photo log). The team continued along the north beach and back to the main village area.

Photos 53 - 58: Site 2/3 – vicinity of 1999 soil excavation, local debris and campfire remnants

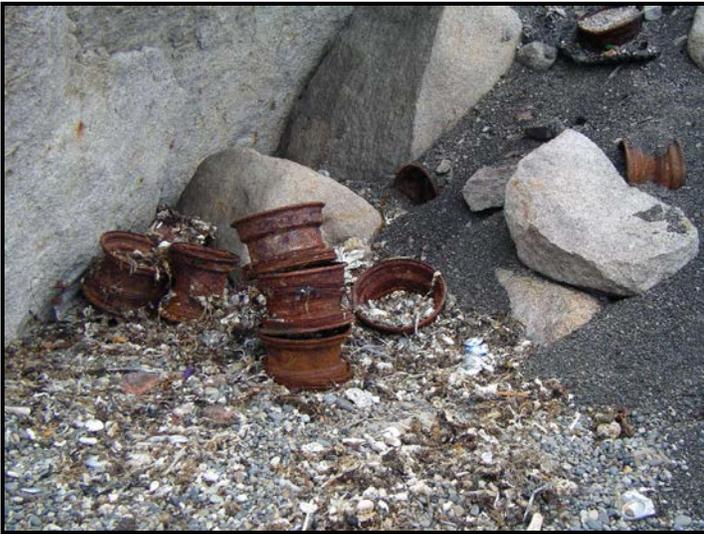
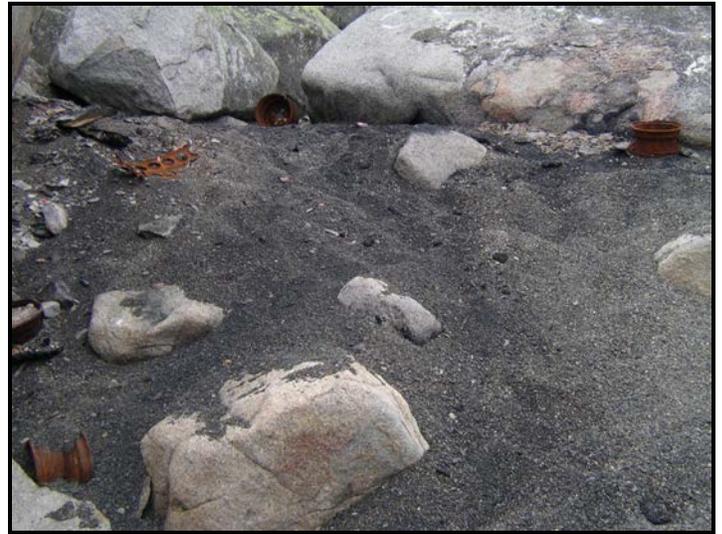
Photos 59 - 60: Near north beach and Sevuokuk Mountain, local debris and ATV wheel rims.

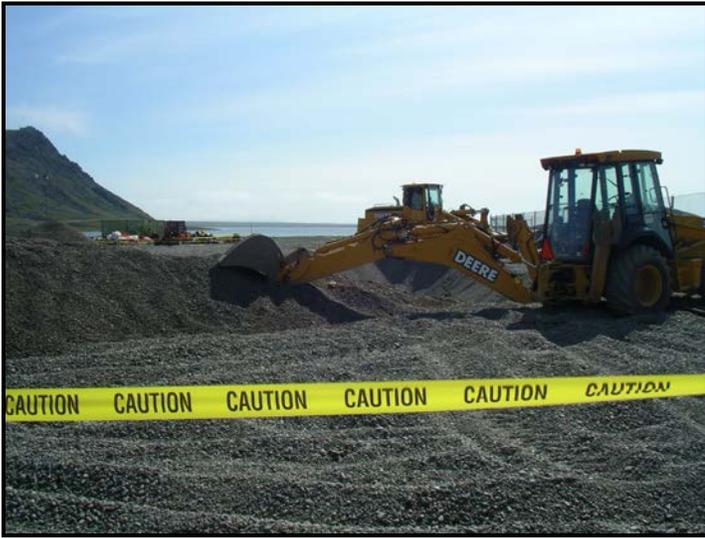
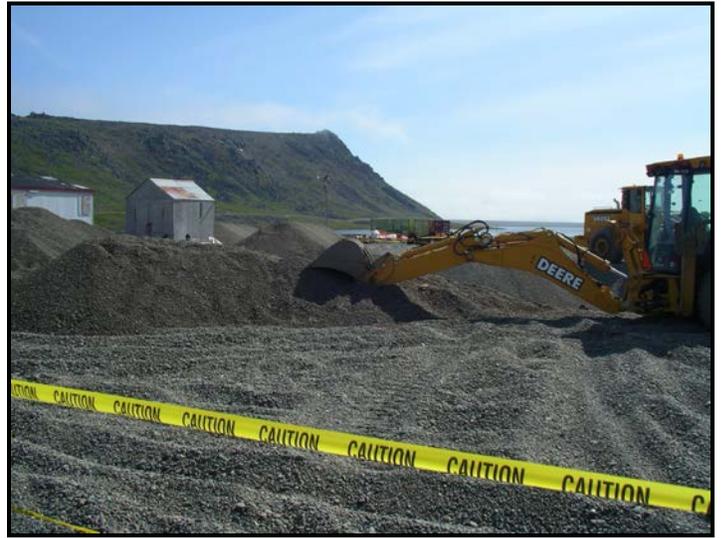
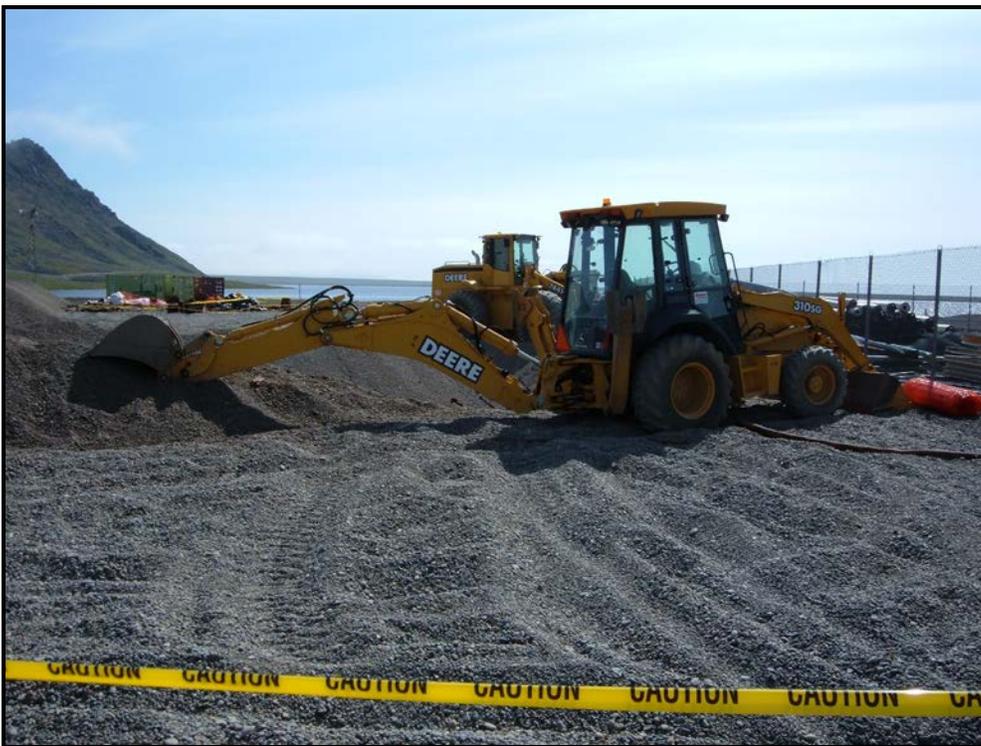
Photos 63 - 65: NALEMP excavation activities at Site 18, east of the Washeteria complex. Views south and southeast towards Troutman Lake.

At the end of the day, the field team observed the local NALEMP staff working on the excavation of buried debris at Site 18, just east of the washeteria/water treatment complex. The local laborers were hand cutting debris and loading a staged connex at the job site. The team noted that the John Deere 744H Loader's rear windshield was broken, and required covering with plastic bags by the equipment operator. Several supersacks were observed, but appeared to be only partially filled with contaminated soil. Many black plastic garbage bags had been used to containerize debris (later determined to be insulation) in piles. The excavation area was a large pit, with some twisted Quonset hut metal frames visible. A portion of a fuel pipeline had also been exposed near the washeteria fence. The job site area was marked with yellow caution tape. The local laborers moved the debris using ATV trailers and then transferring the debris by hand into the front-door of a standard connex box. The backhoe was also used to transport debris from the excavation pit location to the staging area.

Although the team did not spend a lot of time observing the ongoing NALEMP project, questions were raised regarding their familiarity with the workplan, and the effective use of laborers, equipment, and communicating safe work practices.
