**U.S. Army Corps of Engineers, Alaska District  
White Alice Tram and Debris Removal  
Northeast Cape, St. Lawrence Island, Alaska  
Contract No. W911KB-04-C-0019  
FUDS Property No. F10AK096901**

**REMOVAL ACTION REPORT  
FINAL  
September 2006**

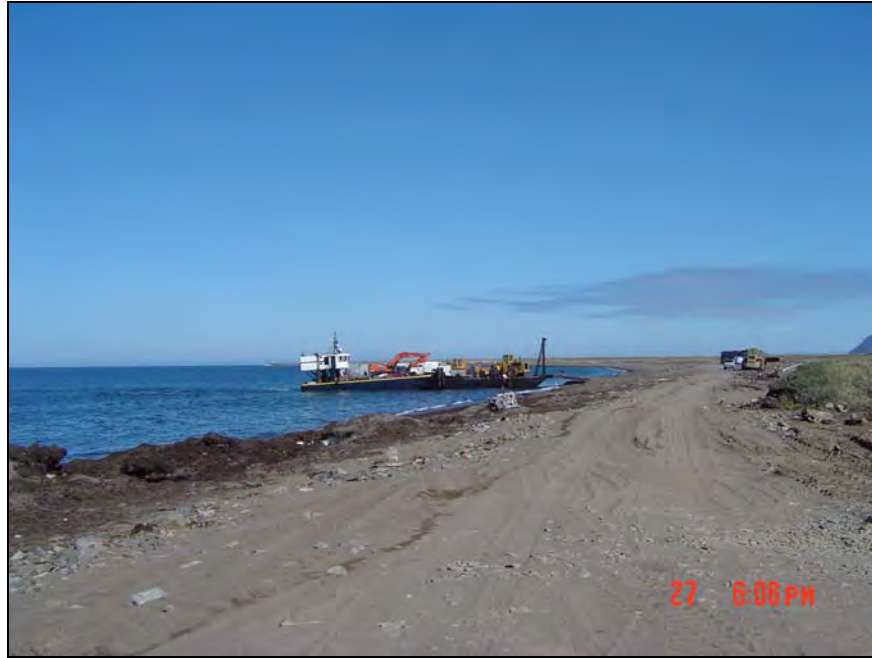
### Figure 5-1 Mobilization Activities

Photograph 1. Unloading heavy equipment during mobilization activities. Photo facing northeast.

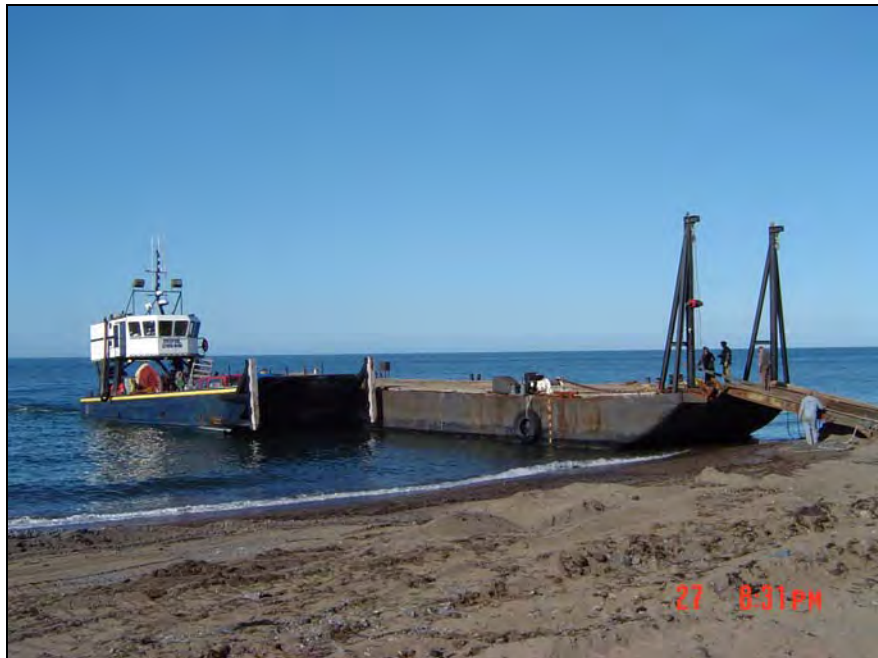
Photograph 2. Landing craft unloaded and ready to depart after mobilization activities. Photo facing north.

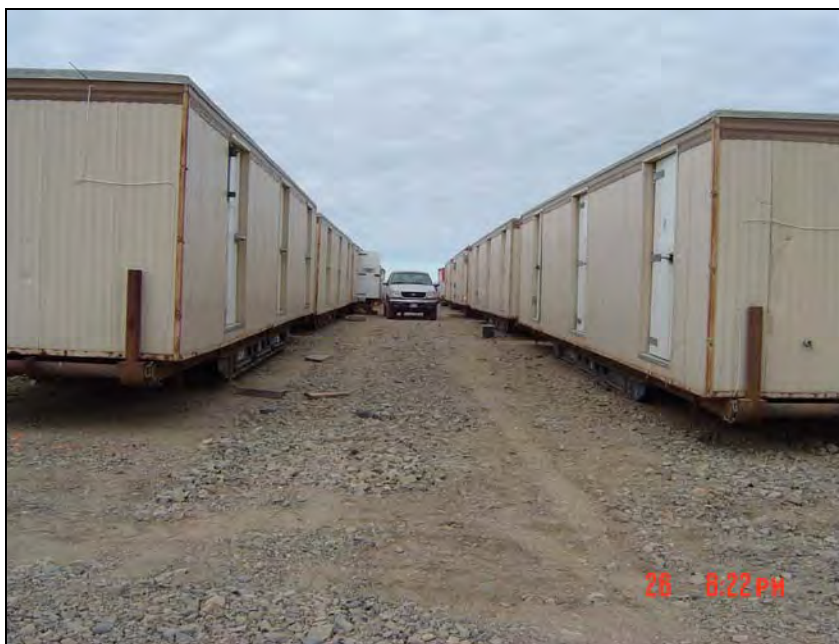
### Figure 5-2 Barge Offloading Activities

Photograph 3. Temporary construction camp being set up during mobilization activities. Photo facing northeast.

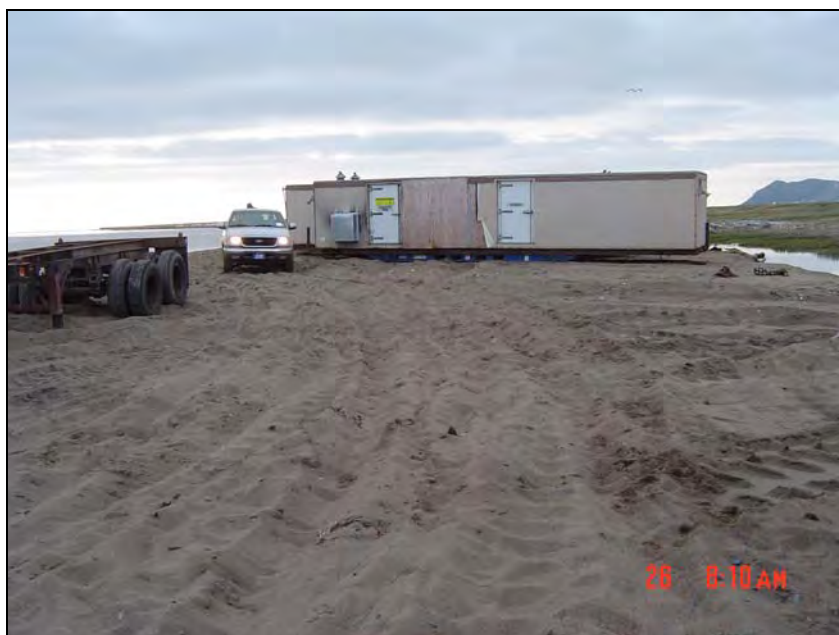
Photograph 4. Remaining camp trailers on cargo beach during mobilization activities. Photo facing northeast.

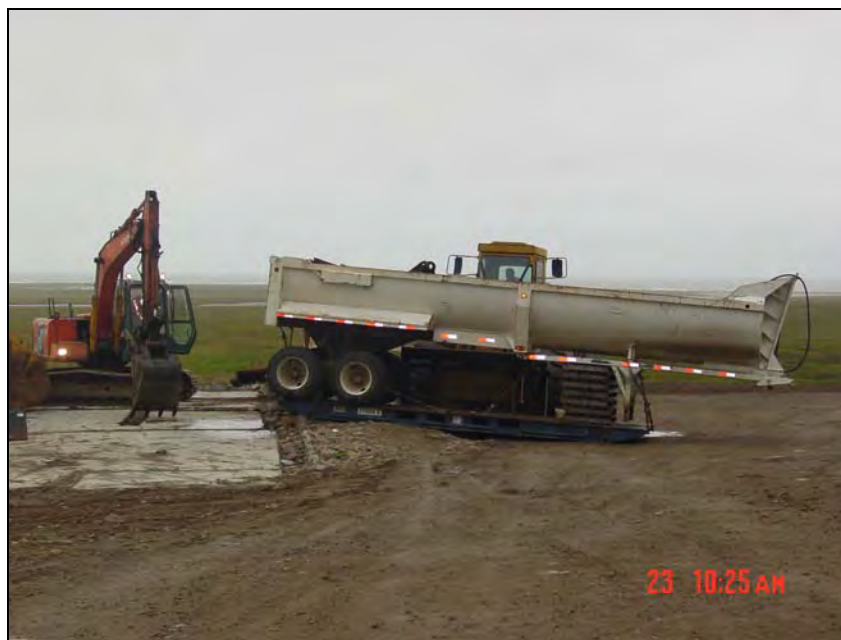
**Figure 5-3 Demobilization Activities**

Photograph 5. A mobile demolition trailer is being placed on a shipping flat as part of demobilization activities. Photo facing north.

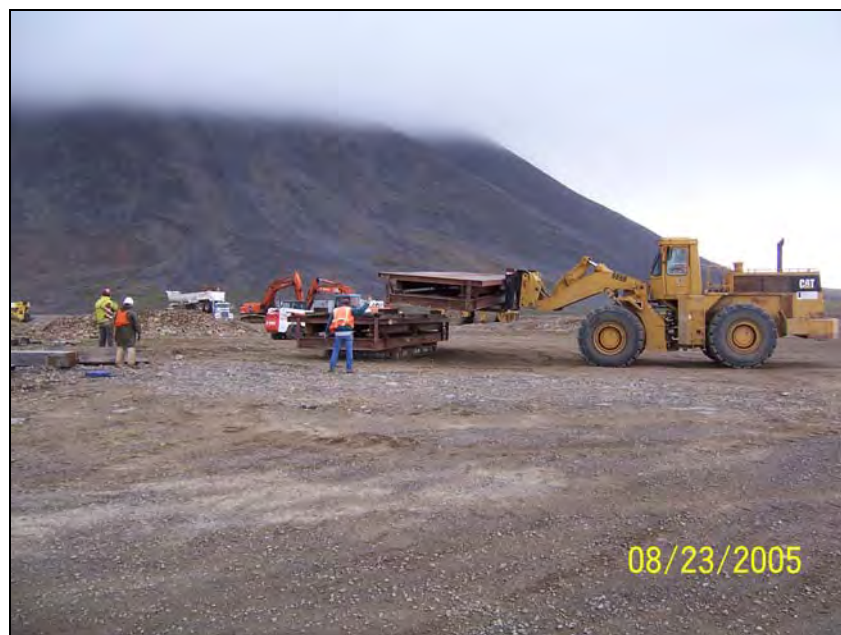
Photograph 6. Removal of the truck/waste scale during demobilization activities. Photo facing southwest.

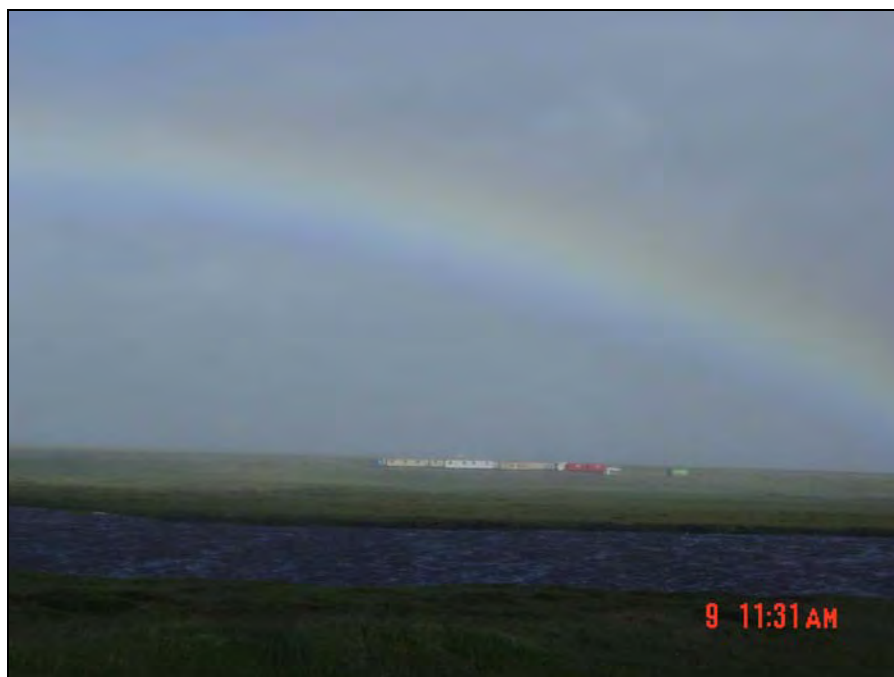
**Figure 5-4 Temporary Construction Camp**

Photograph 7. NE Cape temporary campsite. Note the camp is parallel to the NE Cape runway, behind the camp in this picture. Photo facing north.

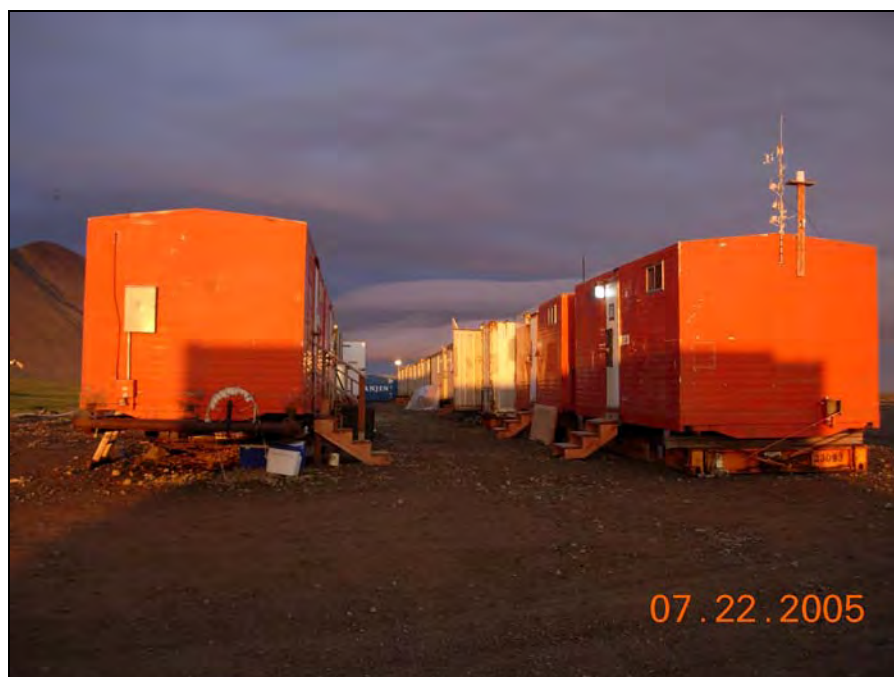
Photograph 8. Fully operational temporary construction camp. Note the weather station located on top of the trailer to the right. Photo facing southwest.

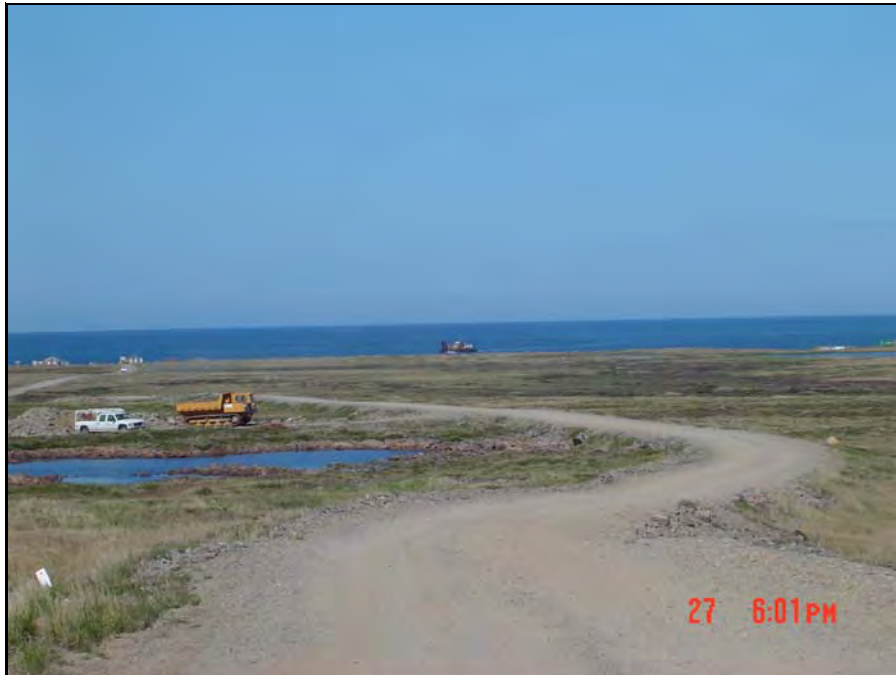
Photograph 9. Existing Cargo Beach road conditions during removal activities. Photo taken from Site 7 facing north.

Approximately six miles of gravel road connected the various work areas at the site. The roads were generally in good condition, and only required grading and minor backfilling to re-establish and maintain their usability. Although BEESC had a water truck on site to suppress dust, it was not needed because of the heavy precipitation. Photographs depicting typical conditions along the road system before and after the access improvements were made are shown on Figure 5-5.

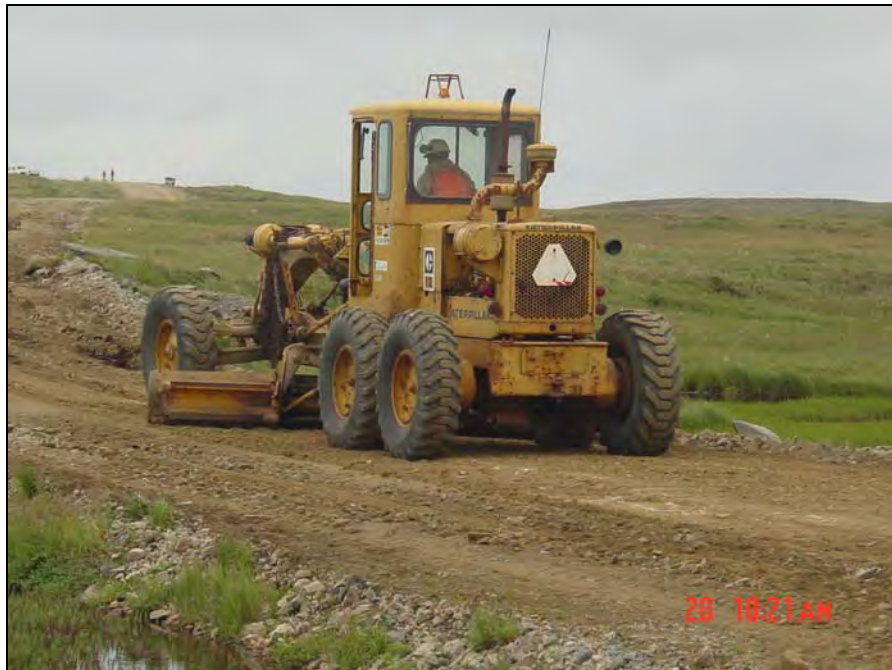
Photograph 10. BEESC repaired existing roadways throughout NE Cape including Cargo Beach road seen here. Note that the vehicles and people in the upper left background are at Site 7. Photo facing southwest.

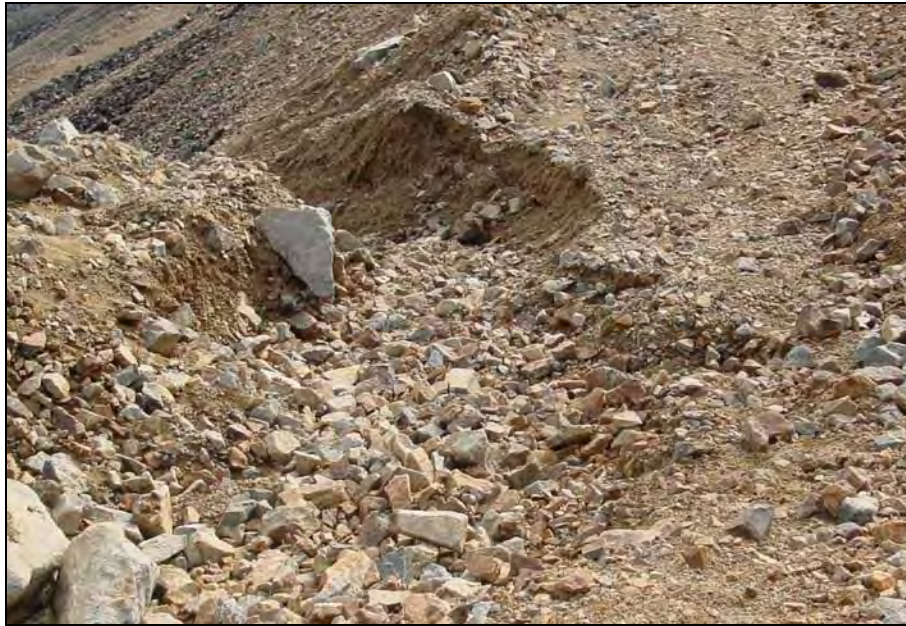
Photograph 11. Existing cat trail between the lower and upper mountain areas. Note the large washout area. Photo facing northeast.

The trails were improved by BEESC in 2003, however, water runoff erosion occurred between 2003 and 2005, which required BEESC to perform maintenance on the trails in 2005. The existing conditions, along with BEESC's improvements to the cat trails, are shown and described on Figure 5-6. The Main Cat Trail begins at Trail Point (TP) 30, at an elevation of 420 feet MSL datum, and ends at Site 34 at an elevation of approximately 1,810 feet MSL. The total vertical rise along the trail is 1,390 feet. The trail is 12,928 feet (2.45 miles) long with an average grade of 10.7 percent. The maximum grade of 31 percent occurs over a distance of a few hundred feet in the vicinity of TP 12 (Figure 5-7). The trail was constructed by the USAF to support construction of the AC&WS site at the top of the mountain.

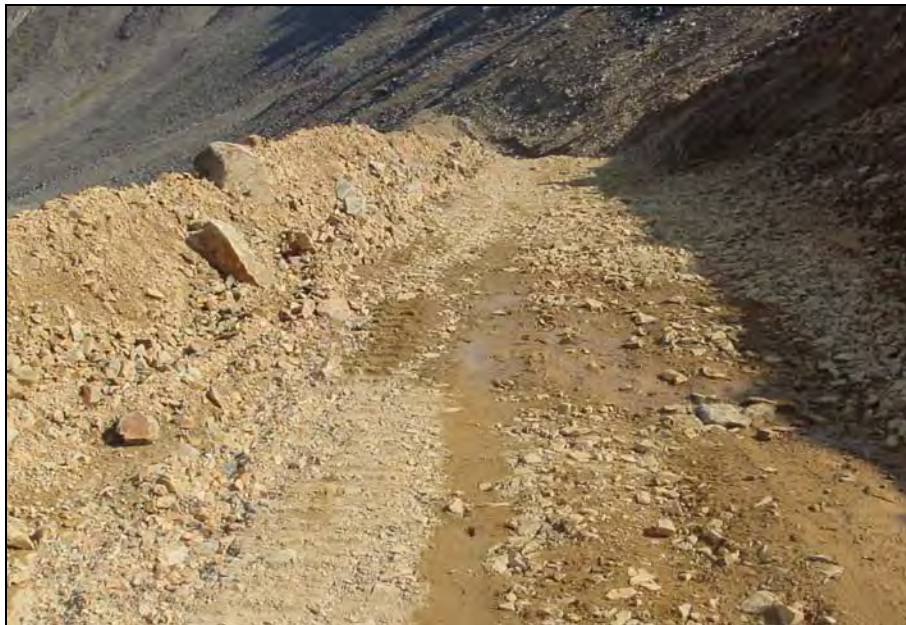
Photograph 12. The same Cat Trail area between the lower and upper mountain after BEESC's trail improvements. Photo facing northeast.

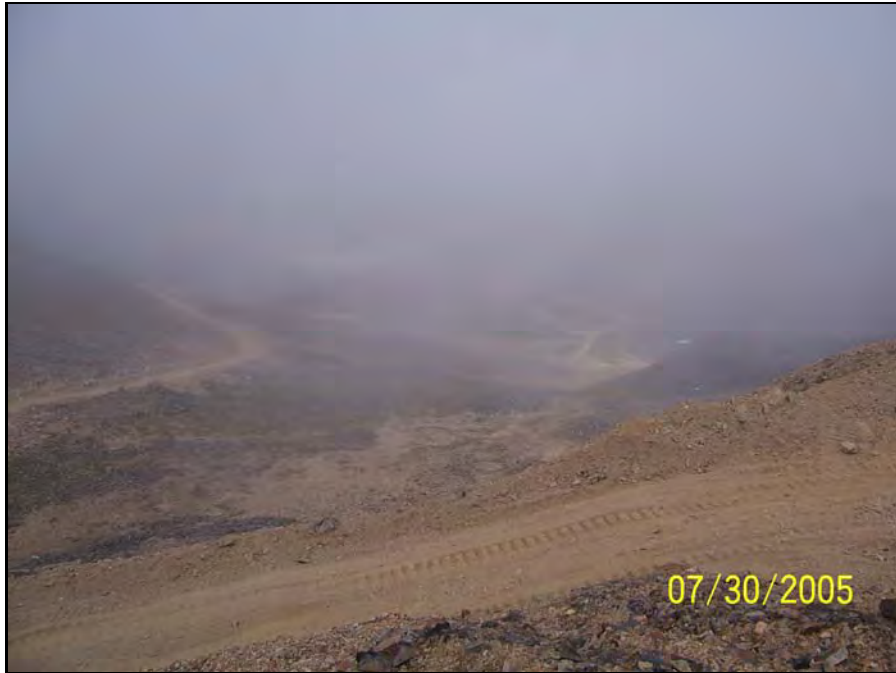
**Figure 5-7 Steep Grades Along Cat Trails**

Photograph 13. Cat trails traversed steep terrain using a series of sharp switchbacks. Photo facing northeast.

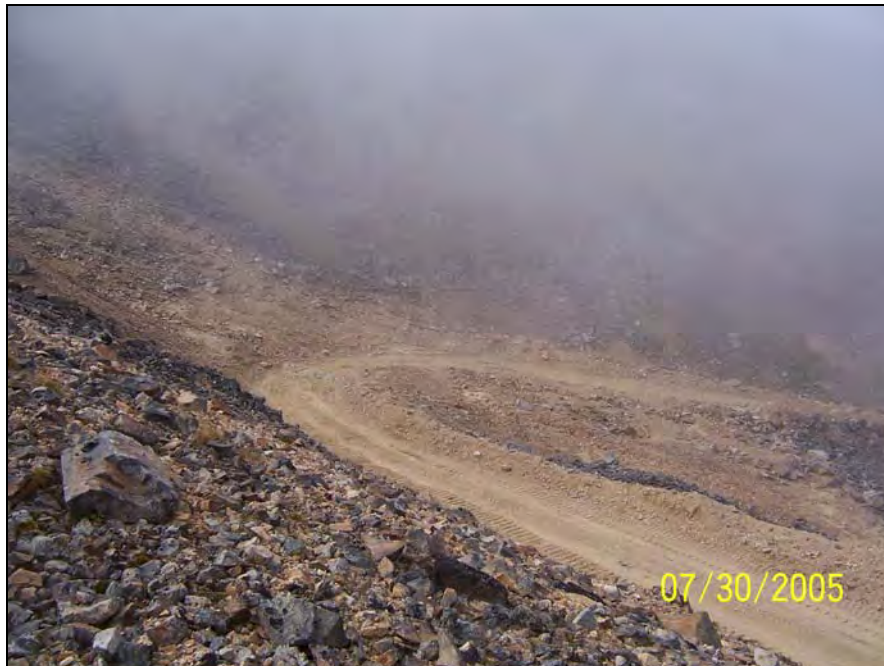
Photograph 14. A steeper area along the mountain cat trail with a sharp switchback. Photo facing northwest.

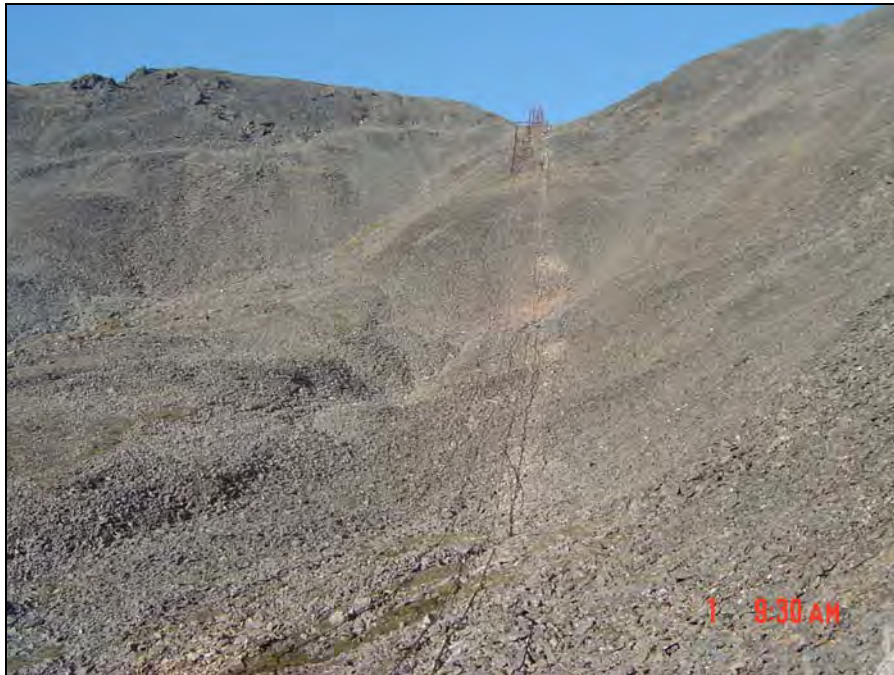
**Figure 5-8 Steepest Grades Encountered During Tram Removal**

Photograph 15. A steeper area along the mountain with terrain in excess of 100 percent grade. Photo facing southwest.

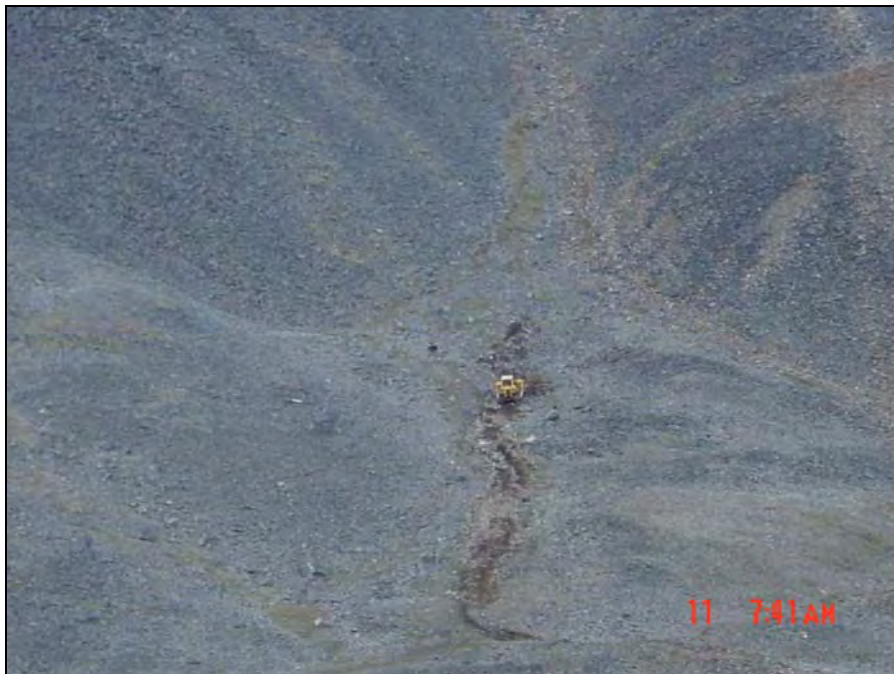
Photograph 16. Removing debris below the steepest portion of the mountain complex area. Photo facing west.

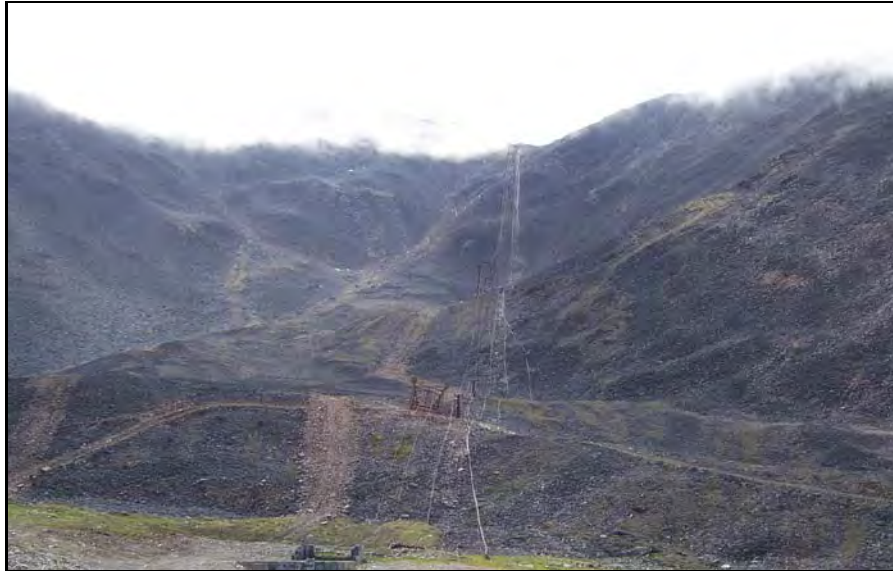
**Figure 5-9 Tram Tower and Cable Demolition**

Photograph 17. The existing tram system connecting the lower and upper mountain areas. Photo facing southwest.

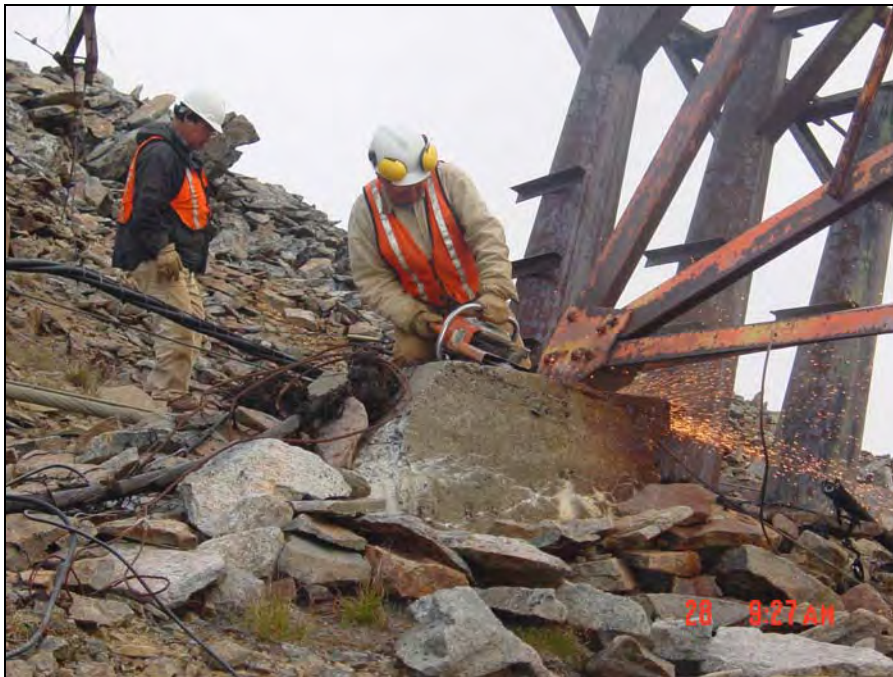
Photograph 18. BEESC crews used chop saws to notch the tram towers above their concrete footings. Photo facing north.

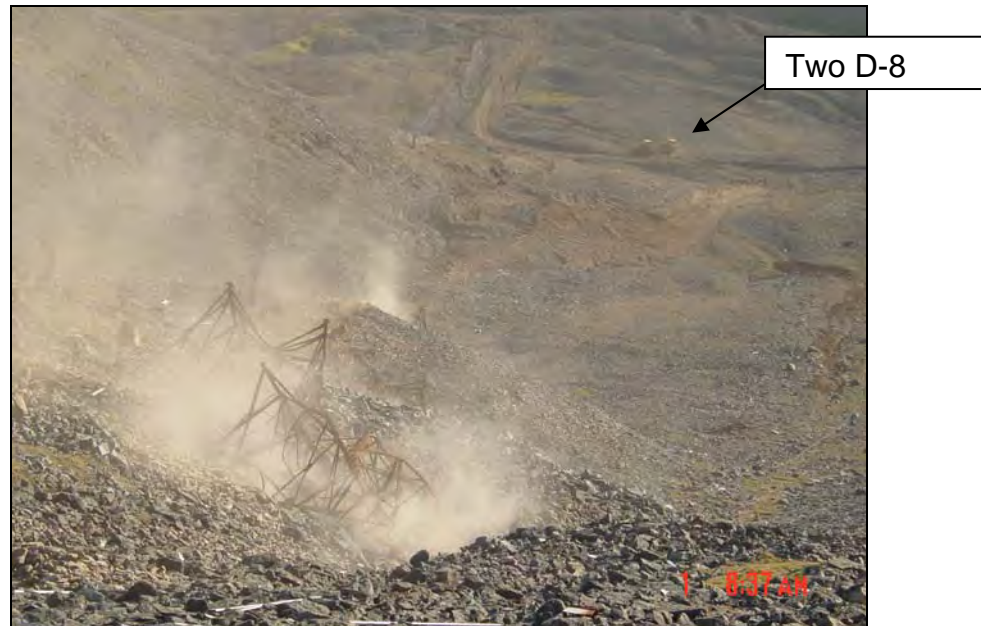
**Figure 5-10 Tram Tower and Cable Demolition**

Photograph 19. After the tram tower bases were notched, two D-8 Cats were attached to the existing tram cables to pull all the tram towers down the Kinipaghulghat Mountain slopes at one time. Photo facing northeast.

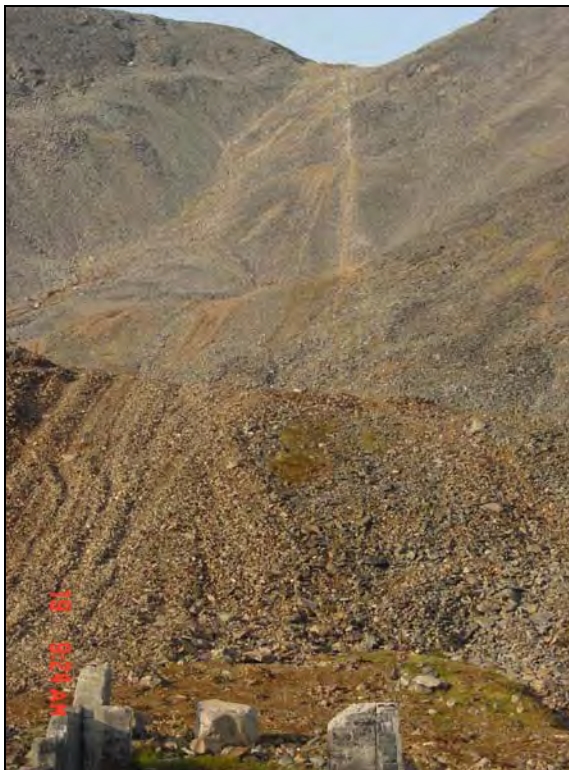
Photograph 20. The tram line area, after BEESC removed all the towers and debris from the mountain side. Photo facing southwest.

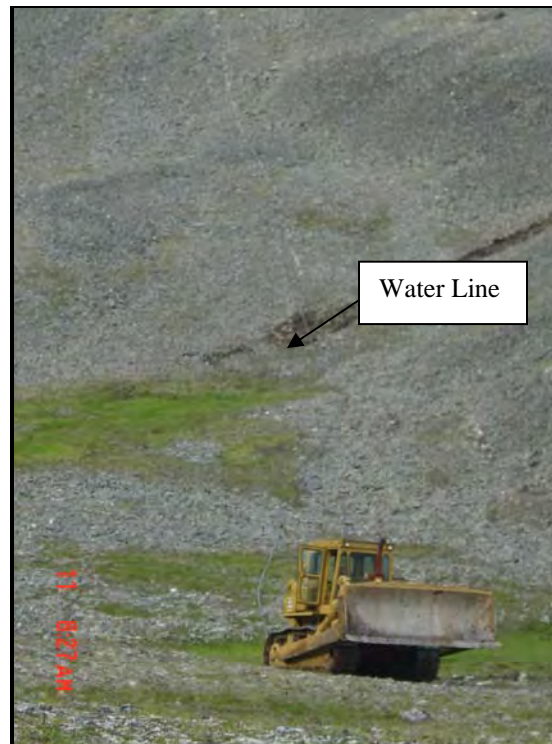
### Figure 5-11 Water Line Removal

Photograph 21. D-8 Cat pulling the upper mountain complex water line down to the base of the mountain for cutting and disposal. Photo facing southwest.

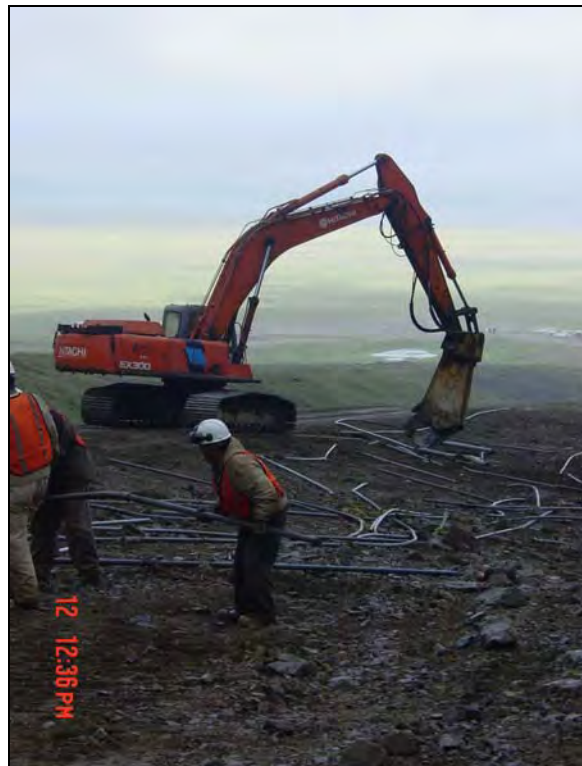
Photograph 22. Excavator outfitted with hydraulic shears was used to cut the water line. Note the BEESC crew in the foreground, placing the cut pieces of piping into a Conex. Photo facing north.

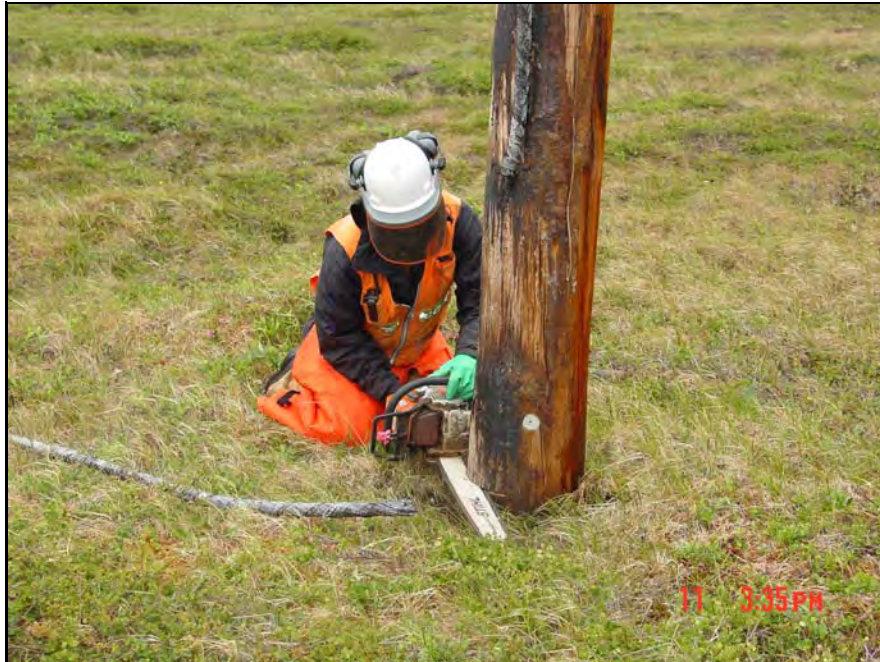
**Figure 5-12 Pole Line and Debris Field Removal Methods and Equipment**

Photograph 23. Chain saws were used to cut existing wooden poles down.

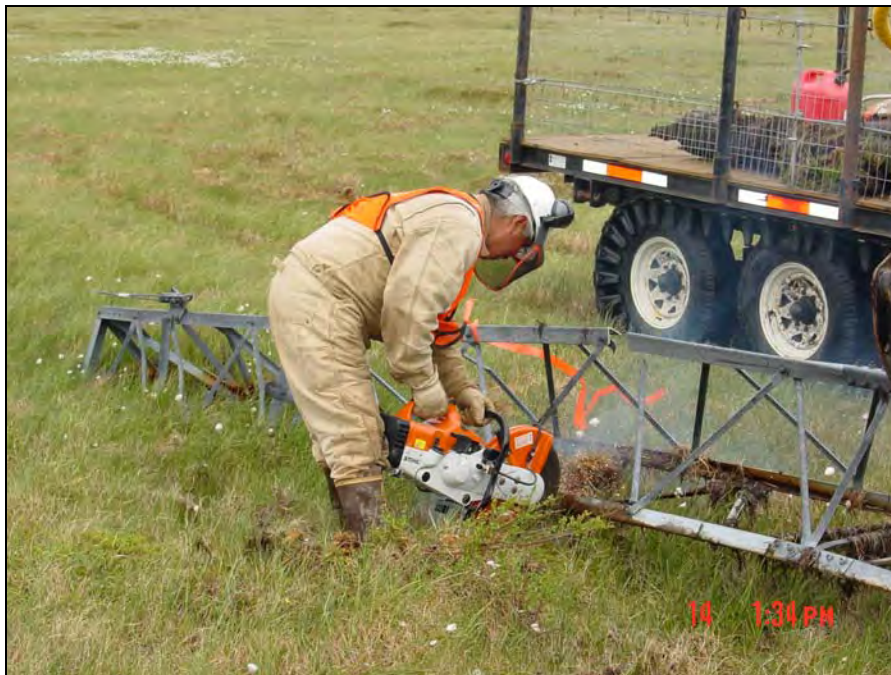
Photograph 24. Chop saws with grinder blades were used to cut existing metal poles.

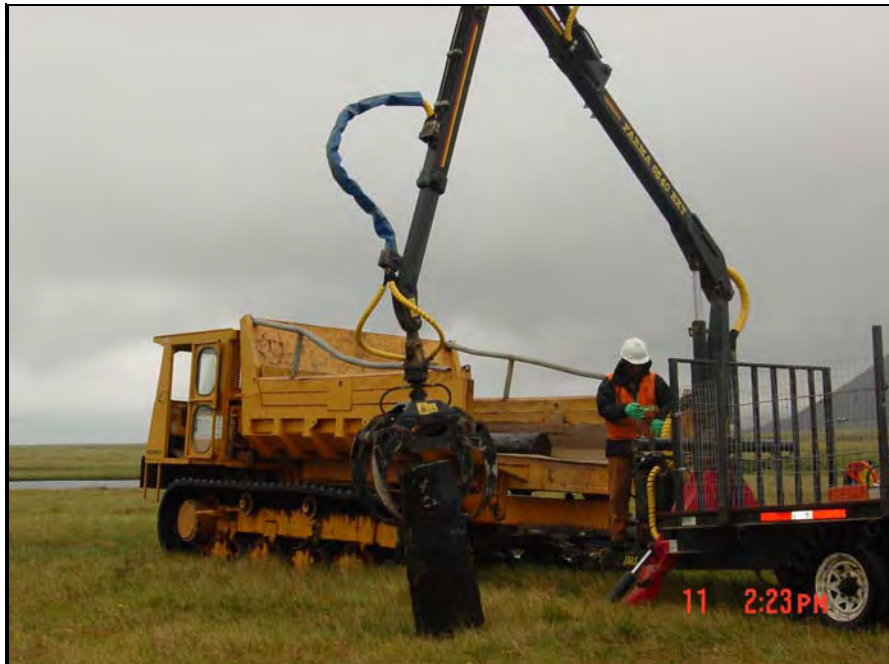
**Figure 5-13 Pole Line and Debris Field Removal Methods and Equipment**

Photograph 25. A hydraulic log grapple was used to pull wooden poles out of the ground and pick up fallen poles. Note the wooden pole in the back of the Morooka track vehicle. Photo facing northeast.

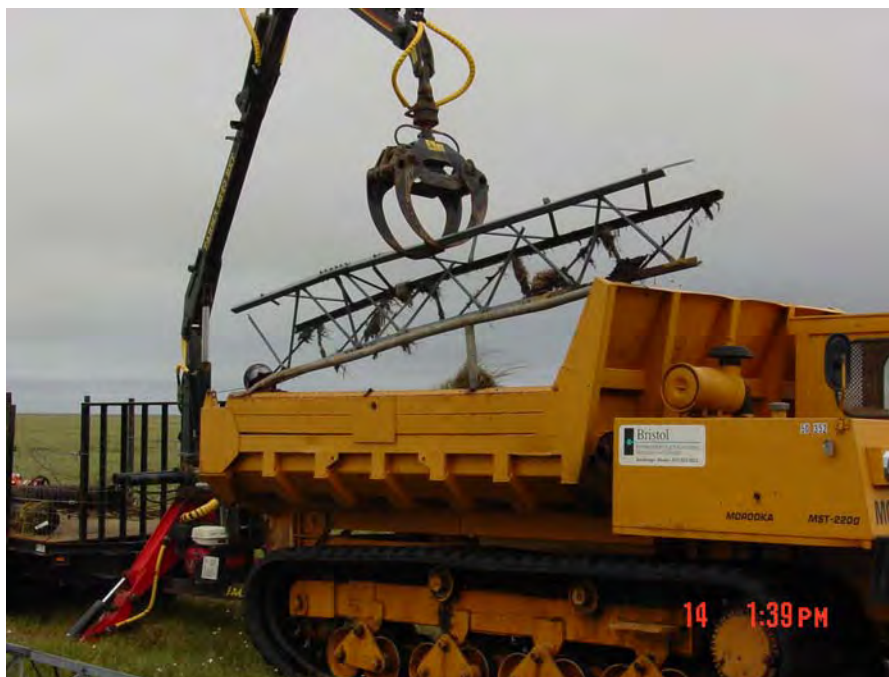
Photograph 26. The log grapple was also used to place various metal towers and poles into Morooka tracked vehicles for transport to the scrap metal staging areas.

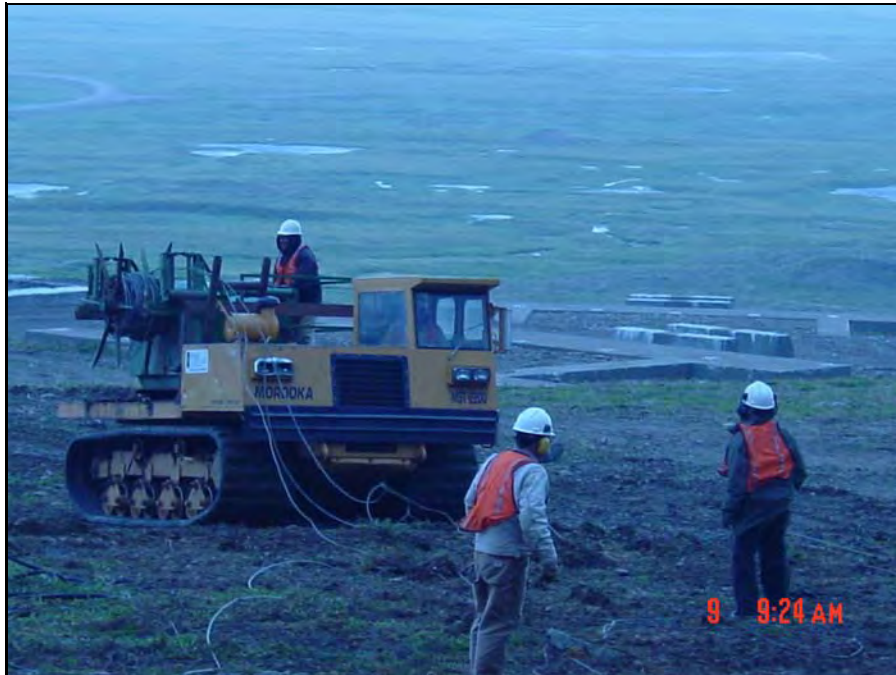
**Figure 5-14 Pole Line and Debris Field Removal Methods and Equipment**

Photograph 27. Various cables and wires were spooled with a custom spooler mounted on a Morooka tracked vehicle. Note the White Alice Communications Towers footing in the background. Photo facing north.

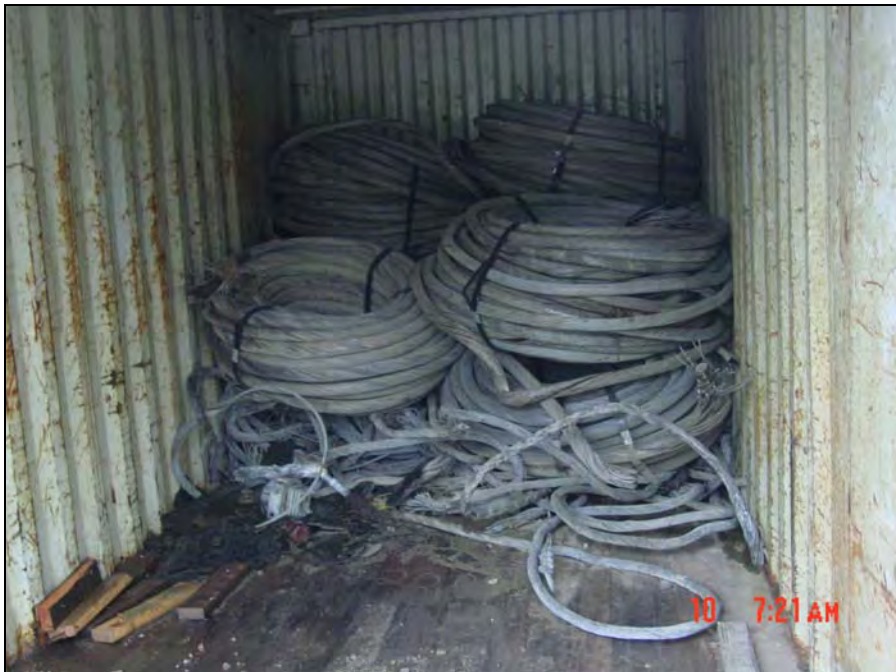
Photograph 28. The spooled cable was placed into Conexes for disposal.

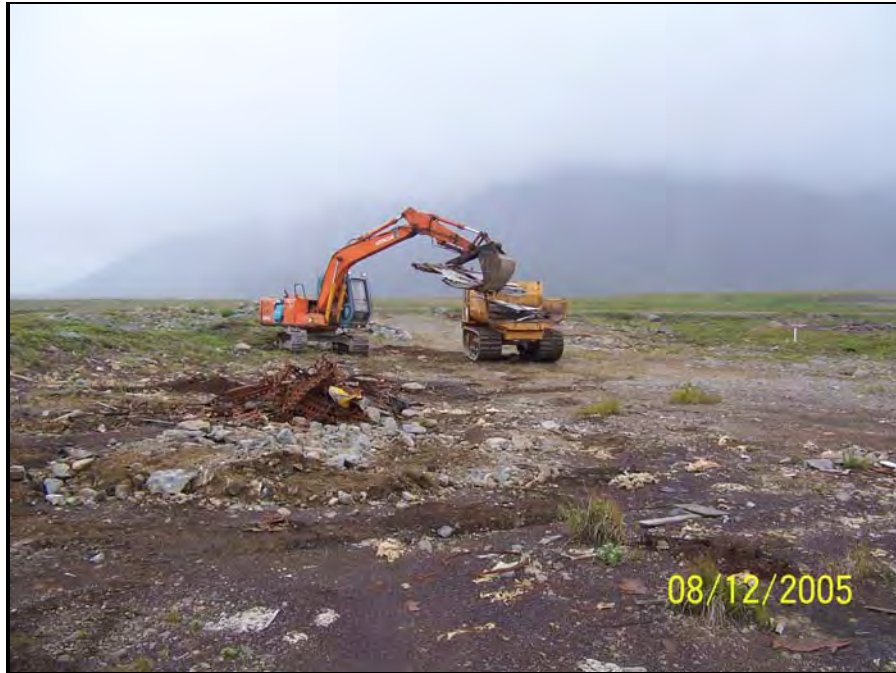
**Figure 5-15 Pole Line and Debris Field Removal Methods and Equipment**

Photograph 29. Various forms of debris were removed from NE Cape, the majority being scrap wood and metal. Photo facing southeast.

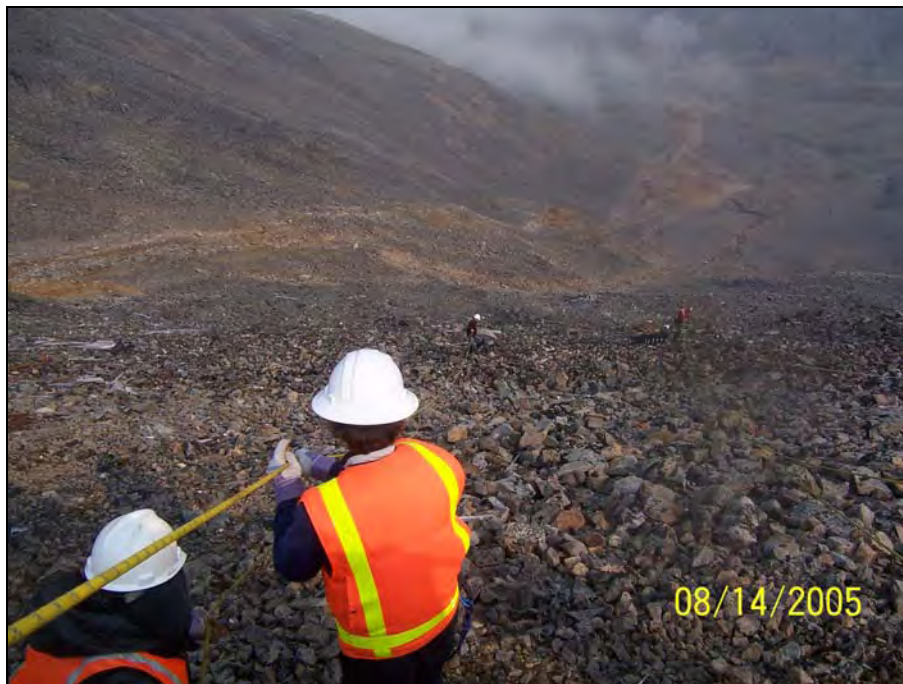
Photograph 30. A belay system was used to remove various forms for wood and metal debris from steep slopes. Photo facing north.

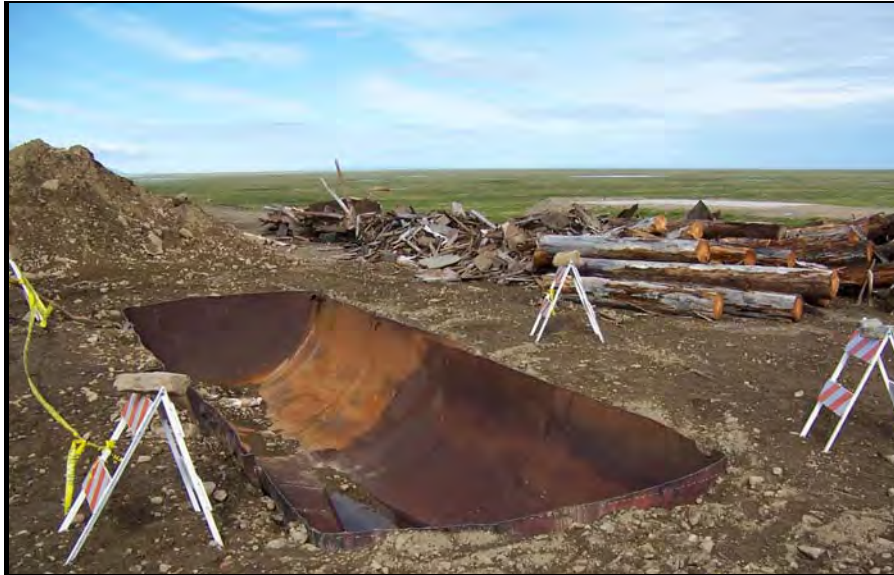
Photograph 31. Two quarters of an old AST was placed inside the 5 by 30-foot burn pit to minimize ash amounts left in the burn pit and to make removing the ash more efficient. Photo facing west.

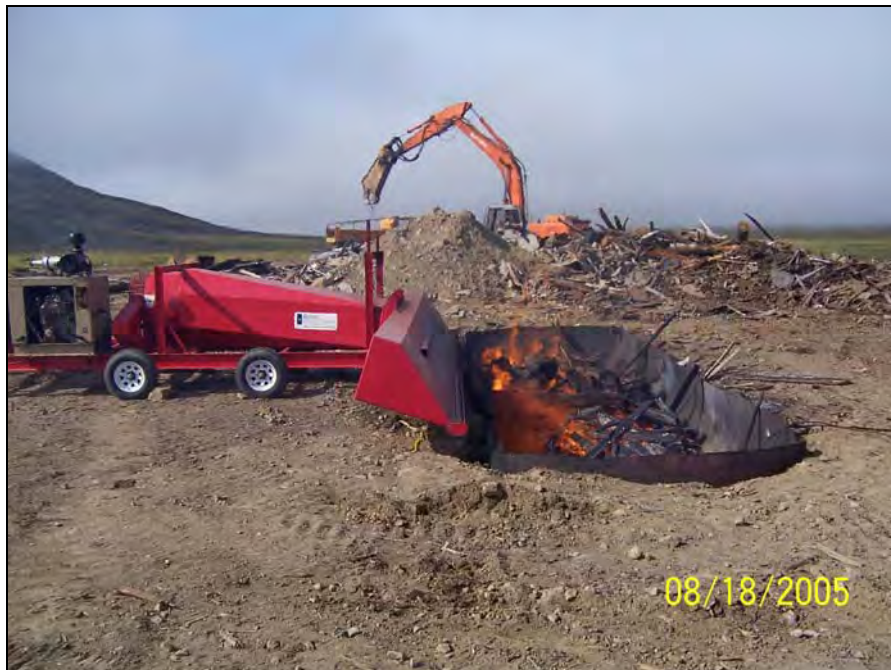
Photograph 32. The burn pit in action. Note that very little, if any, smoke is coming out of the burn pit as a result of the air curtain blower to the left of the pit. Photo facing southwest.

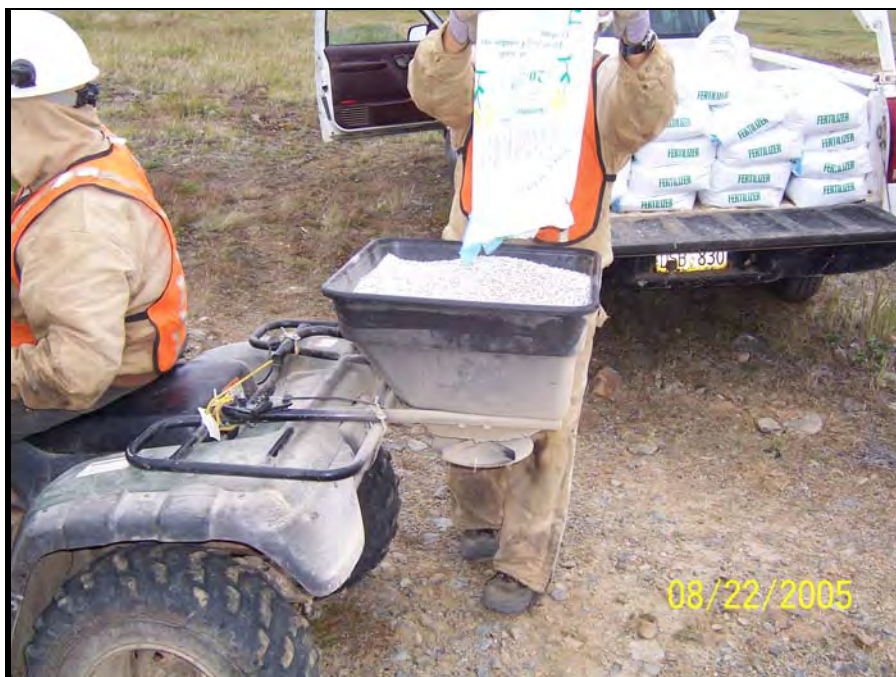
Photograph 33. Fertilizer being loaded into a spreader mounted on an ATV as part of the final seeding process around the AFS Ops Area.

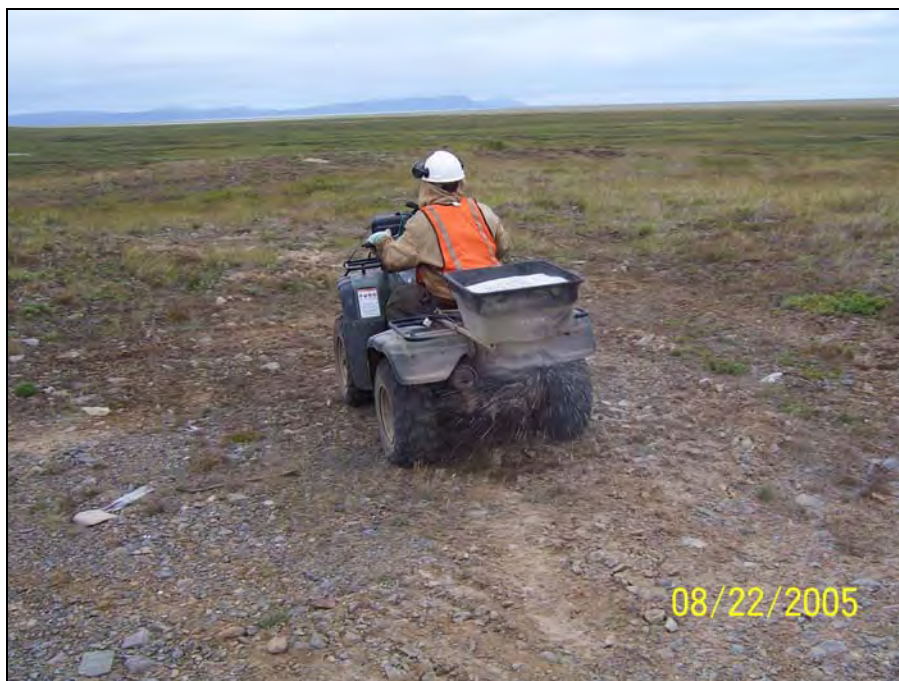
Photograph 34. Applying fertilizer and seeding was performed throughout Site 31, Site 7, and the AFS Ops Area. Photo facing west.

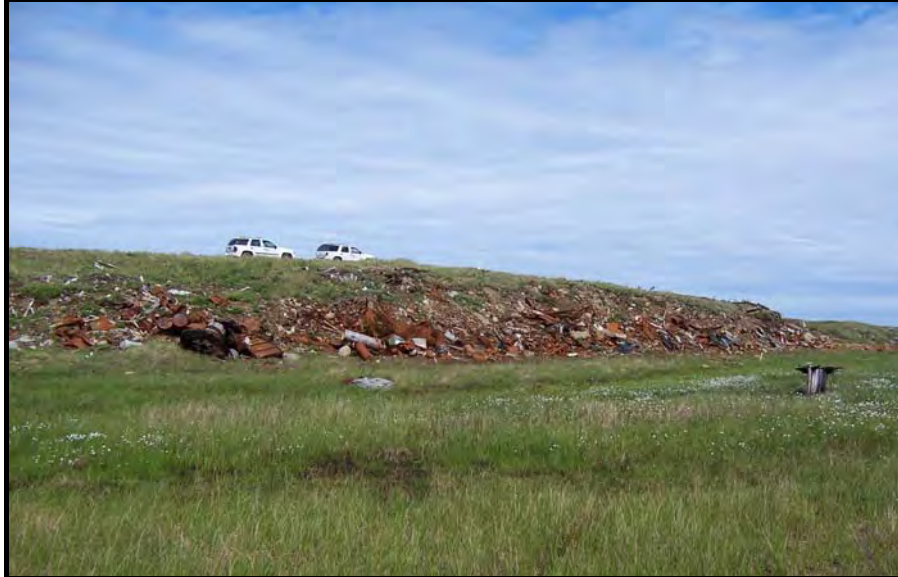
**Figure 5-18 Site 7 Pre- and Post-removal Action**

Photograph 35. Debris along the south side of Cargo Beach Road in Site 7. Photo facing north.

Pre- and post-removal photographs of the debris removal areas are shown on Figures 5-18 and 5-19. Table 5-7 summarizes where the pre- and post-removal action photographs may be found.

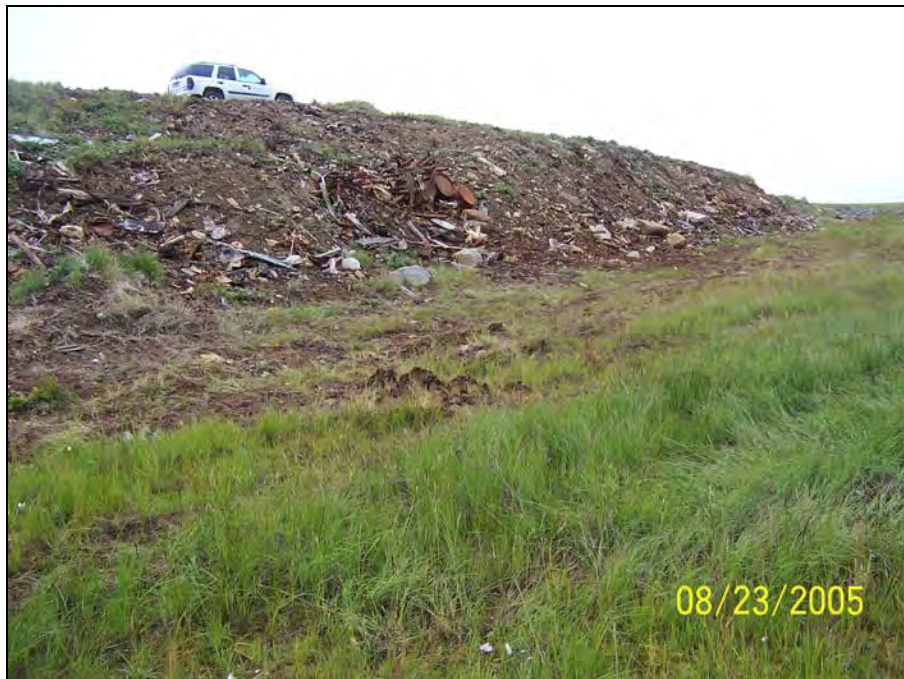
Photograph 36. After BEESC removed debris from the area previously mentioned. Note that although a lot of debris was removed, some still remains. Photo facing north.
