**U.S. Army Corps of Engineers, Alaska District  
White Alice Tram and Debris Removal  
Northeast Cape, St. Lawrence Island, Alaska  
Contract No. W911KB-04-C-0019  
FUDS Property No. F10AK096901**

**REMOVAL ACTION REPORT  
FINAL  
September 2006**

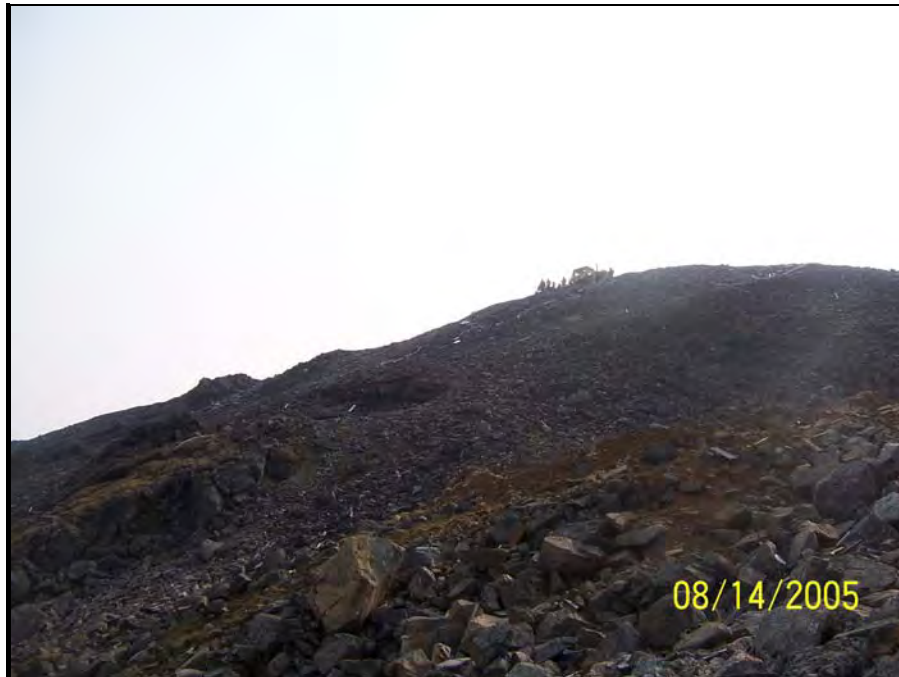
**Figure 5-19 Debris Field 1 Pre- and Post-removal Action**

Photograph 37. Various forms of debris were removed from the slopes below Sites 33 and 34 (Upper Mountain Complex). Note the small pieces of debris scattered throughout the site. Photo facing southeast.

Pre- and post-removal photographs of the debris removal areas are shown on Figures 5-18 and 5-19. Table 5-7 summarizes where the pre- and post-removal action photographs may be found.

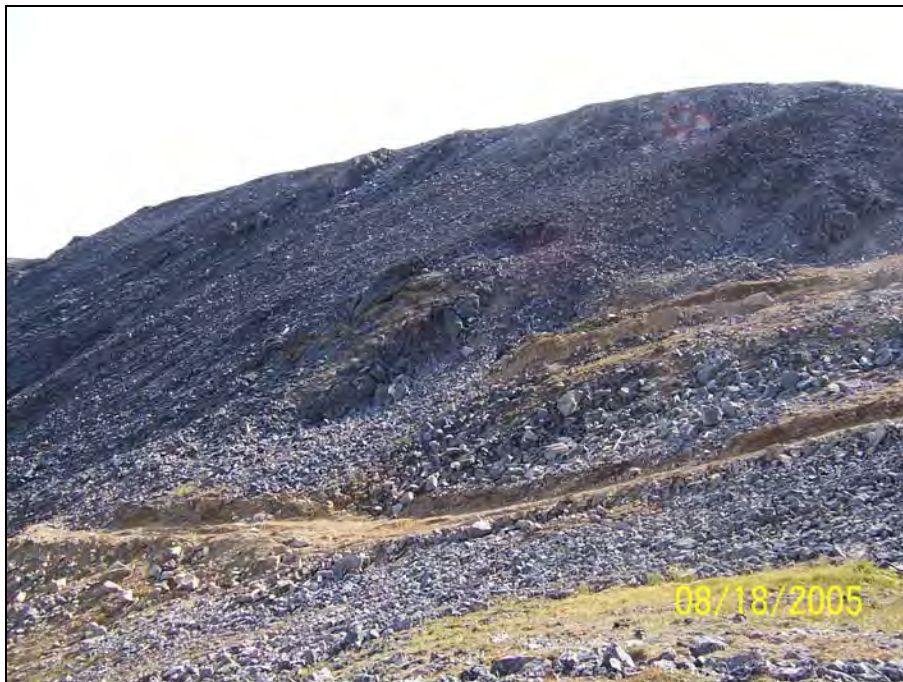
Photograph 38. The same site as previously mentioned after debris removal. Photo facing southeast.

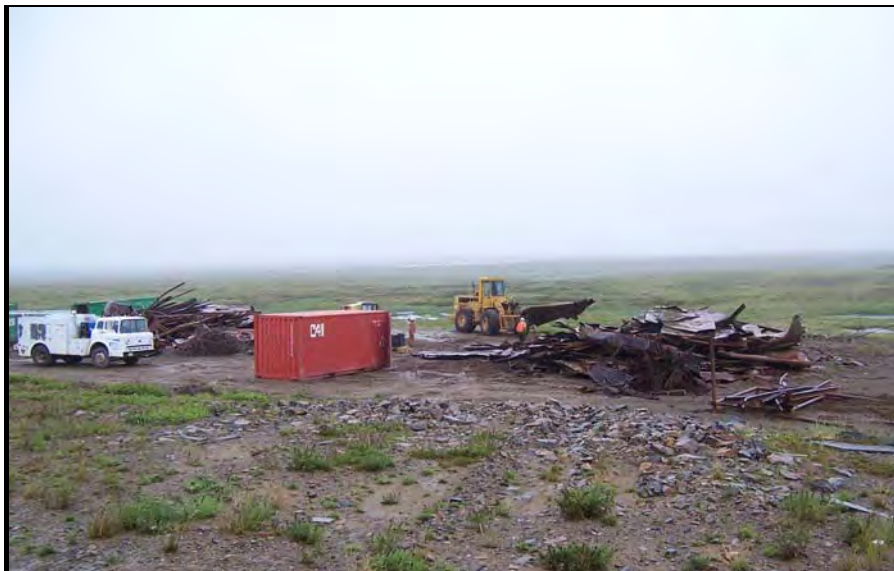
**Figure 5-20 AFS Ops Scrap Metal Pre- and Post-demolition**

Photograph 39. Old AST scrap metal piles located along the north side of the AFS Ops Area. Photo facing west.

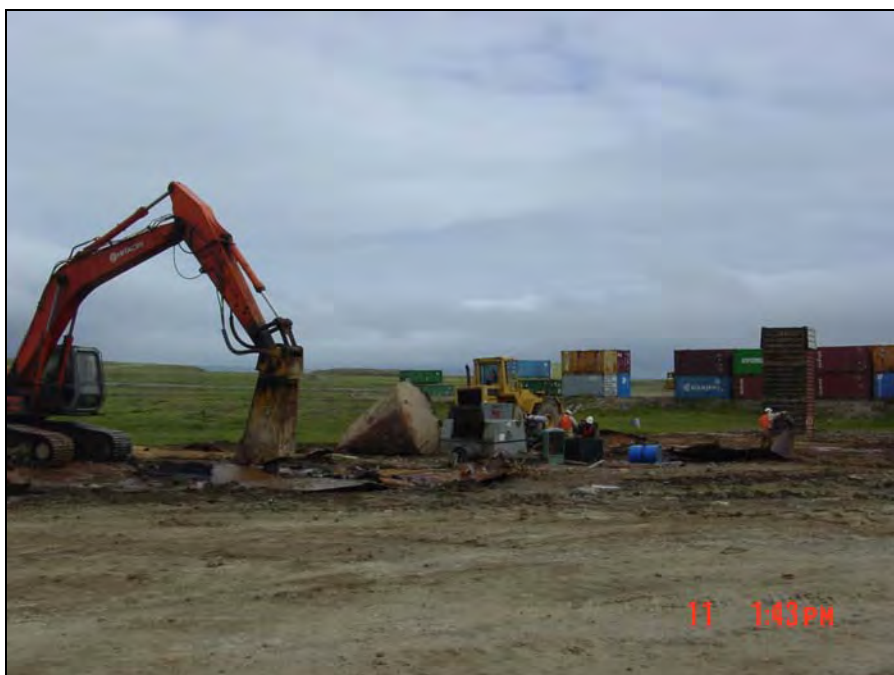
Photograph 40. BEESC nearing completion of tank scrap metal removal in the previously mentioned area. Note that all the tank scrap was removed and shipped off-island from this area. Photo facing north.

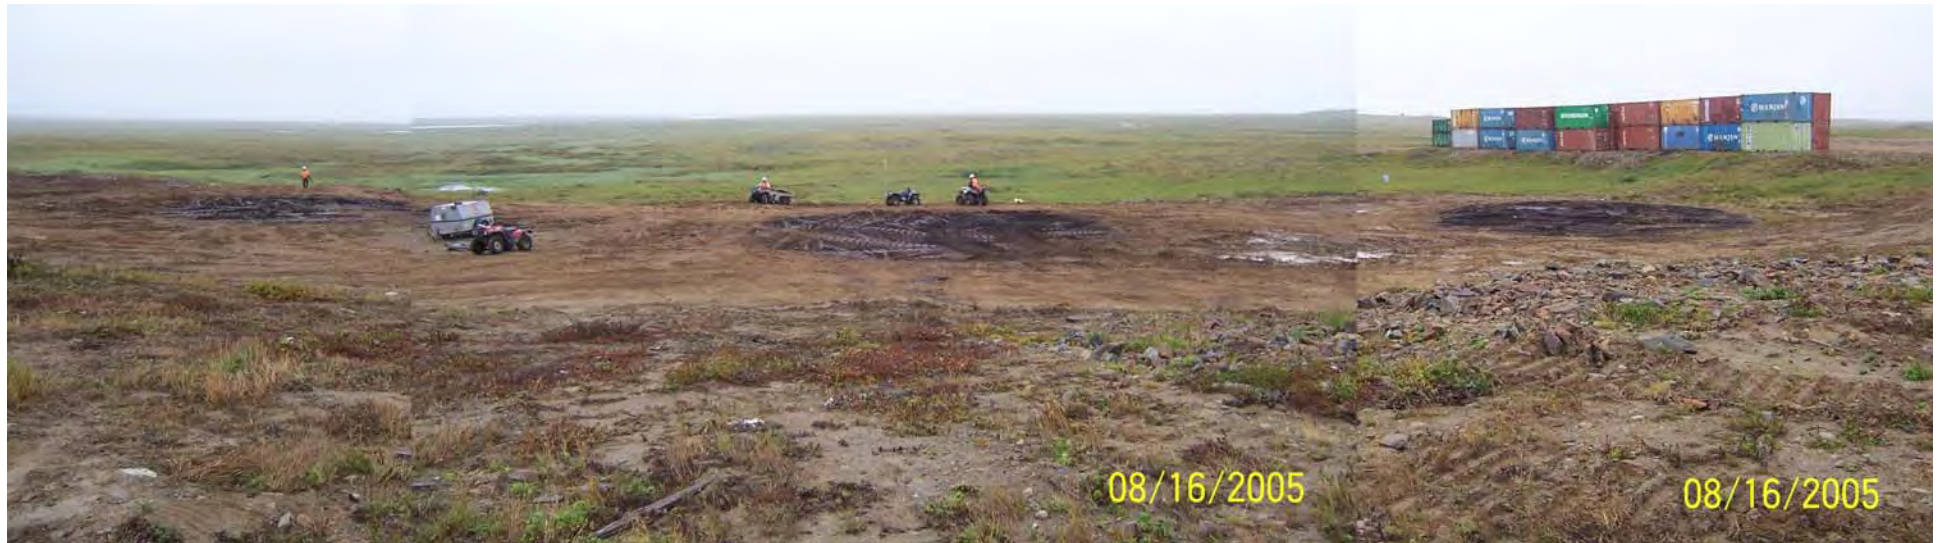
**Figure 5-20a AFS Ops Post-Demolition**

Photograph 41. AFS Ops Area after removal of tank scrap metal. Photo facing north.

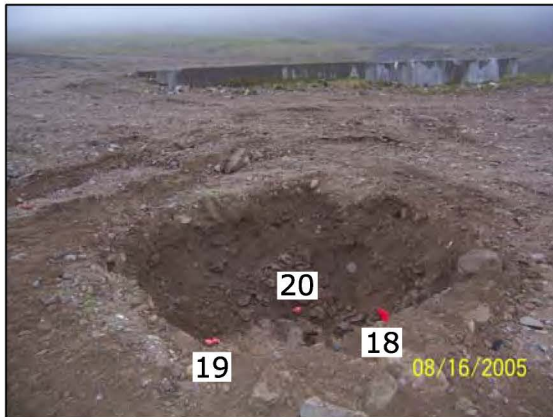
FIGURE 6-2  
WHITE ALICE SITE REMOVAL ACTION  
NOTHEAST CAPE ST. LAWRENCE ISLAND, ALASKA  
SOIL EXCAVATION AREA 31C  
SAMPLE LOCATIONS AND RESULTS

Excavation Area 31 C (Figure 6-2) was initially excavated to a depth of 0.5 feet bgs, and sampled at three locations. EnSys field screening indicated PCB concentrations above 0.5 mg/kg throughout, so the excavation was deepened to 1.5 feet bgs. Subsequent field screening indicated PCB concentrations were still above 0.5 mg/kg, so the excavation was deepened to 2.0 feet bgs. At 2.0 feet bgs, EnSys field screening indicated that PCB levels were below 0.5 mg/kg. Two samples (05NEC31SL19 and 20) were sent to the analytical laboratory. As shown on Figure 6-2, the analytical results were well below the cleanup criterion of 1.0 mg/kg PCB. Consequently, no further excavation was performed at Area 31 C.

31SL019  
Ensys @ 0.5'bgs > 0.5mg/kg  
Ensys @ 1.5'bgs > 0.5mg/kg  
Ensys @ 2.0'bgs < 0.5mg/kg  
05NEC31SL019  
Aroclor®-1260@2.0'bgs=ND(0.0576mg/kg)

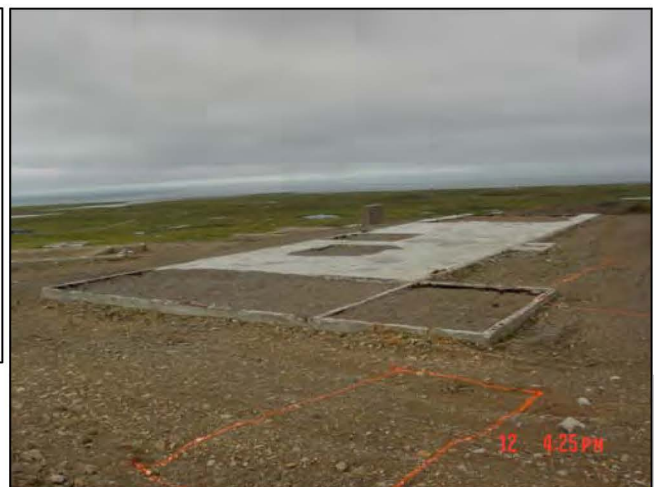
**FIGURE 6-3**  
**WHITE ALICE SITE REMOVAL ACTION**  
**NORTHEAST CAPE ST. LAWRENCE ISLAND, ALASKA**  
**SOIL SAMPLE LOCATIONS AND RESULTS BENEATH**  
**CONCRETE AT BUILDING 1001 MEC**

demolished and disposed of are shown on Figure 6-3. Per the requirements set forth in the SAP, soil samples were taken to determine if PCBs were present in the soil beneath the floor slab. Soil samples were obtained at the locations shown on Figure 6-3. Eight EnSys field screenings were performed in Room A, 3 in rooms C and E, 9 in Room F, and 3 in Room G. All field screening results indicated that PCB concentrations were below 0.5 mg/kg. Results of confirmation samples sent to the analytical laboratory showed that one location (05NEC31SL109) had PCB concentrations in excess of 1.0 mg/kg.

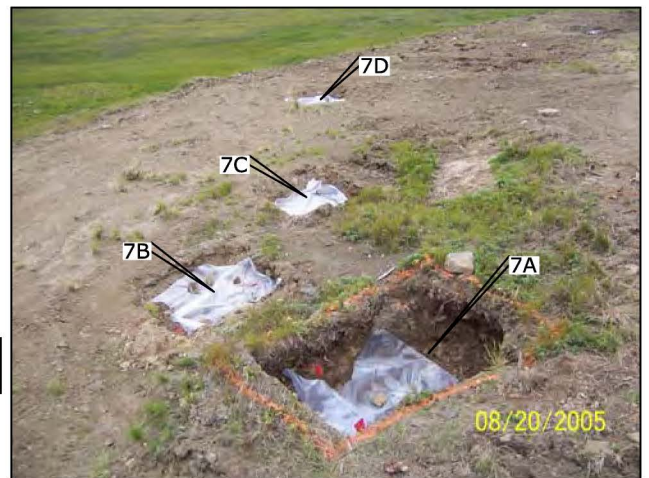
**FIGURE 6-4**  
WHITE ALICE SITE REMOVAL ACTION  
NORTHEAST CAPE ST. LAWRENCE ISLAND, ALASKA  
SOIL EXCAVATION AREAS 7A, 7B, 7C, AND 7D  
SAMPLE LOCATIONS AND RESULTS

Six excavations, measuring 5 feet by 5 feet, were performed at Site 7 (Figures 6-4 and 6-5). Areas 7A through 7F were initially excavated to depths ranging between 1 foot and 2.5 feet bgs. The first round of EnSys field screening indicated that soil in Excavations 7A and 7E contained PCB at concentrations above 0.5 mg/kg. Excavations 7A and 7E were then deepened to 3.5 feet and 2.0 feet bgs, respectively, and resampled. EnSys field-screening results indicated that the PCB concentrations in soil remained above 0.5 mg/kg. No more soil was removed from these areas because landfill debris was encountered in the floor of both excavations.

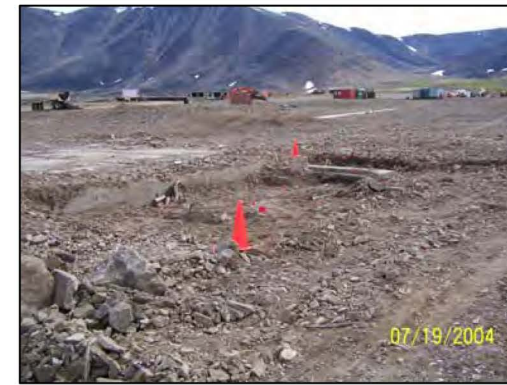
FIGURE 6-7  
WHITE ALICE SITE REMOVAL ACTION  
NORTHEAST CAPE ST. LAWRENCE ISLAND, ALASKA  
SOIL EXCAVATION AREAS 13A AND 13B  
SAMPLE LOCATIONS AND RESULTS

As shown on Figure 6-7, Excavations 13A-1, 13A-2, 13B-1 and 13B-2, lie immediately west of the former Building 110 floor slab. BEESC demolished CTP 13-1 to provide access to the underlying soil in this area. Concrete rubble from CTP 13-1 was disposed of off-island as described in Section 5.3. Areas 13A-2 and 13B-2 were initially excavated to a depth of 1.5 feet bgs, and Areas 13A-1 and 13B-1 were initially excavated to a depth of 2.5 feet bgs. Field screening results (Figure 6-7) indicated that soils in these excavations contained PCBs at concentration in excess of 0.5 mg/kg. However, budget constraints prevented additional excavation in these areas. Analytical results for samples 05NECAFSL062 and 05NECAFSL064 from Excavation 13B-2, confirmed that PCB concentrations in soil in these excavations were greater than the 1.0 mg/kg action level. All of the excavations were lined with plastic sheeting and backfilled with clean borrow material.

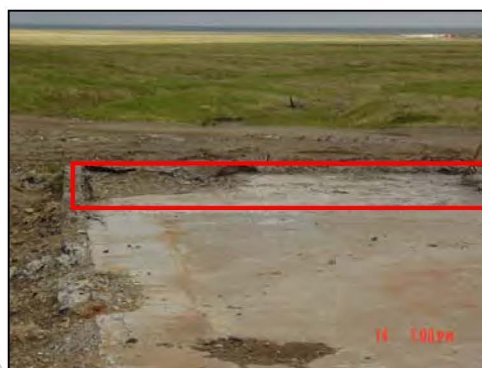
Former Building 108  
(Concrete foundation remains)

Concrete Removal  
Area

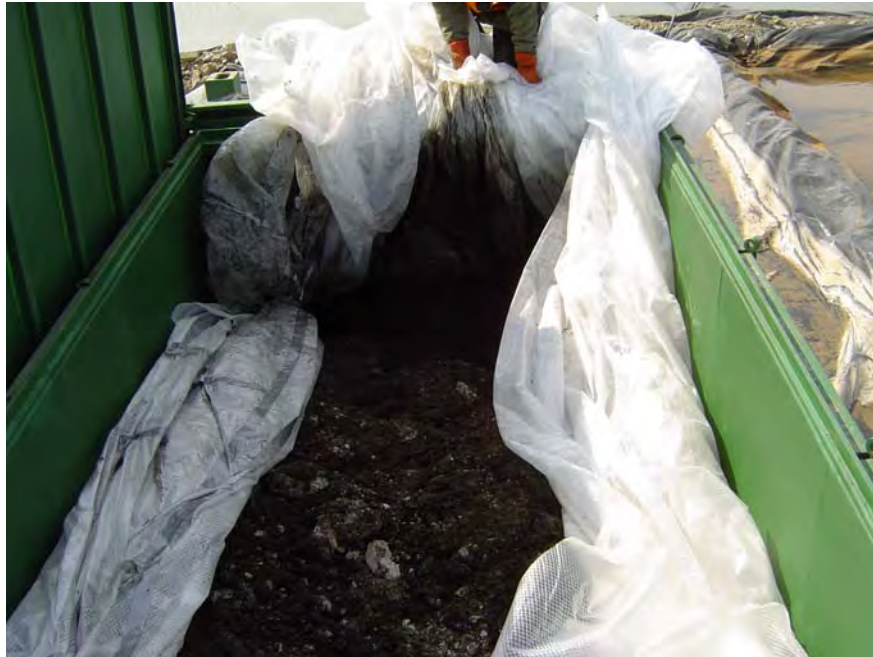
1. PCB-contaminated soil in double-lined Baker box. BEESC photograph.

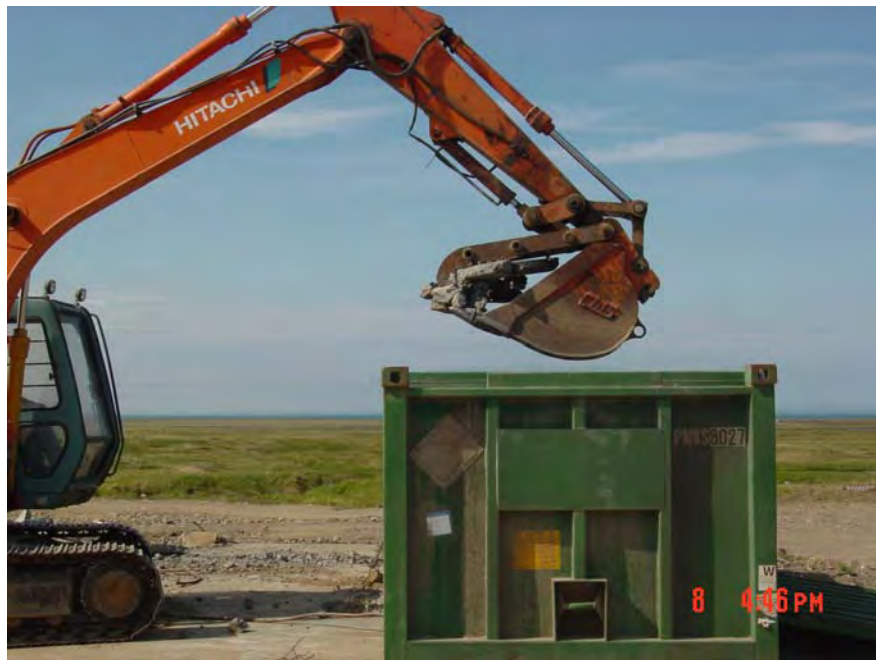
2. PCB-contaminated concrete being placed in double-lined Baker box. BEESC photograph.

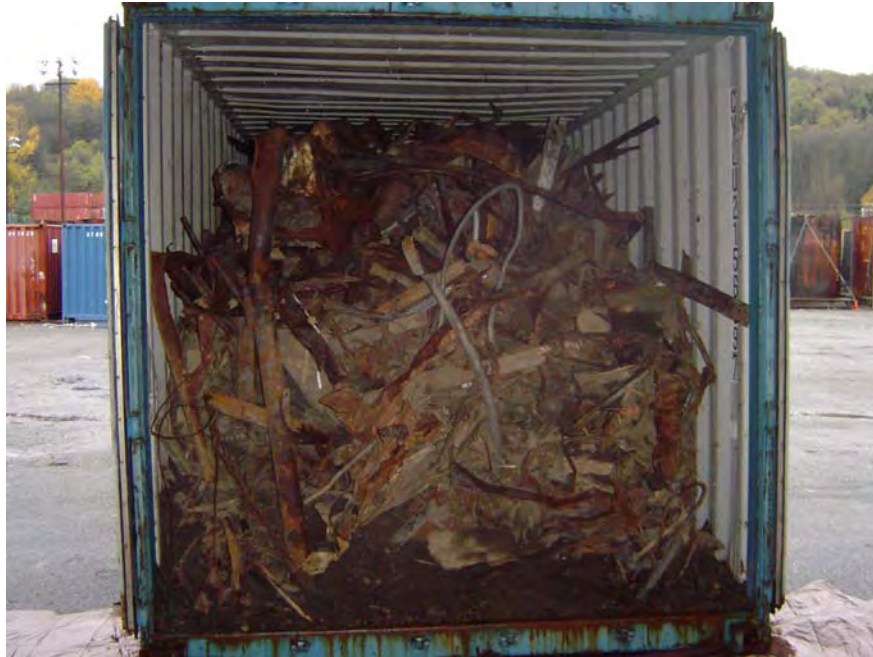
3. Scrap metal in Conex trailer. BEESC photograph.

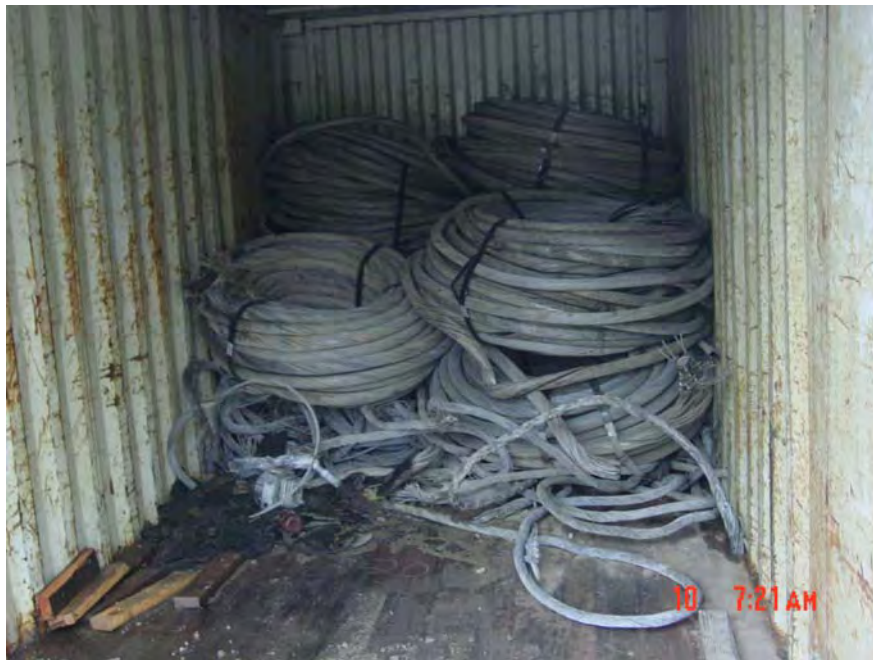
4. Scrap metal (cable) in Conex trailer. BEESC photograph.

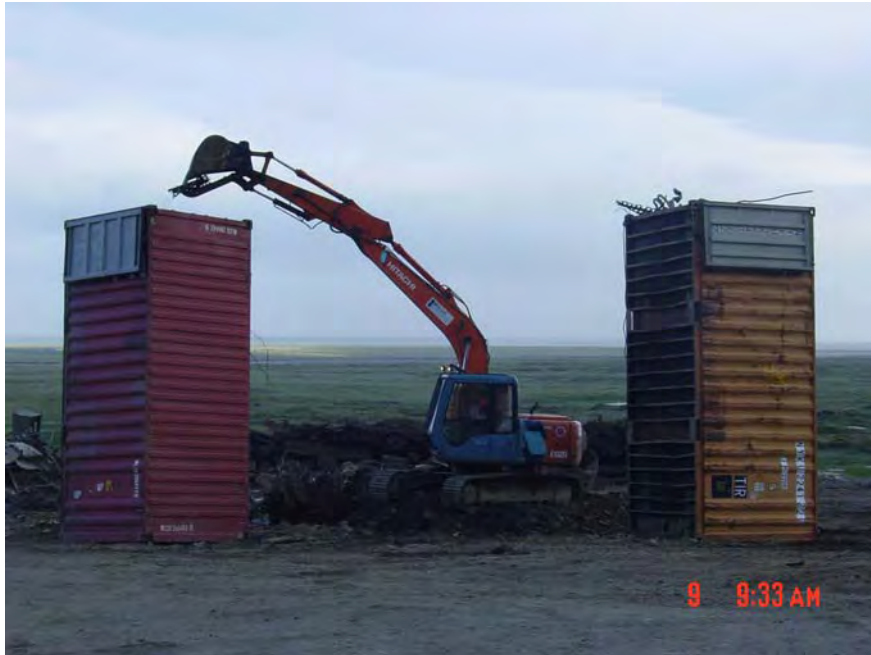
5. Scrap metal being placed in Conex trailer. BEESC photograph.

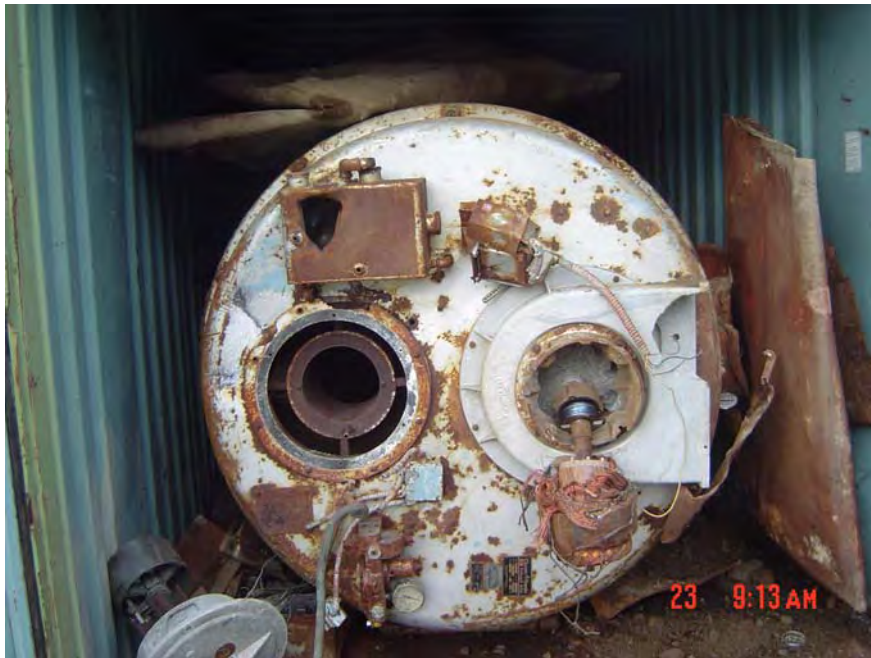
6. Steel boiler with asbestos gasket and asbestos bricks in Conex trailer. BEESC photograph.

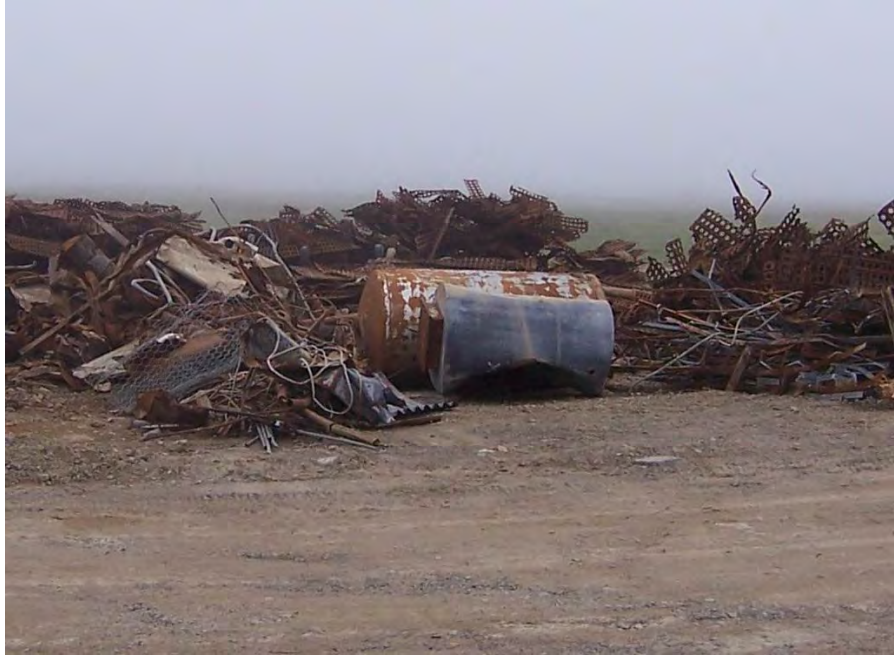
7. Tank with PCB-bearing paint (larger tank, rusted with silver PCB-paint). BEESC photograph.

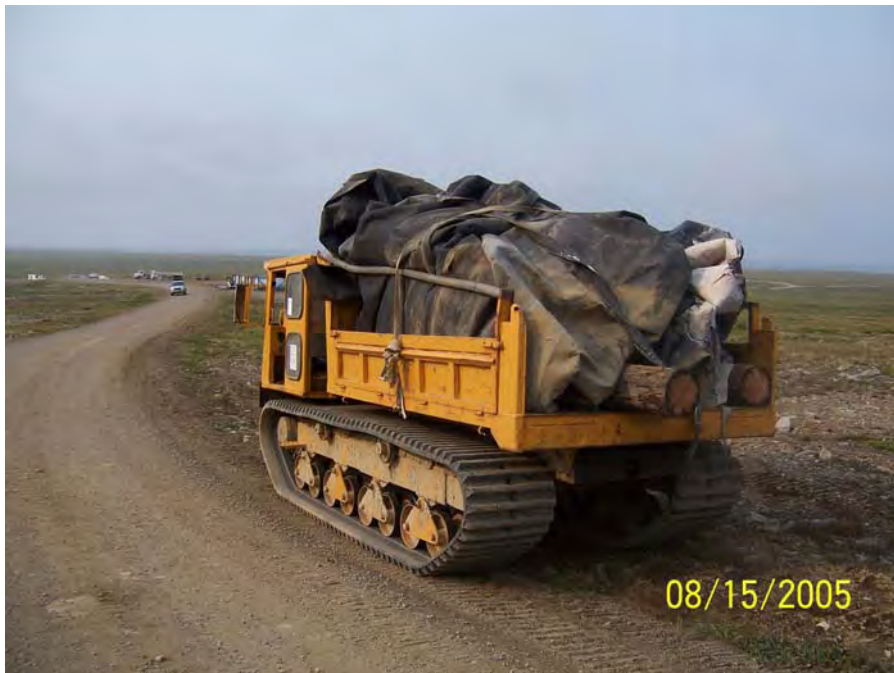
8. Rubber tarp and creosote wood poles for disposal. BEESC photograph.

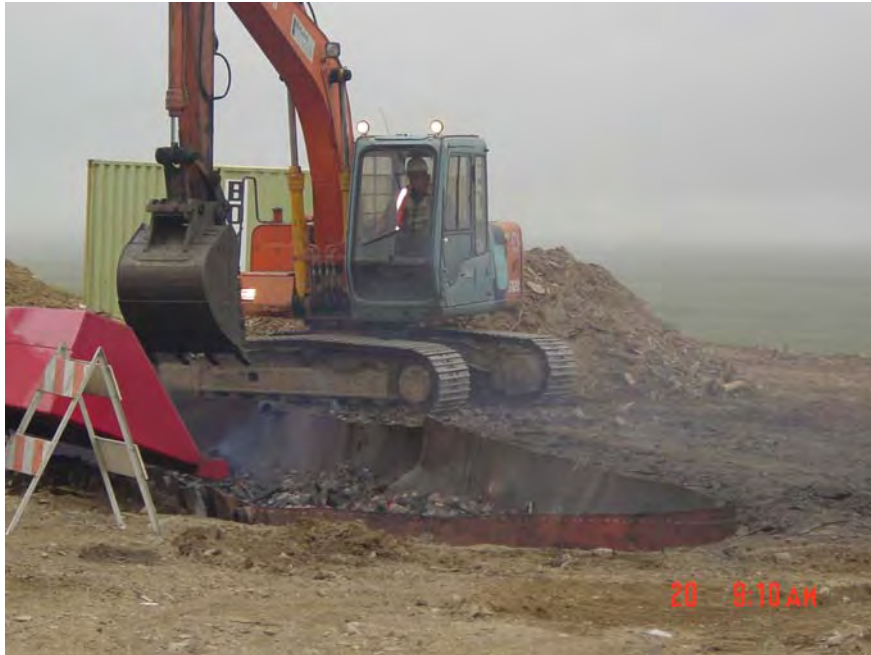
9. Lead ash being removed from burn pit and placed in Conex trailer.  
BEESC photograph.

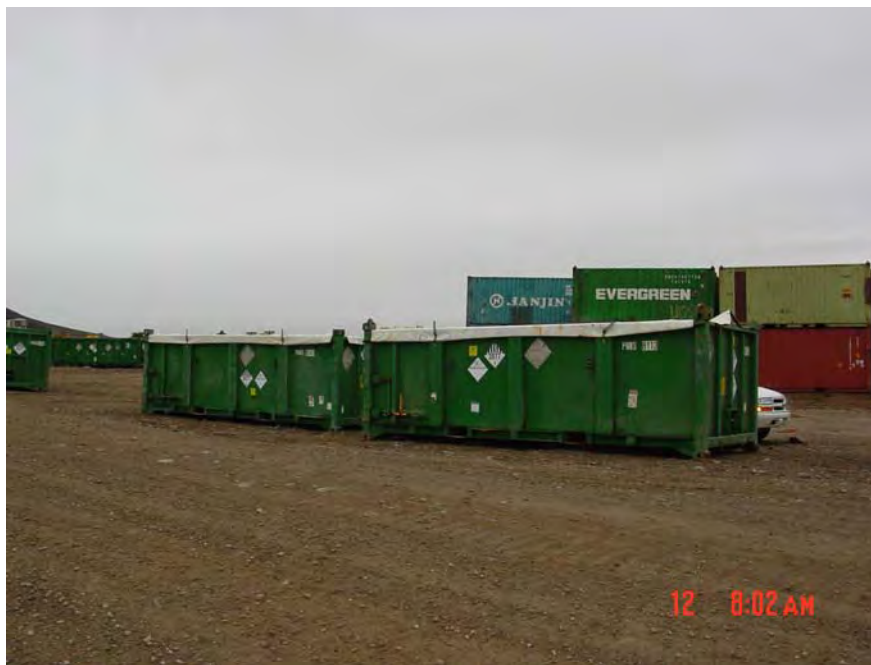
10. Baker boxes placarded and ready for transport. BEESC  
photograph.

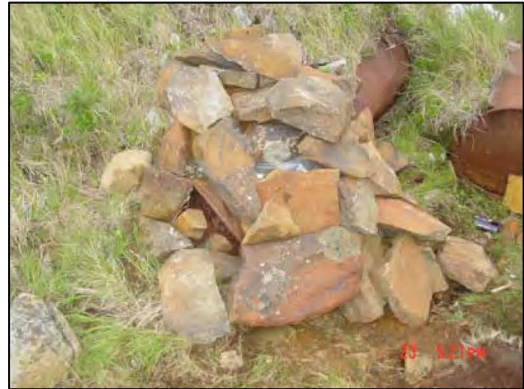
Both full and empty exposed drums observed along face of landfill and extending upslope (10-20 ft.) of landfill face.

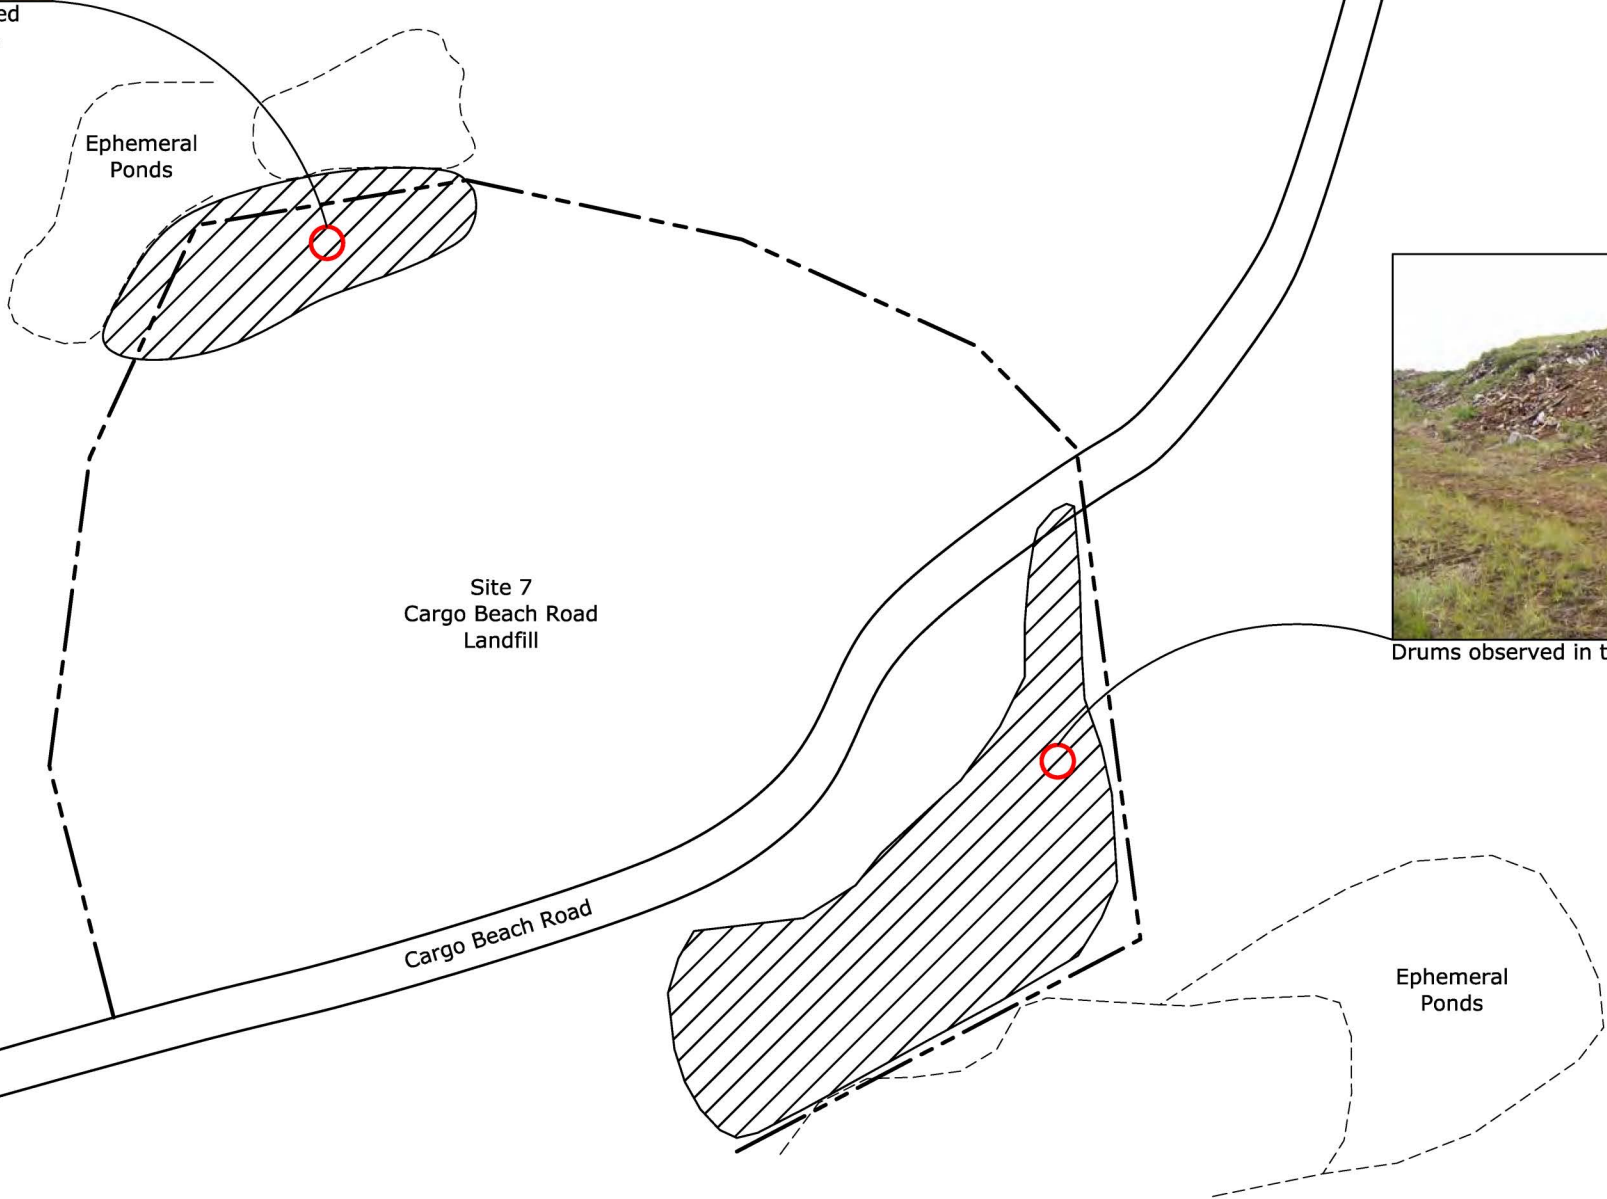
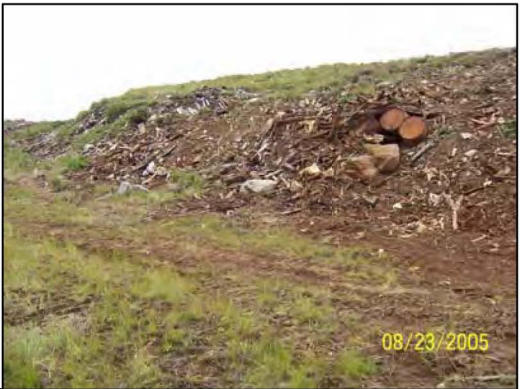
FIGURE 1, APPENDIX K  
WHITE ALICE SITE REMOVAL ACTION  
NORTHEAST CAPE ST. LAWRENCE ISLAND, ALASKA  
**SITE 7 - CARGO BEACH ROAD LANDFILL**  
**DRUM LOCATIONS**

**DRUM LOCATIONS SITE 7**  
SCALE: NTS

Drums observed in this area.

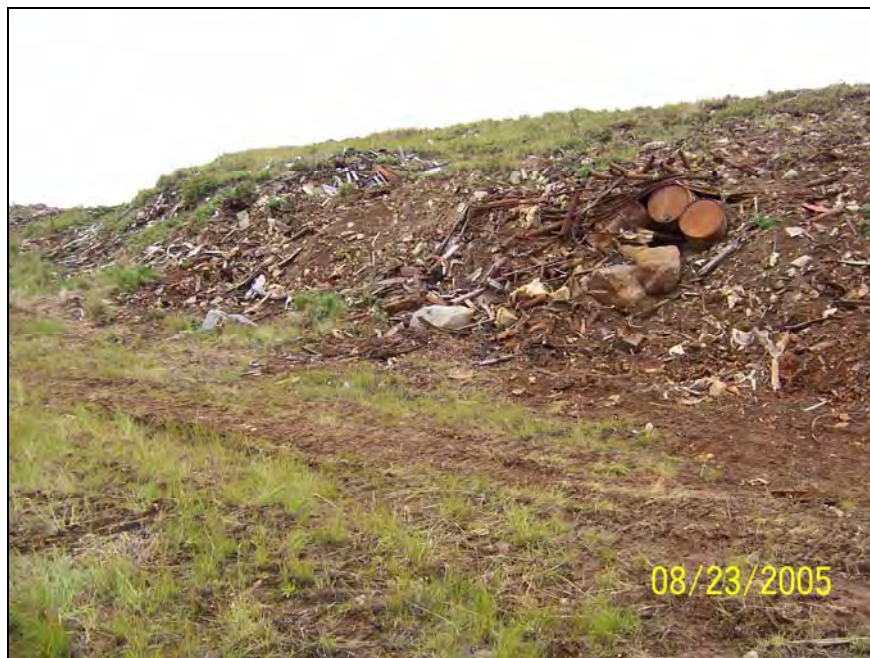
**Photograph 1. CLIN0008, Debris Removal Gravel Pads, Roads, and Cargo Beach.** Additional debris remains at the Cargo Beach Road Landfill.

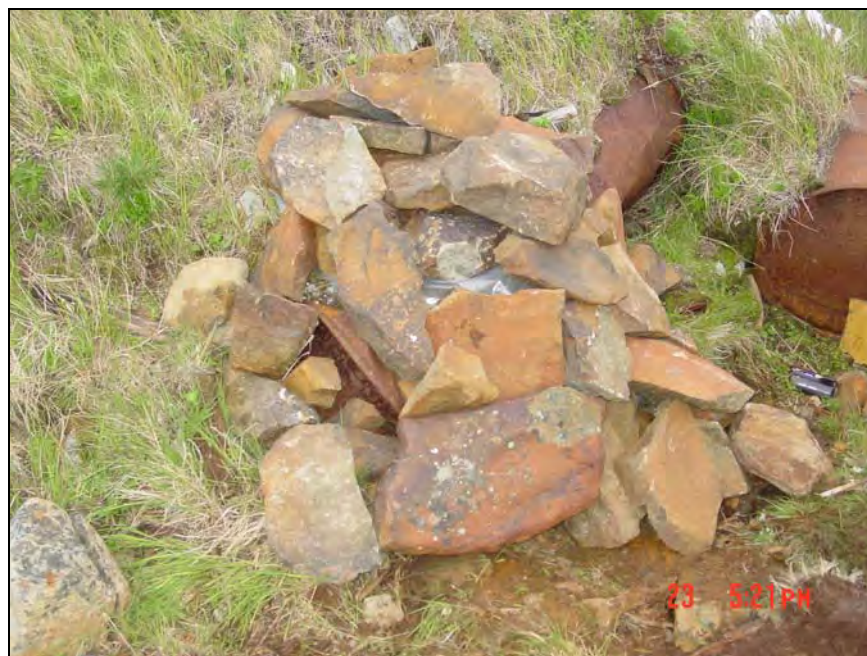
**Photograph 2. CLIN0008, Debris Removal Gravel Pads, Roads, and Cargo Beach.** Additional debris remains at the Cargo Beach Road Landfill, including drums, some of which BEESC covered with rocks to prevent tampering or shooting.

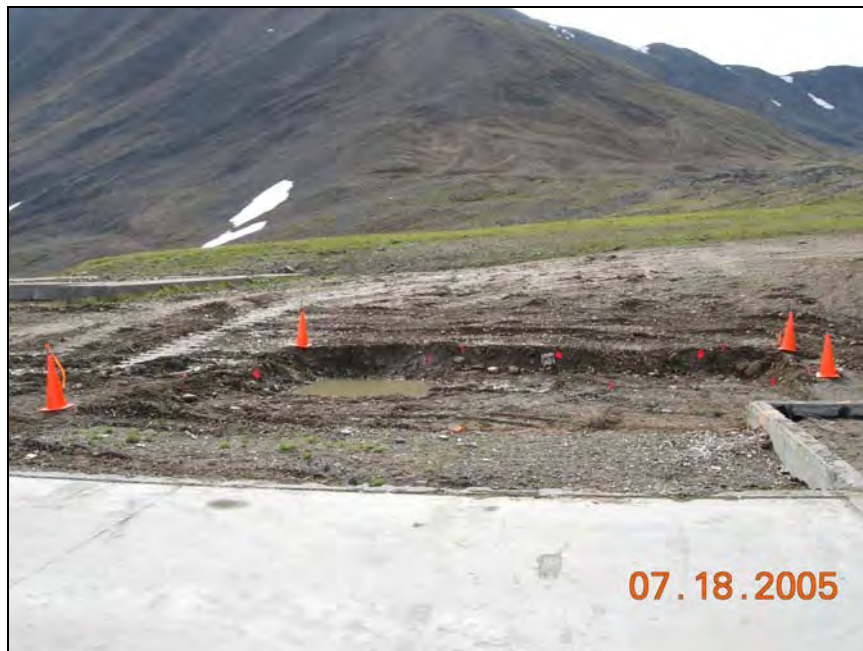
**Photograph 3. CLIN 0015, Option Remove Additional PCB Contaminated Soil.** Additional Soil remains at 8 locations, including Excavations 31A-1 and 31A-3. Note the standing water in Excavation 31A-3.

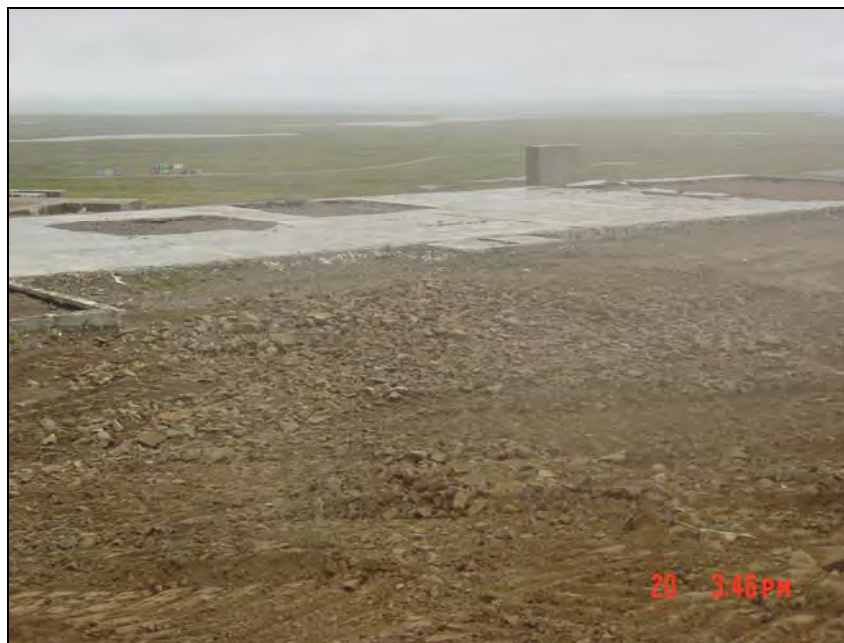
**Photograph 4. CLIN 0015, Option Remove Additional PCB Contaminated Soil.** Additional Soil remains at 8 locations, including Excavations 31A-1 and 31A-3. Excavations after backfilling with clean fill material.

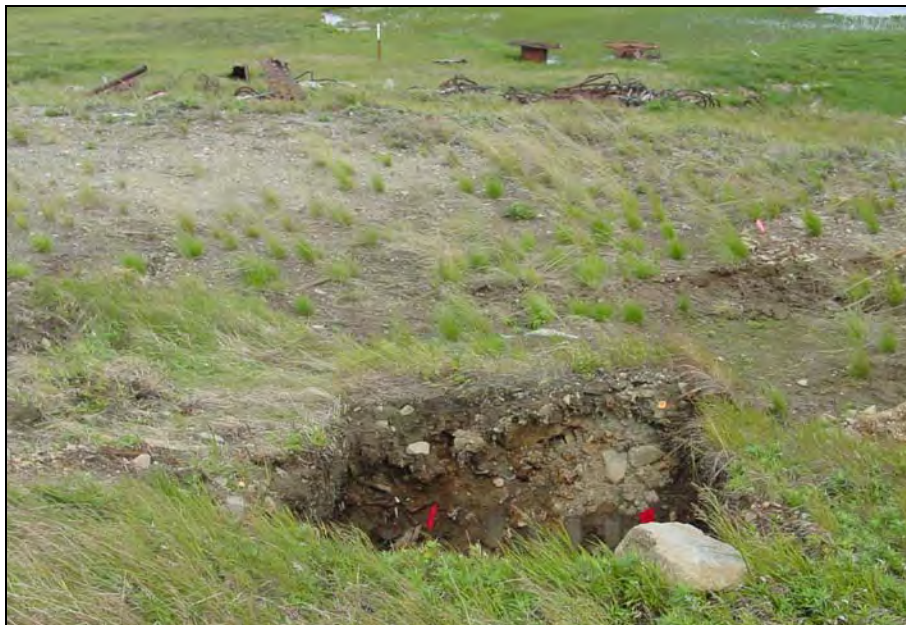
**Photograph 5. CLIN 0015, Option Remove Additional PCB Contaminated Soil.** Additional soil remains at 8 locations, including Excavation 7A.

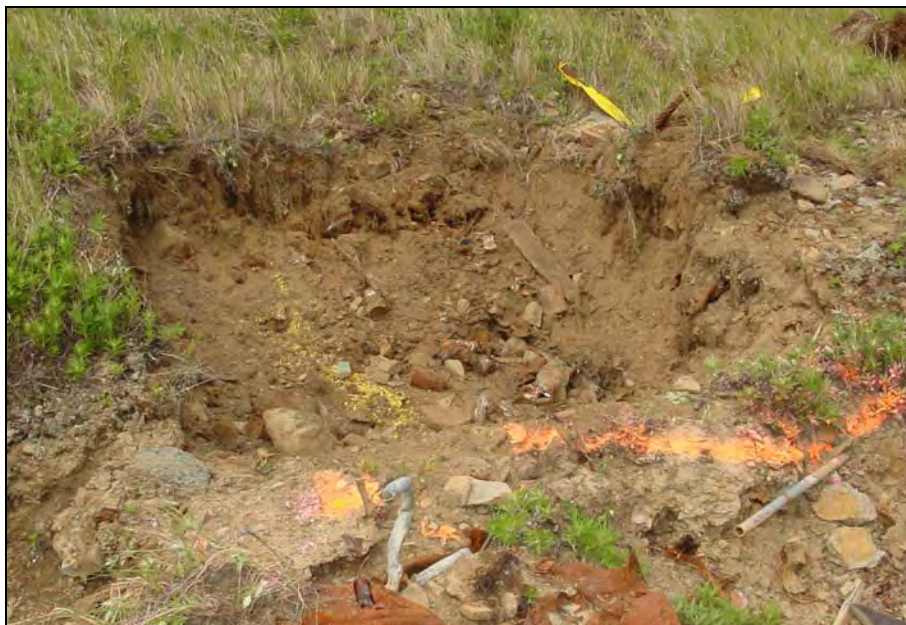
**Photograph 6. CLIN 0015, Option Remove Additional PCB Contaminated Soil.** Additional Soil remains at 8 locations, including Excavation 7E.

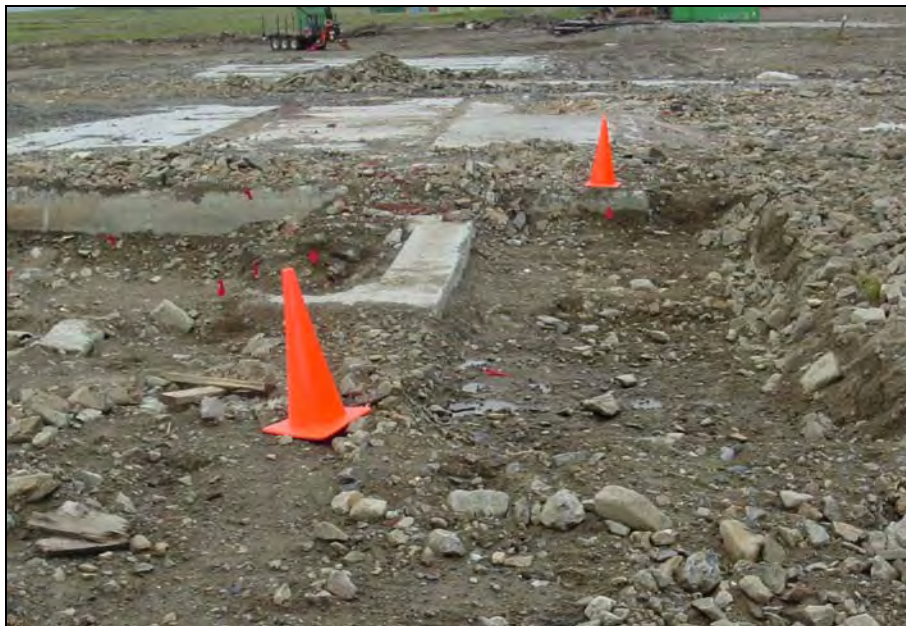
**Photograph 7. CLIN 0015, Option Remove Additional PCB-contaminated Soil.** Additional Soil remains at 8 locations, including Excavation 13A-1 and 13A-2.

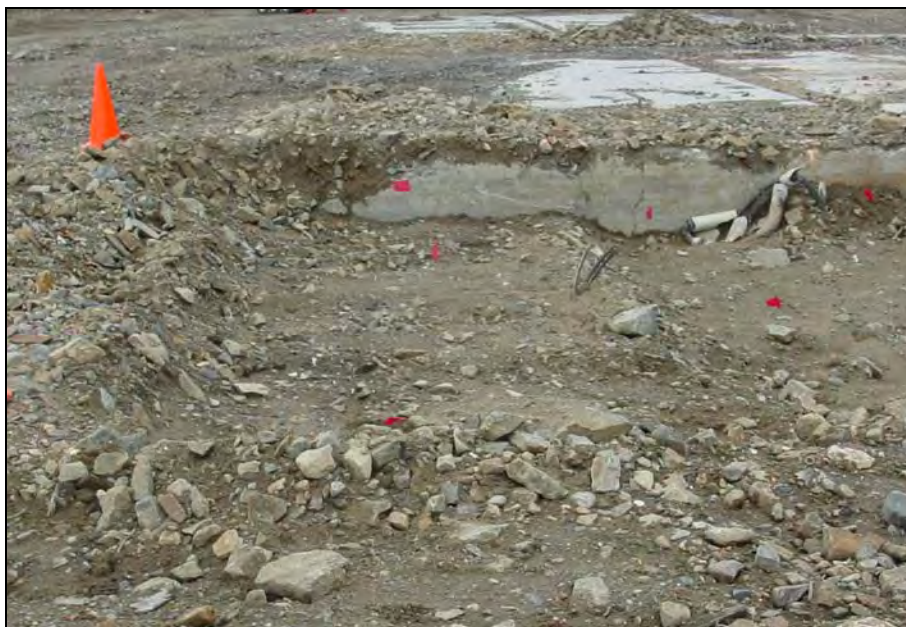
**Photograph 8. CLIN 0015, Option Remove Additional PCB Contaminated Soil.** Additional Soil remains at 8 locations, including Excavation 13B-1 and 13B-2.
