**US Army Corps of Engineers®  
Alaska District**

**NORTHEAST CAPE HTRW  
REMEDIAL ACTIONS  
Northeast Cape, Saint Lawrence Island,  
Alaska**

**Contract No. W911KB-10-C-0002**

**FINAL REPORT  
JULY 2011**

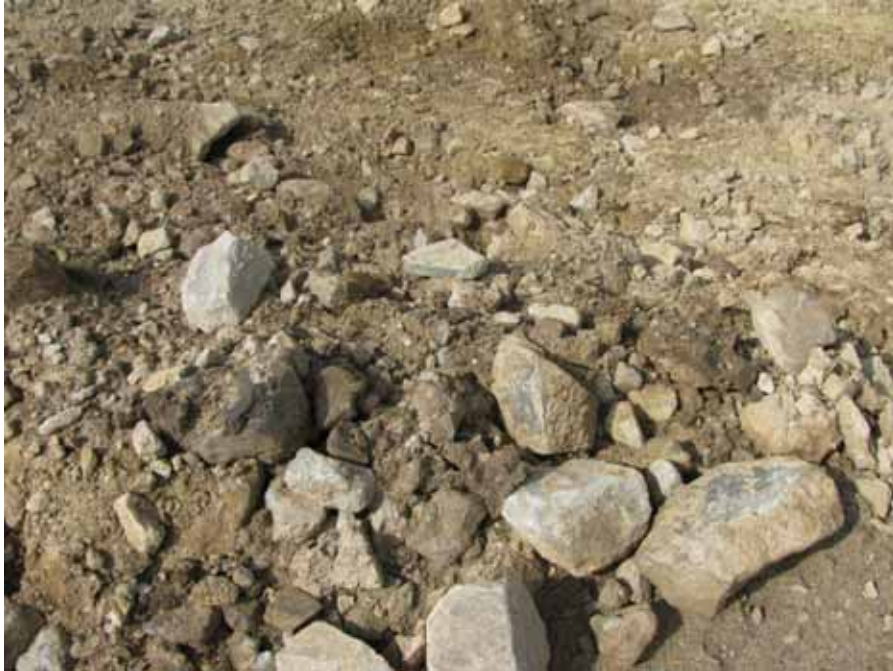
Photograph 7: Site 6 POL-stained soil. Direction: downward view.  
Date: July 2010.

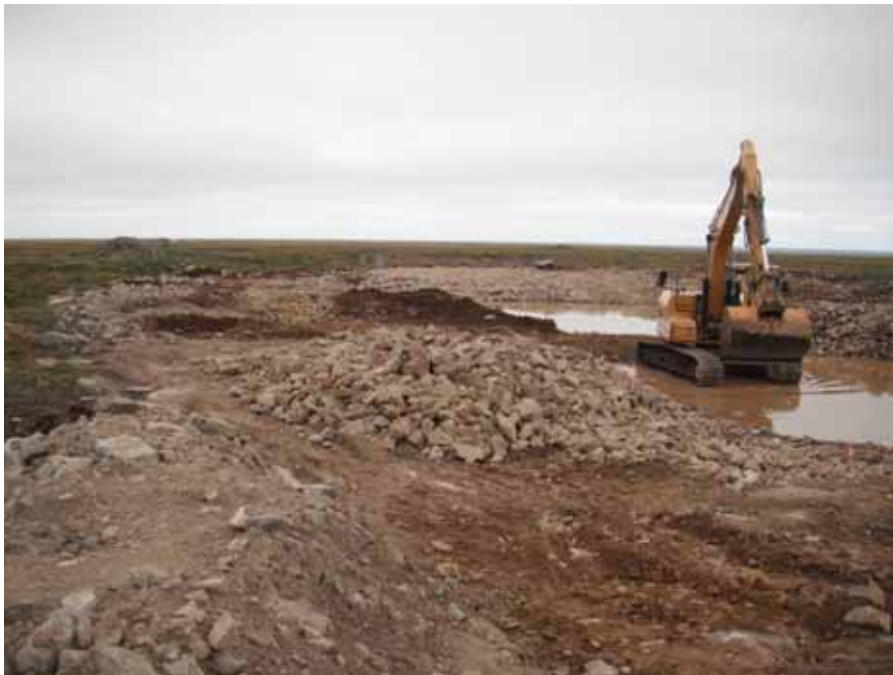
Photograph 8: Site 6 view of partially capped excavation. Direction: west.  
Date: July 2010.

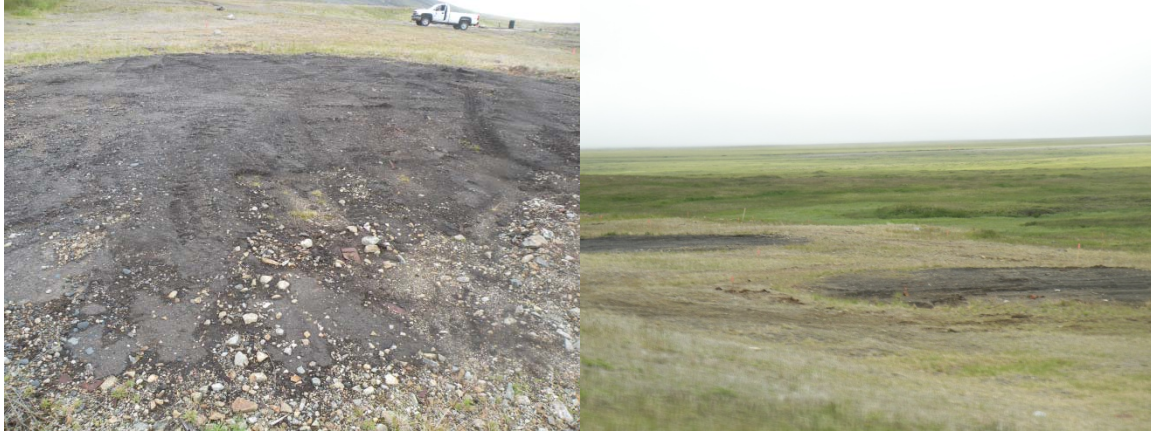
This site will require a mechanical implement, such as ripper to fracture the soil.

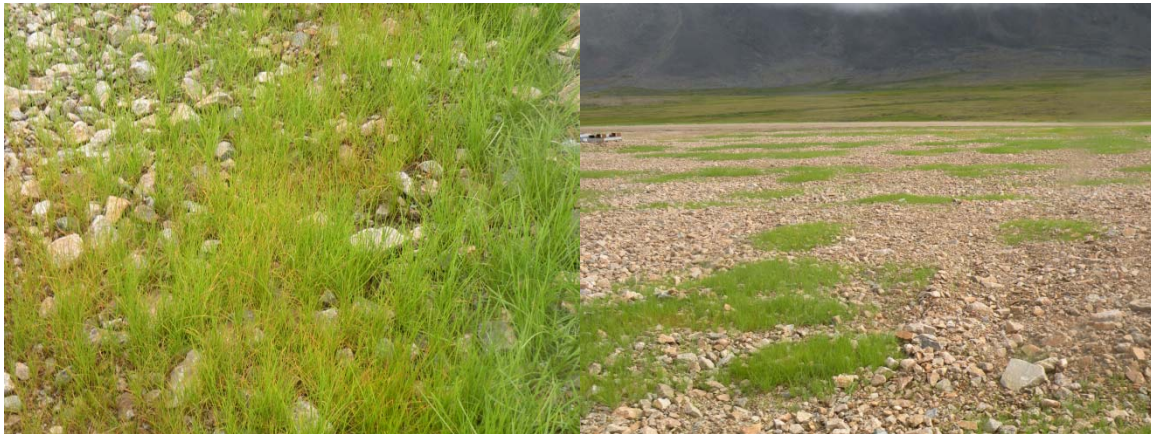
I recommend reseeding this site with 70% Tufted hairgrass and 30% Red fescue. Fertilize with 20-20-10 at 500 pounds per acre. Yellowing of the grasses is probably due to fertilizer deficiency.
