2016 SITE 8 AND SUQITUGHNEQ RIVER SURFACE WATER AND SEDIMENT SAMPLING REPORT

NORTHEAST CAPE ST. LAWRENCE ISLAND, ALASKA

FUDS No. F10AK0969-03

**Final
September 2017**

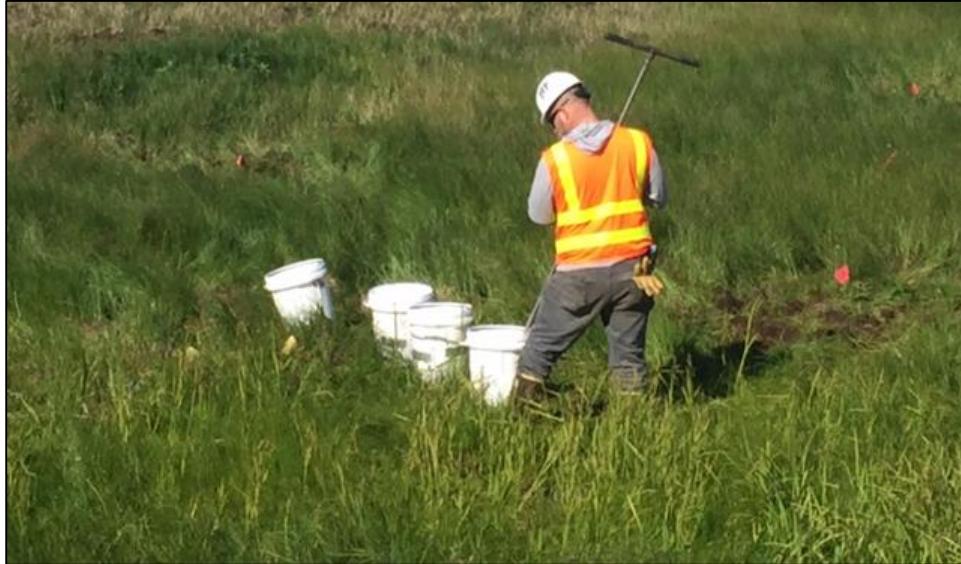
Photograph 5-4: Decontaminating sample collection equipment during sediment and soil sampling at Site 8 on 17 August 2016. View facing west.

Reusable sampling tools were decontaminated before use with Alconox and deionized water rinses (Photograph 5-4) and one-time-use equipment was disposed of after use. Decontamination water was collected and treated onsite using a granulated activated carbon (GAC) filter drum prior to discharge onsite (Section 5.4).

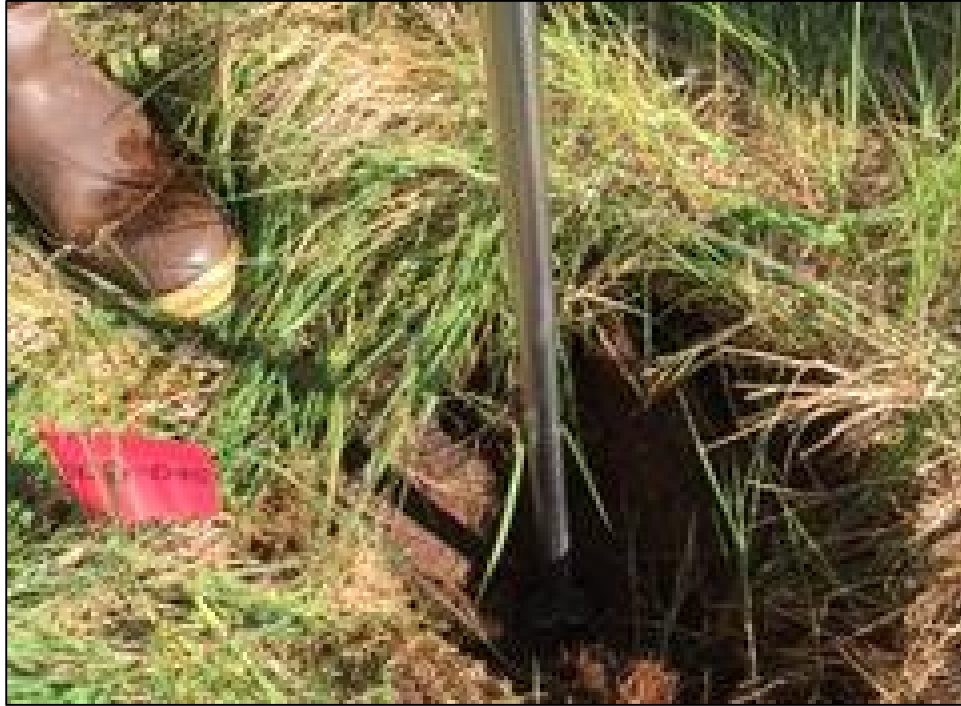
Photograph 5-5: Typical depth of samples (1 to 2 feet bgs) collected from Site 8 on 17 August 2016; this sample was collected southwest of the UDU and northwest of the MDU from SS-045. View facing down.

A total of 83 samples (44 soil and 39 sediment) were collected from 75 sample locations at Site 8 on 17, 18, and 22 August 2016. Shovels, a hand auger, sampling spoons, and gloved hands were used to collect soil and sediment samples (Photograph 5-6). Sample locations were the center point of either 20-foot or 10-foot sample grids that spanned across the three historical decision units and adjacent areas. Samples were collected at surveyed locations (Section 4.0). Samples were typically collected from 1 to 2 feet bgs from depths immediately below the vegetative mat (Photograph 5-5); however, the vertical extent of the vegetative mat exhibited local variation. In order to collect soil or sediment and not vegetative material, sample depths ranged from 0.5 feet to 2.5 feet bgs. No specific evidence of anthropogenic disturbance was noted below the vegetative mat.

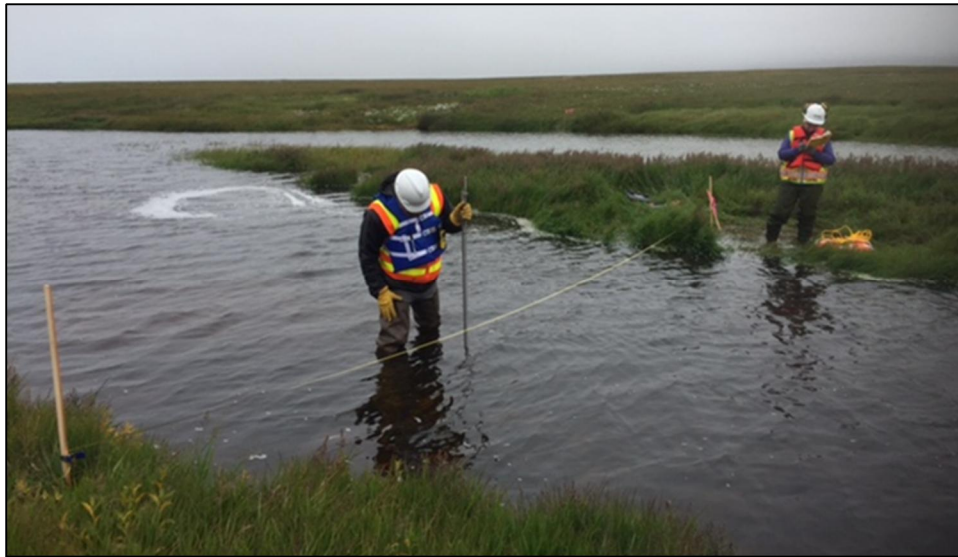
Photograph 5-10: Collecting depth measurements along the tag line at Cross-Section S29-004 on 16 August 2016; while the source of the downstream foam was not investigated, it is likely the result of natural decomposition. View facing northeast, flow to the northeast.

Cross-section S29-004, located approximately 100 feet downstream from the Suqi River culvert near the airstrip, was a shallow, boulder-lined streambed measuring 22 feet across (Appendix C). The mean velocity was 0.37 ft/sec, and the discharge was 10.17 ft³/sec. While the Suqi River was observed to be flowing past the cross-section S29-004, the sand berm at the terminus of the Suqi River estuary may have affected the velocity measurements.

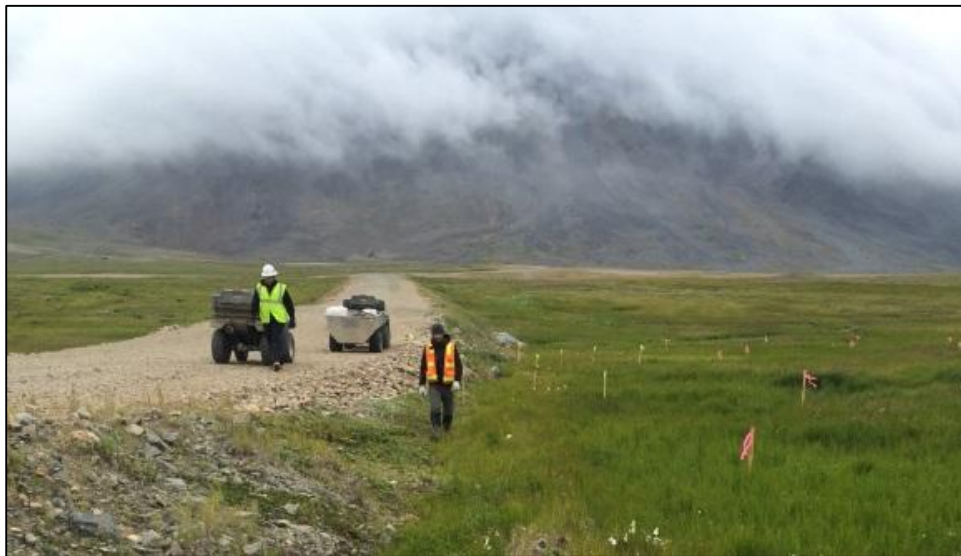
Photograph 6-1: Extent of the road toe along the MDU and LDU on 18 August 2016. View facing south.

In 2016, samples were collected within and adjacent to the Site 8 Decision Units (Figure A-3). The eastern edge of the sampling area was bounded by Cargo Beach Road and several samples in the southeastern portion of the sample area were collected below roadbed material (Photograph 6-1). Tussocks were encountered more frequently throughout the lower two-thirds of the sampling area (Photograph 6-2).

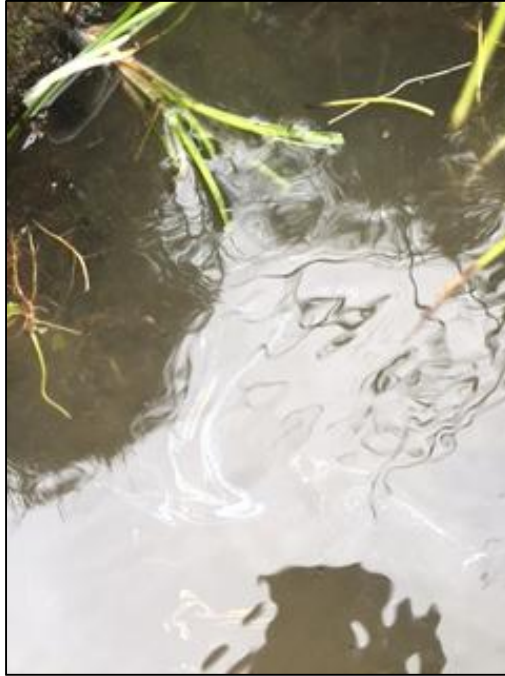
Photograph 6-5: Sheen observed prior to collecting sediment sample S29-SD-003 on 15 August 2016. View facing down.

While isolated pools of surface water sheen were observed at S29-002 and S29-003 (Photograph 6-5) prior to disturbance or sample collection, the source and whether or not the sheen was biogenic or petrogenic were unknown; results from the 2016 sampling effort for TAH and TAqH in surface water do not support an anthropogenic source for sheen. Surface water TAH and TAqH results were below SSCLs. Sheens have been observed during past sampling efforts as a result of sediment or streambank material disturbance.

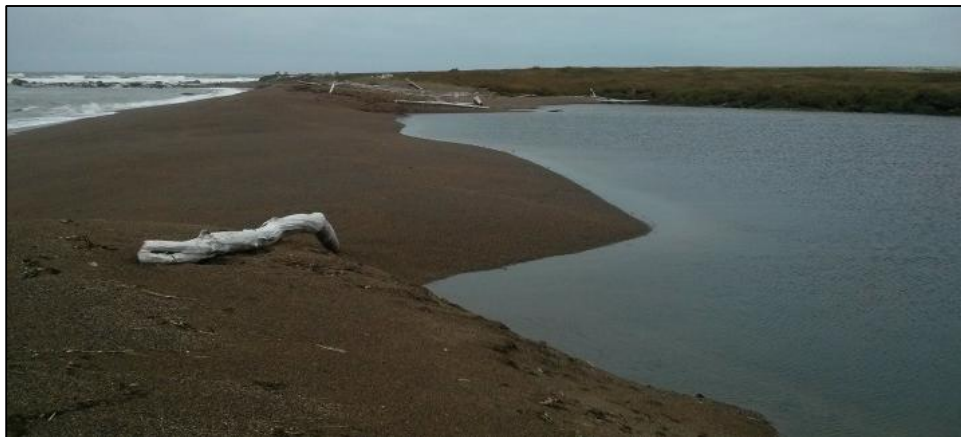
Photograph 6-6: Terminus of Suqi River estuary berm, and Bering Sea on 15 August 2016. View facing east.

A sand berm at the mouth of the Suqi River several feet high prevented direct tidal influence in the estuary. As stated in the Scope of Work and Phase IV RI (USACE 2005), the Bering Sea breaches the sand berm every few years, typically in the fall. Field personnel observed the sand berm on 15 August 2016 and after a storm event on 23 August 2016. As shown in Photographs 6-6 and 6-7, the height and shape of the berm changed after the storm.

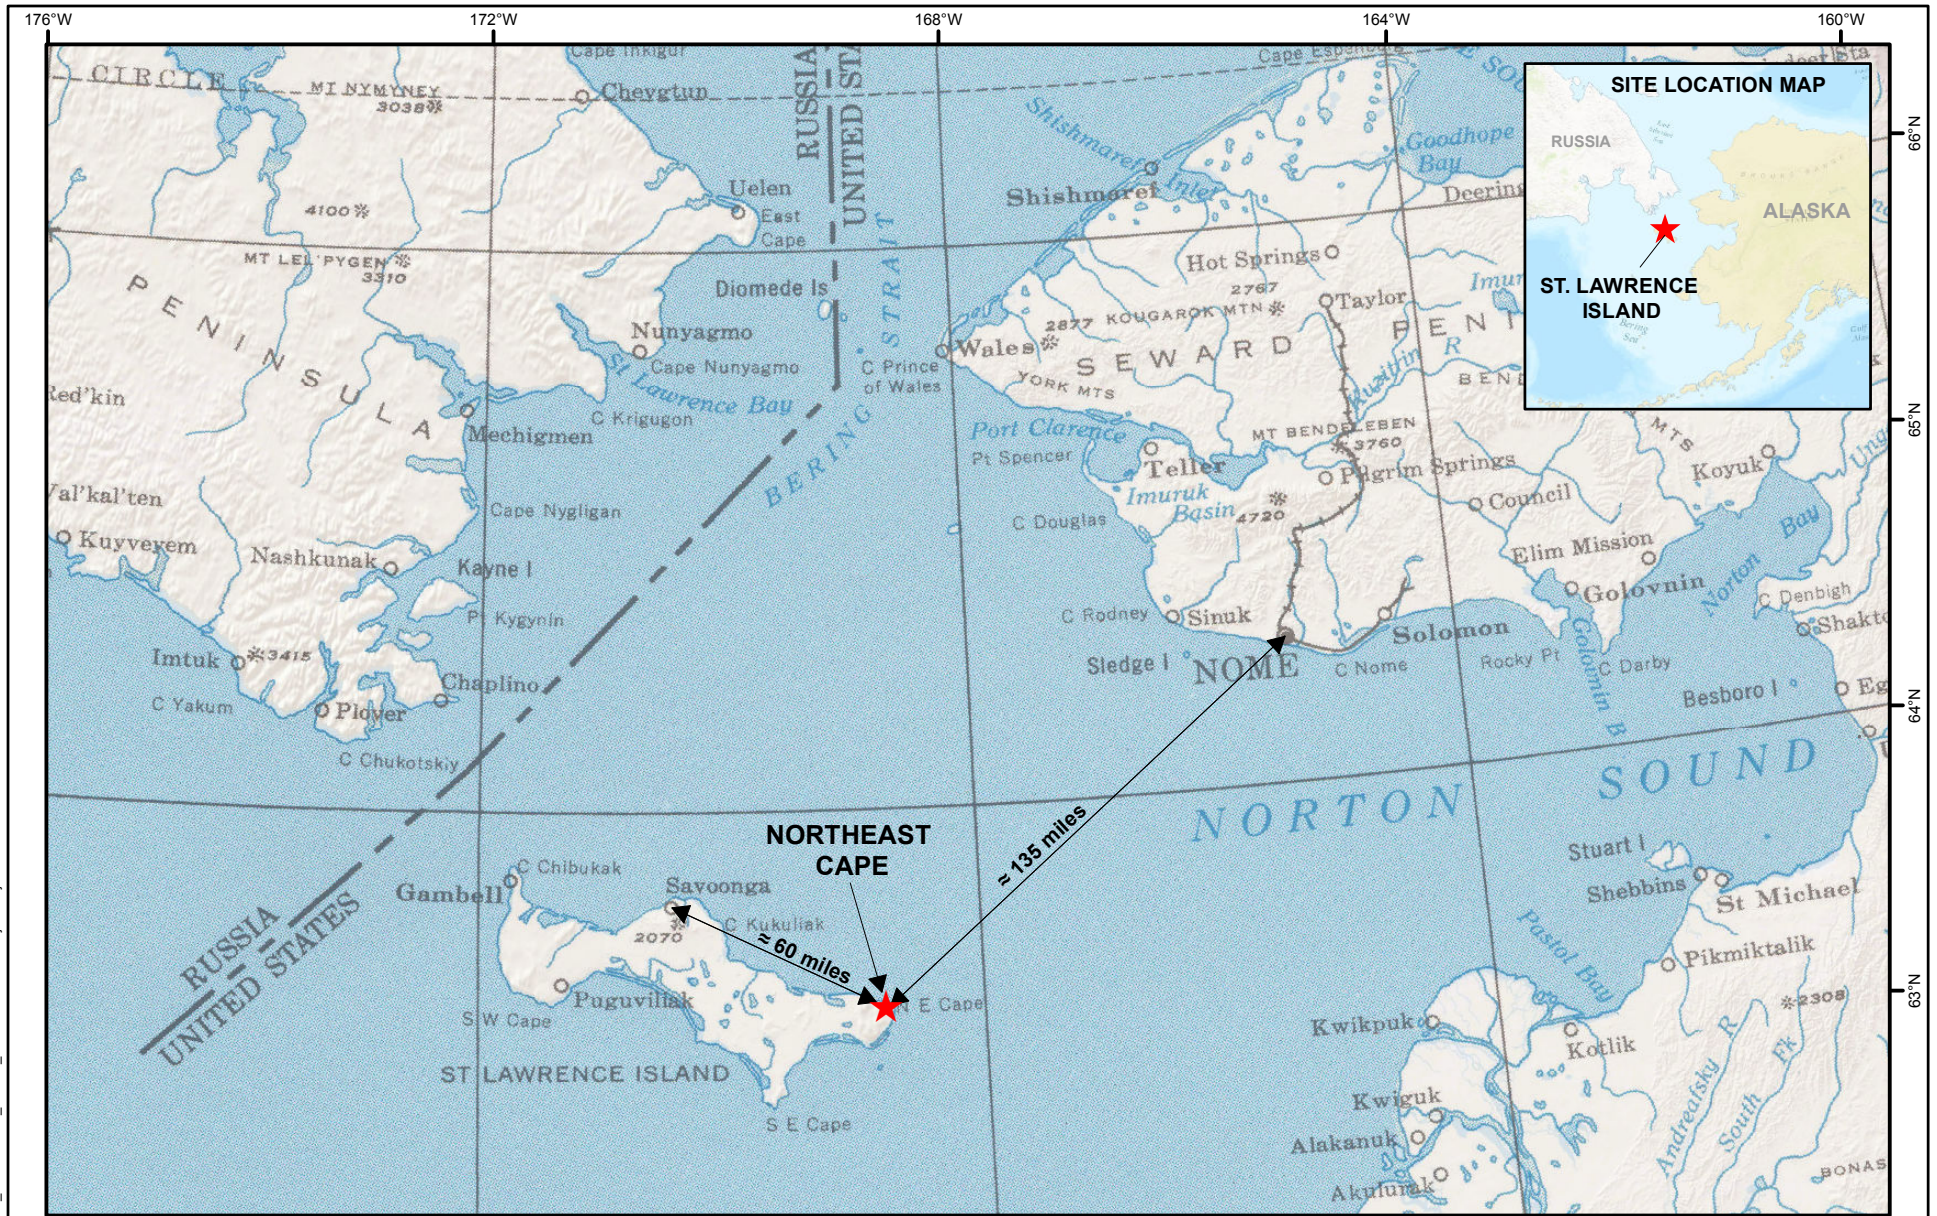
FIGURE NO.:
A-1

All Locations Are Approximate

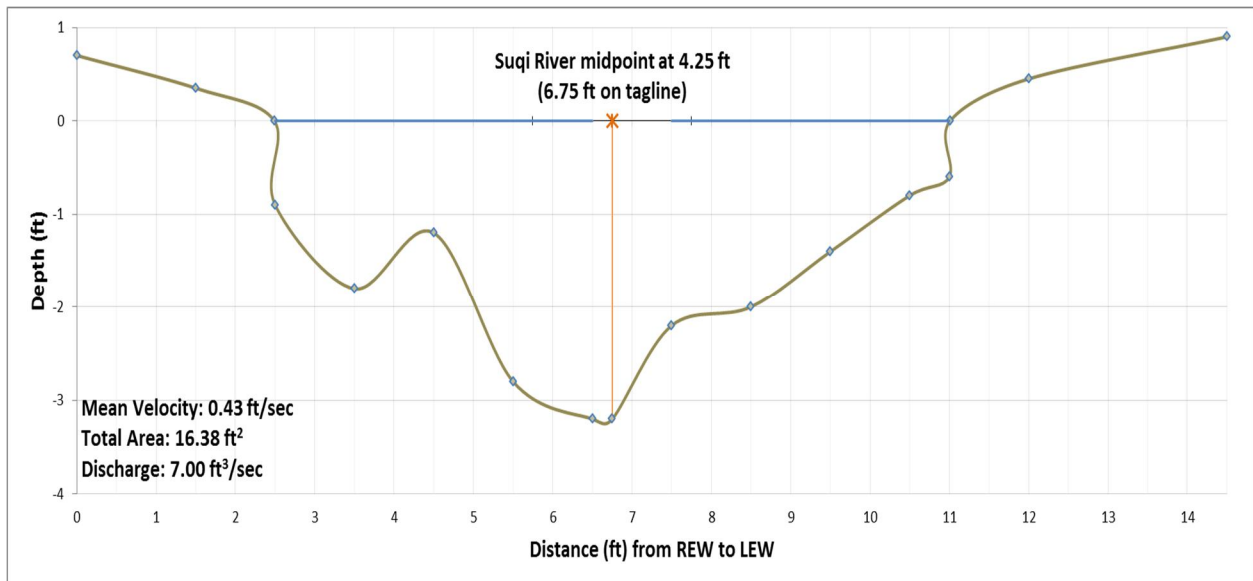
Mean Velocity and Discharge calculated using Marsh McBirney Calculation; see Section 6.3.2.

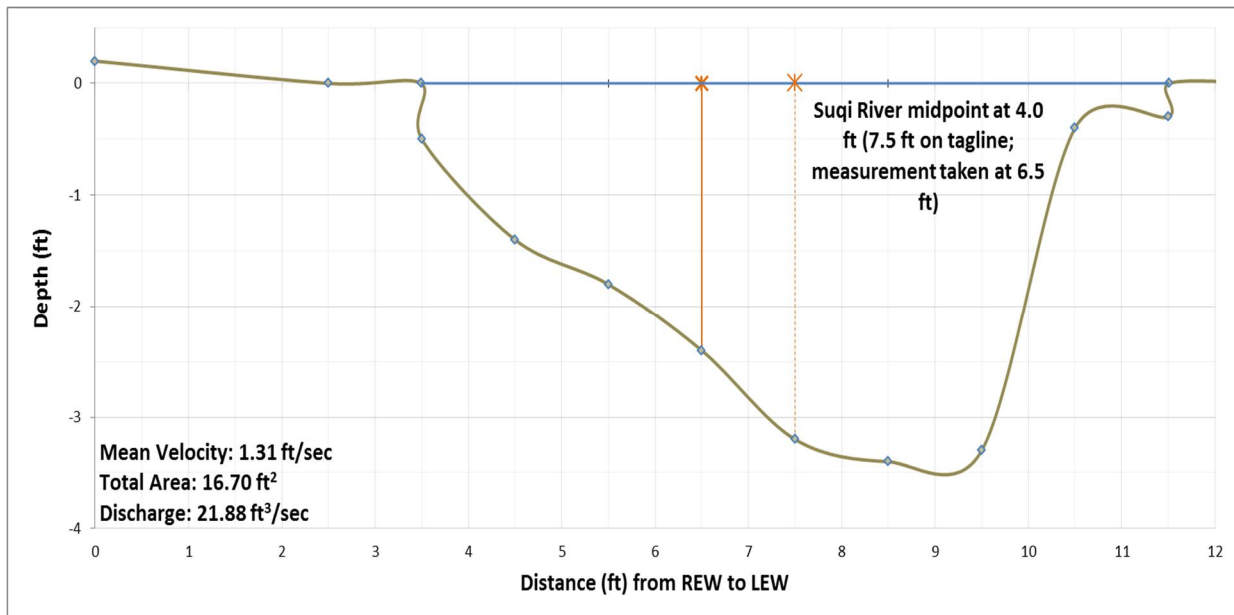
Mean Velocity and Discharge calculated using Marsh McBirney Calculation; see Section 6.3.2.

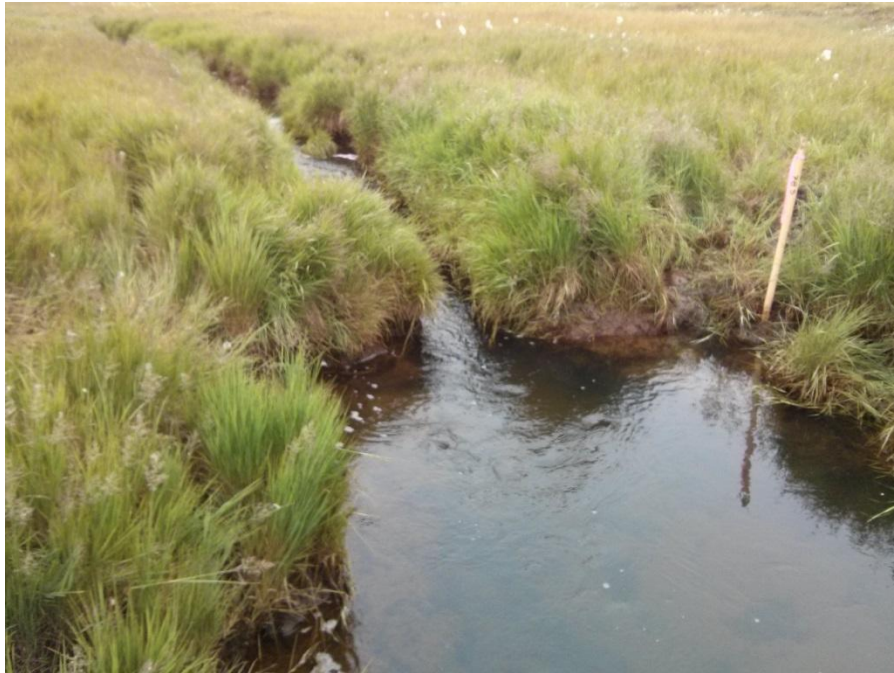
S29-002 - 16 August 2016; 1632 hours.

Notes: Due to eddy at center point of stream, measurement taken 1 ft from center point.

Smooth gravel and silt covered streambed.

Cross section S29-002. Facing east, flow to the west.

- Flow measurements were collected from the Suqi River at two points at cross-section S29-002 (Figure A-6.2). Although flow measurements were collected from the midpoint of the Suqi River channel, the midpoint at this location had an eddy (Photograph No. 21 in Appendix E). An additional velocity measurement was collected 1 foot closer to the right edge of water (when facing downstream) from the midpoint and used to calculate discharge at this location.

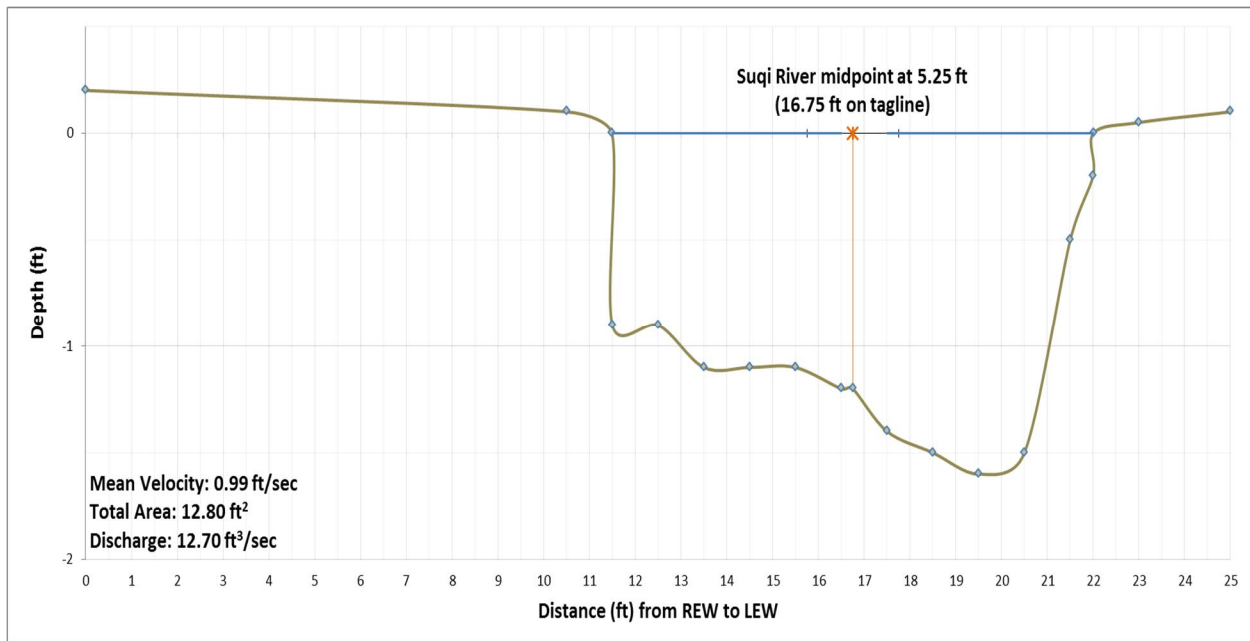
Mean Velocity and Discharge calculated using Marsh McBirney Calculation; see Section 6.3.2.

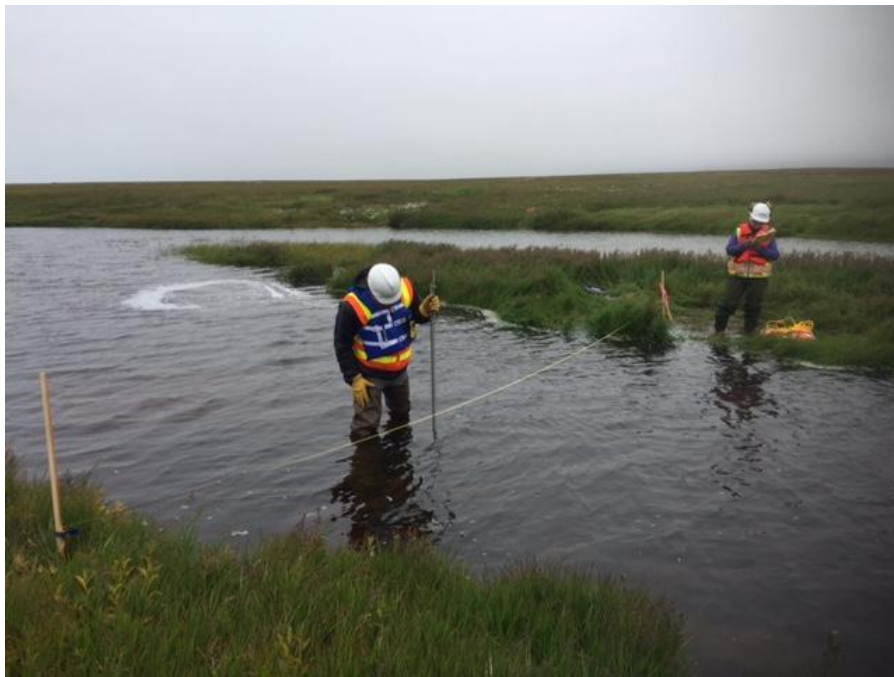
S29-004 - 16 August 2016; 1524 hours.

Notes: Boulder lined streambed.

Collecting depth measurements along the tag line at cross section S29-004. Facing northeast, flow to the northeast.

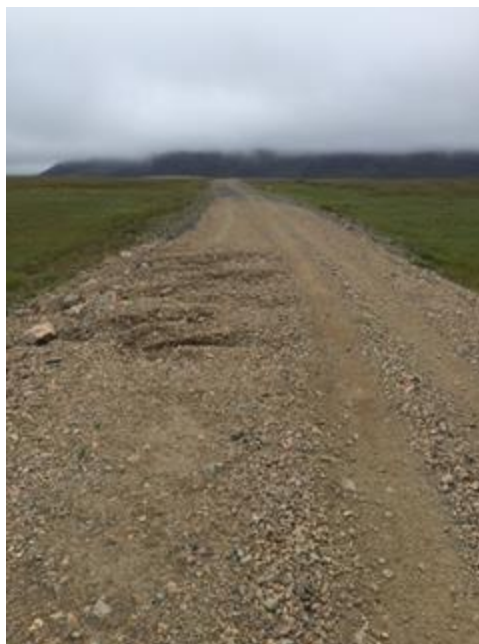
Photo No. 8 – 14 August 2016; 1245 hours.
Washout near Suqi River culvert. Facing southeast.

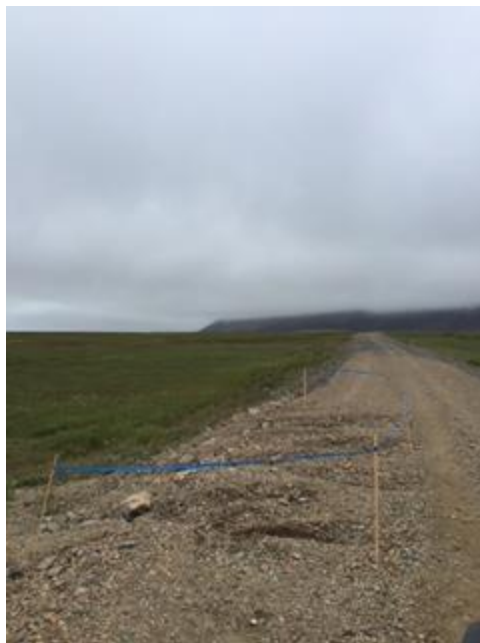
Photo No. 9 – 14 August 2016; 1253 hours.
Flagging placed as safety barrier around washout near Suqi River culvert. Facing southeast.

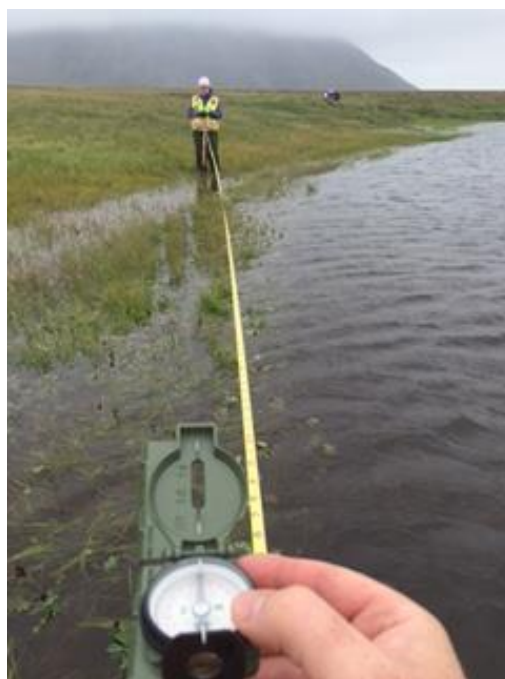
Photo No. 14 – 15 August 2016; 1522 hours.
Method used to locate actual proposed sample location for S29-006 in Suqi River estuary.
Facing south, flow to the northeast.

- The original stakeout did not match the locations proposed in the 2016 work plan (USACE 2016a). In order to collect sediment samples adjacent to historical sample locations, sample locations 005, 006, and 007 were not collected in the surveyed location. Using a compass and tape measure, an attempt was made to collect samples in the proposed locations; these sample locations are estimated (Photograph No. 14 in Appendix E).

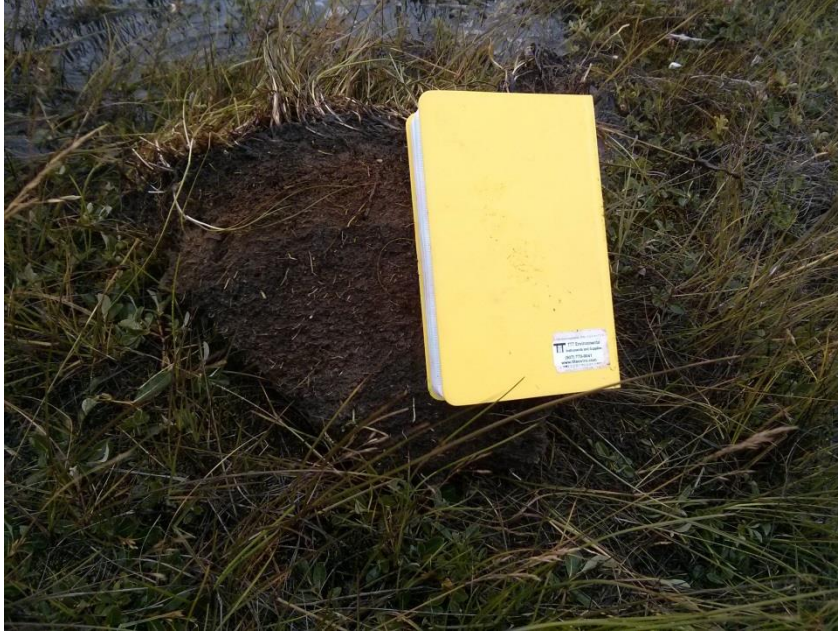
Photo No. 15 – 15 August 2016; 1555 hours.
Organic layer encountered and removed prior to sampling sediment at Suqi River sample location S29-009. Facing down.

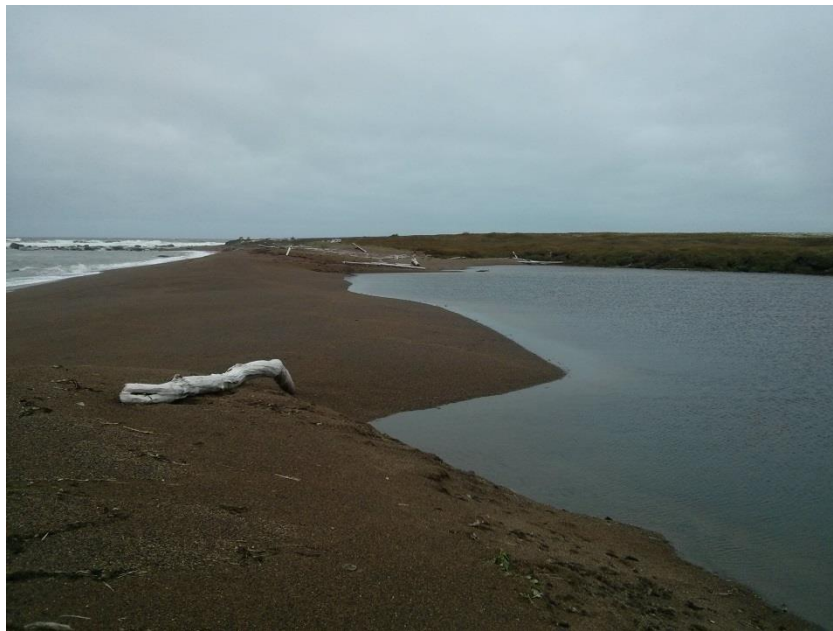
Photo No. 16 – 15 August 2016; 1740 hours.
Terminus of the Suqi River estuary, berm, and Bering Sea. For Northeast Cape (No. 2435), using Nome as a reference station, predicted low tide (0.1 ft mean lower low water) at 1609 on 15 August 2016 and high tide (1.8 ft mean lower low water at 0115 on 16 August 2016.
Data Source: NOAA Tide Tables 2016: High and Low Water Predictions. Facing east.

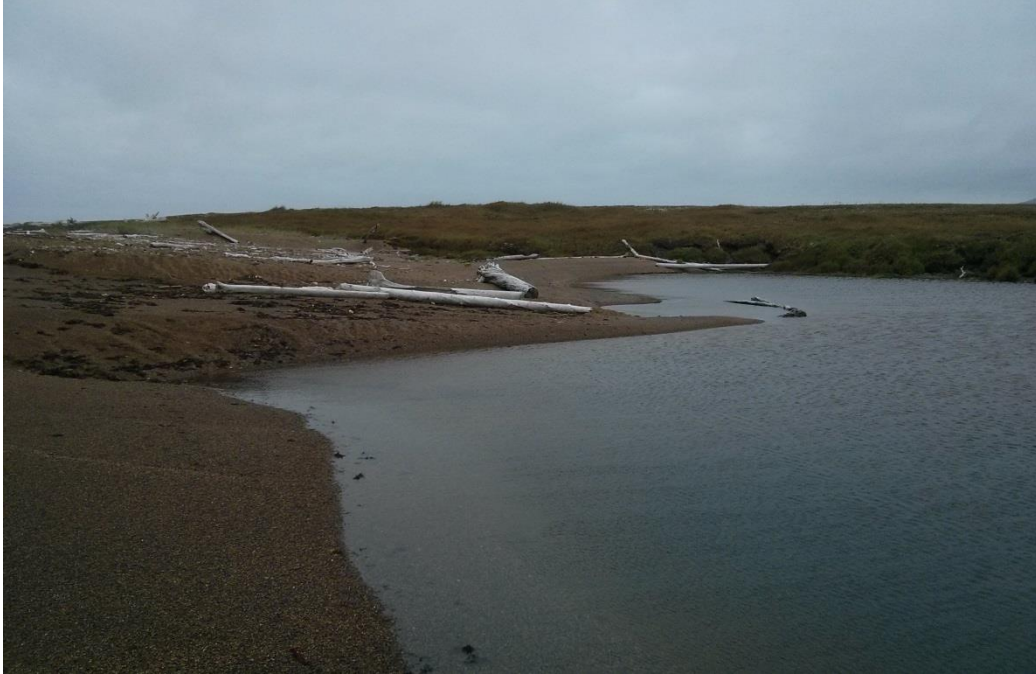
Photo No. 17 – 15 August 2016; 1740 hours.

Terminus of the Suqi River estuary, berm, and Bering Sea. For Northeast Cape (No. 2435), using Nome as a reference station, predicted low tide (0.1 ft mean lower low water) at 1609 on 15 August 2016 and high tide (1.8 ft mean lower low water at 0115 on 16 August 2016.

Data Source: NOAA Tide Tables 2016: High and Low Water Predictions. Facing east.

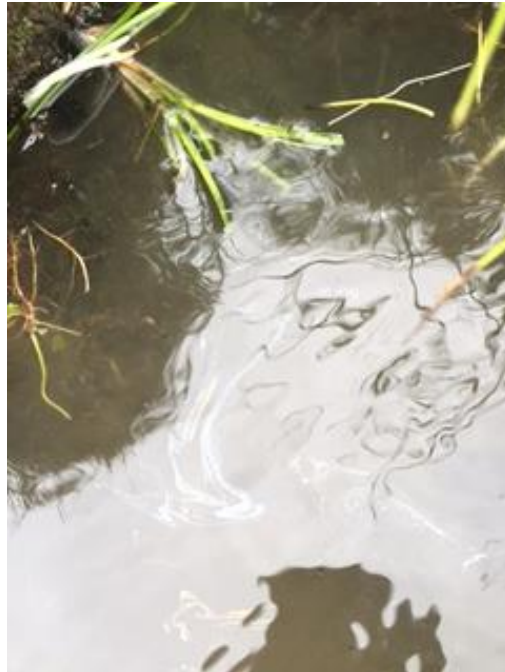
Photo No. 18 – 15 August 2016, 1933 hours.

Sheen observed prior to collecting sediment from Suqi River sample location S29-003. Facing down.

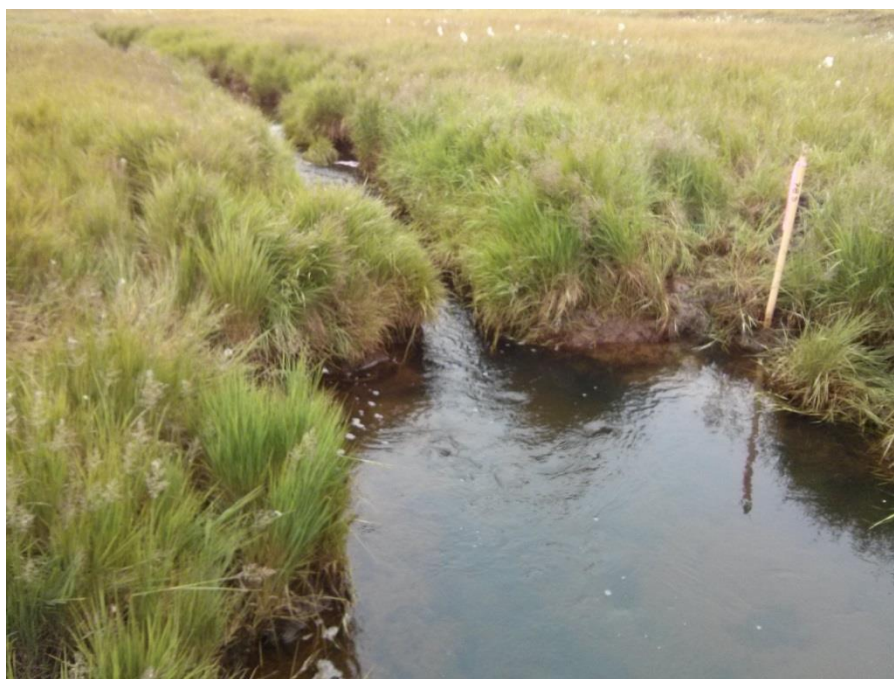
Photo No. 22 – 16 August 2016; 1632 hours.
Suqi River cross section S29-002. Facing east, flow to the west.

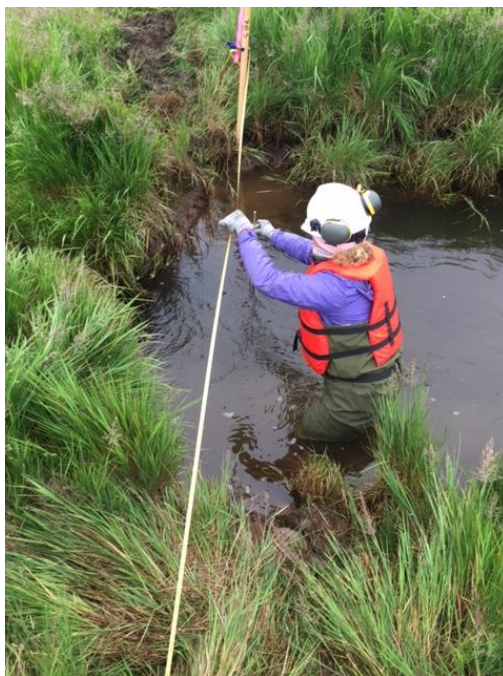
Photo No. 23 – 16 August 2016; 1641 hours.
Collecting the depth measurement at the midpoint of the Suqi River at cross section S29-002.
Facing down, flow to the west (right).

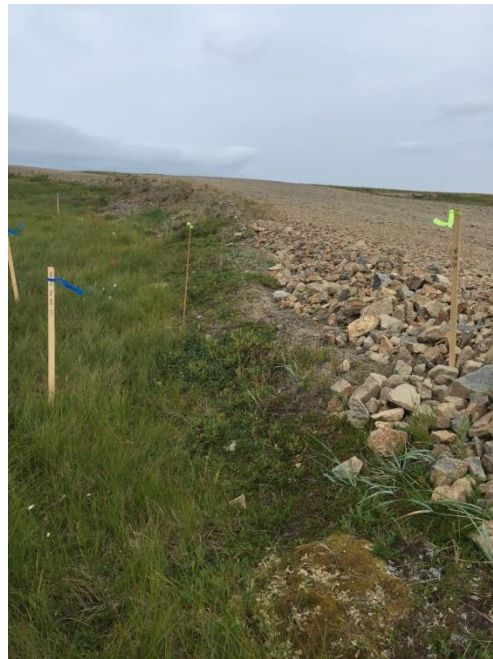
Photo No. 30 – 18 August 2016, 1411 hours.
Survey lathe with blue flagging (left edge of photo) represents the adjusted Site 8 sample location for S08-073 (right edge of photo); both the original proposed and adjusted sample location are east of the MDU. Facing northeast.

- Some sample locations were relocated to target potentially contaminated material. Although sample locations were originally selected across and adjacent to the three decision units with the intent of sampling potentially contaminated soil, six proposed locations were several feet into the roadbed and could not be accessed with hand tools (Photographs No. 29 and 30 in Appendix E). After discussions with the USACE, Site 8 sample locations 004, 013, 021, 039, 073, and 075 were relocated so that no more than

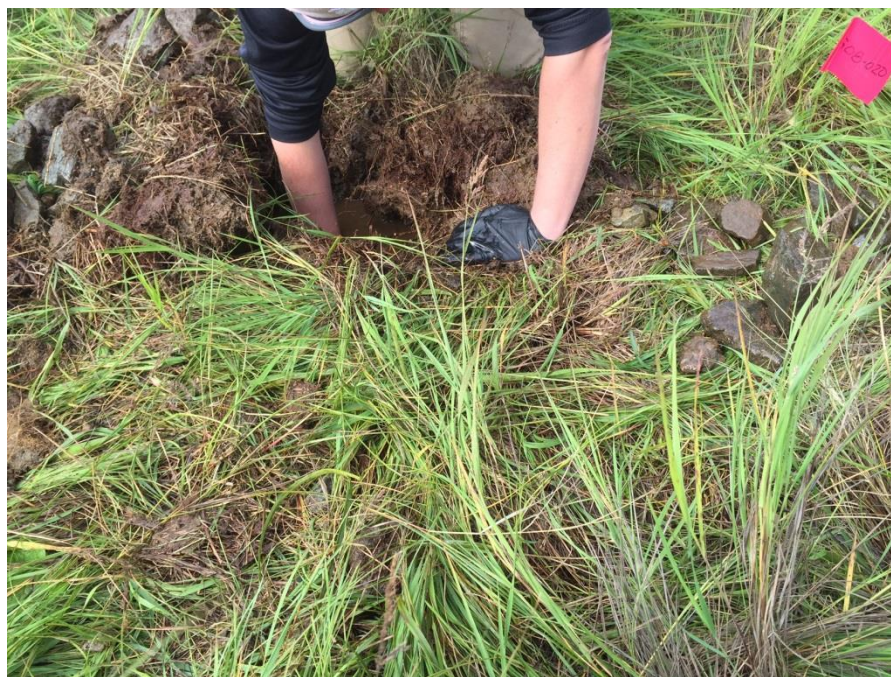
Photo No. 32 – 18 August 2016, 1705 hours.
Site 8 sample collection at S08-020 in the LDU. Facing down.

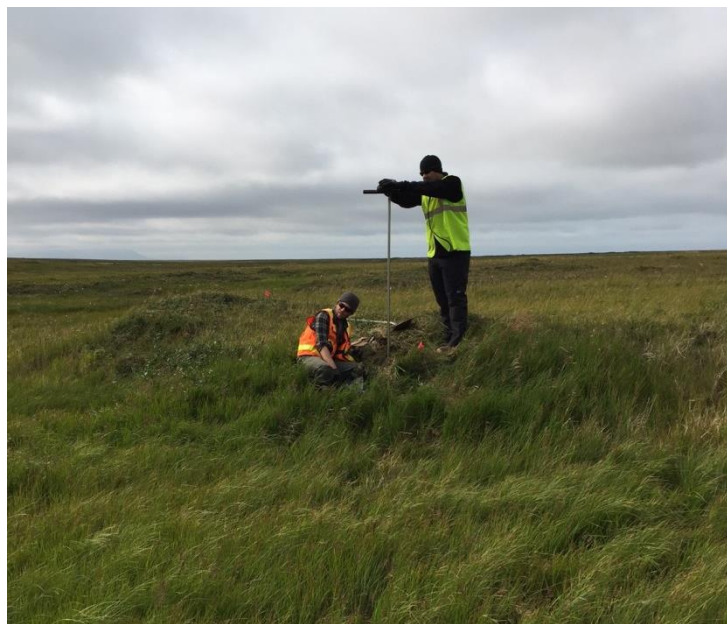
Photo No. 34 – 18 August 2016, 1738 hours.
Soil sampling on a tussock at Site 8 location SS-024 near the southwestern edge of the MDU.
Facing northwest.

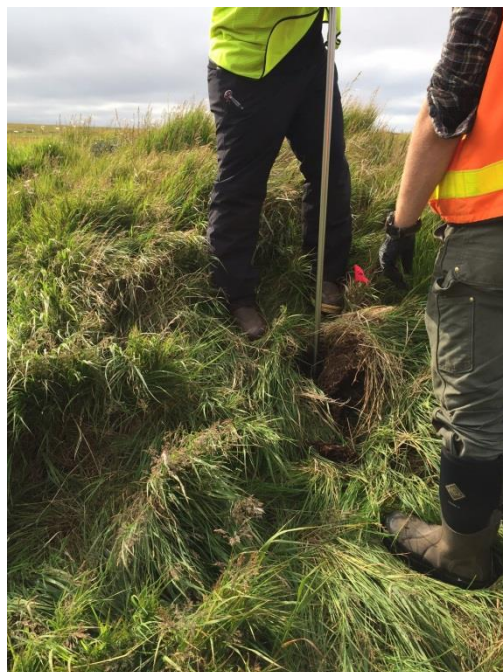
Photo No. 35 – 18 August 2016, 1757 hours.
Soil sampling on a tussock at Site 8 sample location SS-023 west of the MDU and LDU boundaries. Facing northwest.

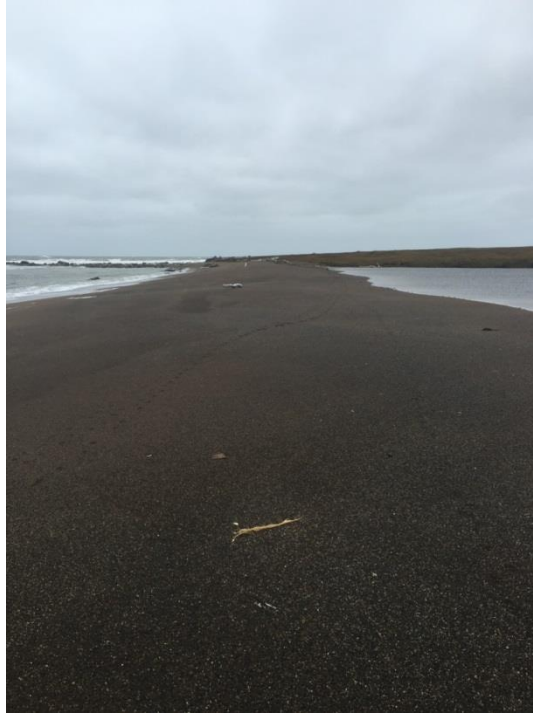
Photo No. 39 – 23 August 2016, 1236 hours.

Terminus of the Suqi River estuary, berm, and Bering Sea after storm event. For Northeast Cape (No. 2435), using Nome as a reference station, predicted low tide (0.2 ft mean lower low water) at 0936 on 23 August 2016 and high tide (2.2 ft mean lower low water at 1539 on 23 August 2016. Data Source: NOAA Tide Tables 2016: High and Low Water Predictions. Facing east.
