INVENTORY REPORT
GAMBELL FORMERLY USED DEFENSE SITE
ST. LAWRENCE ISLAND, ALASKA

Contract No. DACA85-91-D-0003
Delivery Order No. D0010

ECOLOGY AND ENVIRONMENT, INC.

December 1992

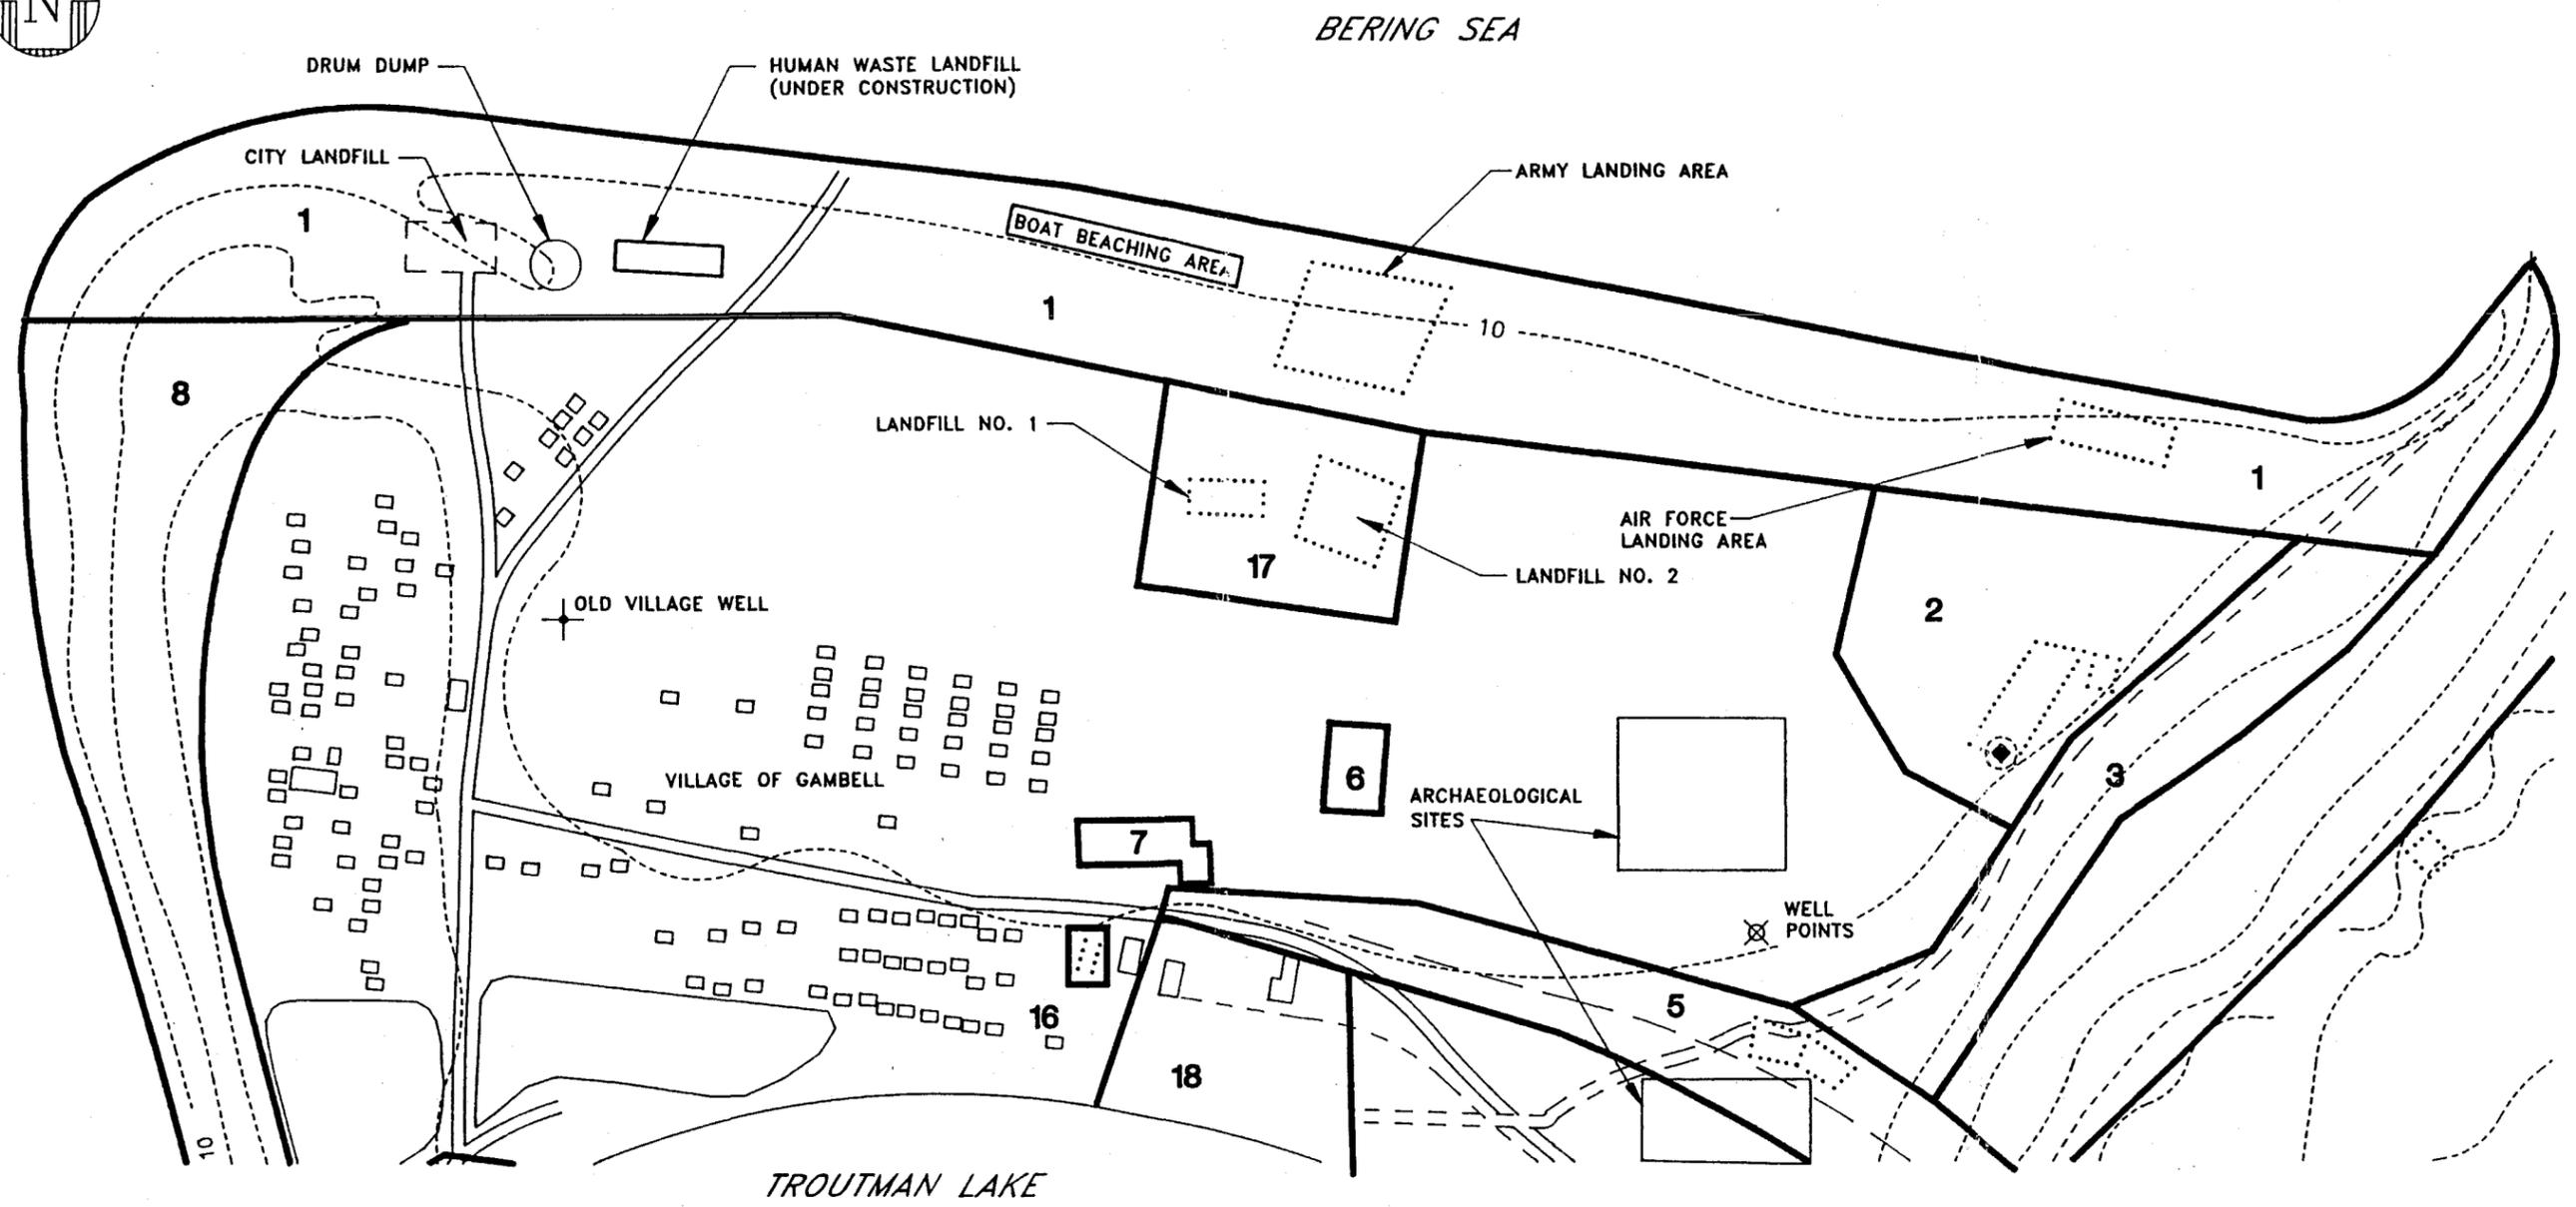
Figure 3-2 SITE 1, NORTH BEACH LOCATION MAP

The Air Force Landing Area is reportedly located adjacent to the beach berm, approximately 900 feet west of the 100-foot contour of Sevuokuk Mountain. (Generally, the beach berm is represented by the 10-foot contour line shown in Figure 3-2.) The Air Force Landing Area is approximately 275 feet by 80 feet. Near the northeast corner of the Air Force Landing Area, within the beach berm, is a decaying drum, black oil or tar-like material, and rust-stained gravel. In addition, there is a 5-foot by 4-foot patch of tar-stained gravel near the center of this area. An area of rust-colored gravel is visible in an ATV road that is oriented east to west and bisects the southern third of the area. Mr. James claims that there are buried drums of heavy weight oils, tars, and asphalt in the Air Force Landing Area (E & E 1992).

The Army Landing Area is characterized by small round gravel mounds, many of which include small metal/rust fragments from deteriorating material. Debris is scattered between the Air Force Landing Area and the Army Landing Area and is concentrated on the beach front and near the berm (E & E 1992).

Surface soil sampling should be conducted in areas of stained soil at the Air Force Landing Area to determine whether the staining is caused by hazardous materials. Due to the potential presence of heavy oil and asphalt, surface soil samples should be analyzed for total residual petroleum hydrocarbons (TRPH), base/neutral and acid extractables (BNA), PCBs, and toxicity characteristic leaching procedure (TCLP) metals (arsenic, barium, cadmium, chromium, lead, mercury, selenium, and silver). Subsurface soil sampling should occur in and around the areas in which debris, drums, and waste are reportedly buried to determine whether any hazardous substances are leaching from buried material. Subsurface soil samples should be analyzed for gasoline-range organics (GRO), diesel-range organics (DRO), TRPH, volatile organic compounds (VOC), PCBs, and TCLP metals. In addition, monitoring wells should be installed and groundwater sampled to determine whether any hazardous or toxic substances have leached from the buried material or soils to groundwater. Groundwater samples should be analyzed for GRO, DRO, TRPH, VOCs, PCBs, and total metals.

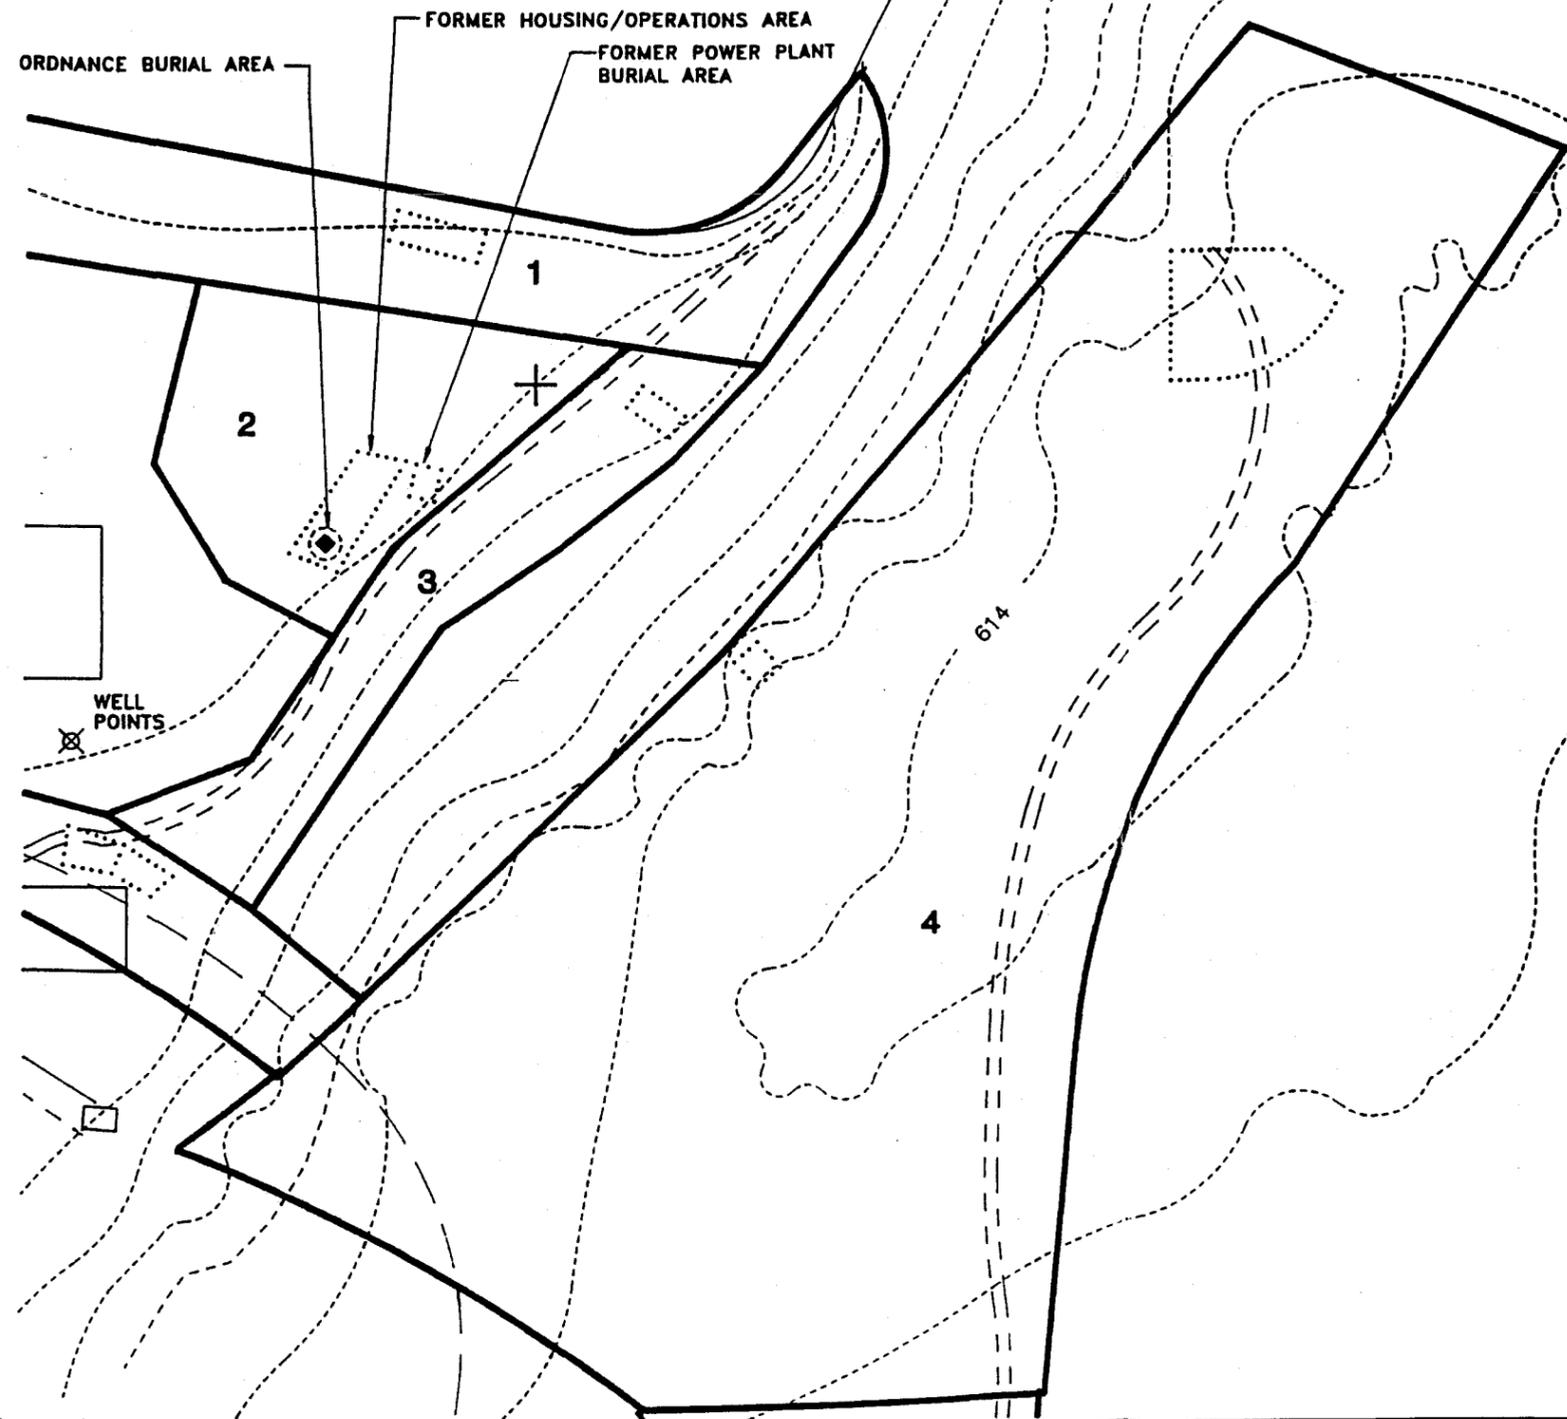
Figure 3-3 SITE 2, FORMER MILITARY HOUSING/OPERATIONS SITE LOCATION MAP

All facilities associated with these areas were demolished, and the debris was buried at Site No. 2. The Former Housing/Operations Area included two rows of six quonset huts oriented north to south. North of the quonset huts was a mess hall and a utility building. The utility building contained showers and a day room. The remnants of an apparent fireplace and a concrete pad, pieces of burned wood, and metal debris are scattered throughout the area (see Appendix A). There are two locations of discolored gravel in the Former Housing/Operations Burial Area; one apparently rust-stained area is located in the northeast corner and the other 2-foot-square area is located near the center of the area and includes burned wood (E & E 1992).

East of the Former Housing/Operations Area was a small power plant. The power plant and all associated machinery were reportedly buried in the Former Power Plant Burial Area. On the surface of the former Power Plant Burial Area is a large gear, and rectangular metal boxes are located in the southeast corner of the area. Part of a tiltadozer blade protrudes from the ground at the northwest corner of this area. Adjacent to the tiltadozer blade is a portion of a weasel track and rusted metal fragments. The underlying gravel is rust stained (E & E 1992).

North of the Former Housing/Operations Area is mounded gravel that reportedly covers the remains of a buried machine gun nest. Fibrous material which may potentially contain asbestos was observed in the gravel mound during the site inventory. Mr. James explained that the machine gunners would sit on this material to insulate themselves from the ground (E & E 1992).

Sampling at this site should include both surface and subsurface soil, groundwater, and the fibrous material. Since staining appears to be petroleum related, surface soil samples should be collected in areas of visible staining (other than rust) and analyzed for TRPH, BNA, and TCLP metals. Subsurface soil and groundwater samples should be collected on the perimeter of areas reported to contain buried debris and ordnance to determine whether

contaminants are leaching through interaction with groundwater. Subsurface soil samples should be analyzed for GRO, DRO, TRPH, TCLP metals, VOCs, and ordnance. Groundwater samples should be analyzed for GRO, DRO, TRPH, VOCs, total metals, and explosives. Asbestos sampling is also recommended for exposed fibrous materials.

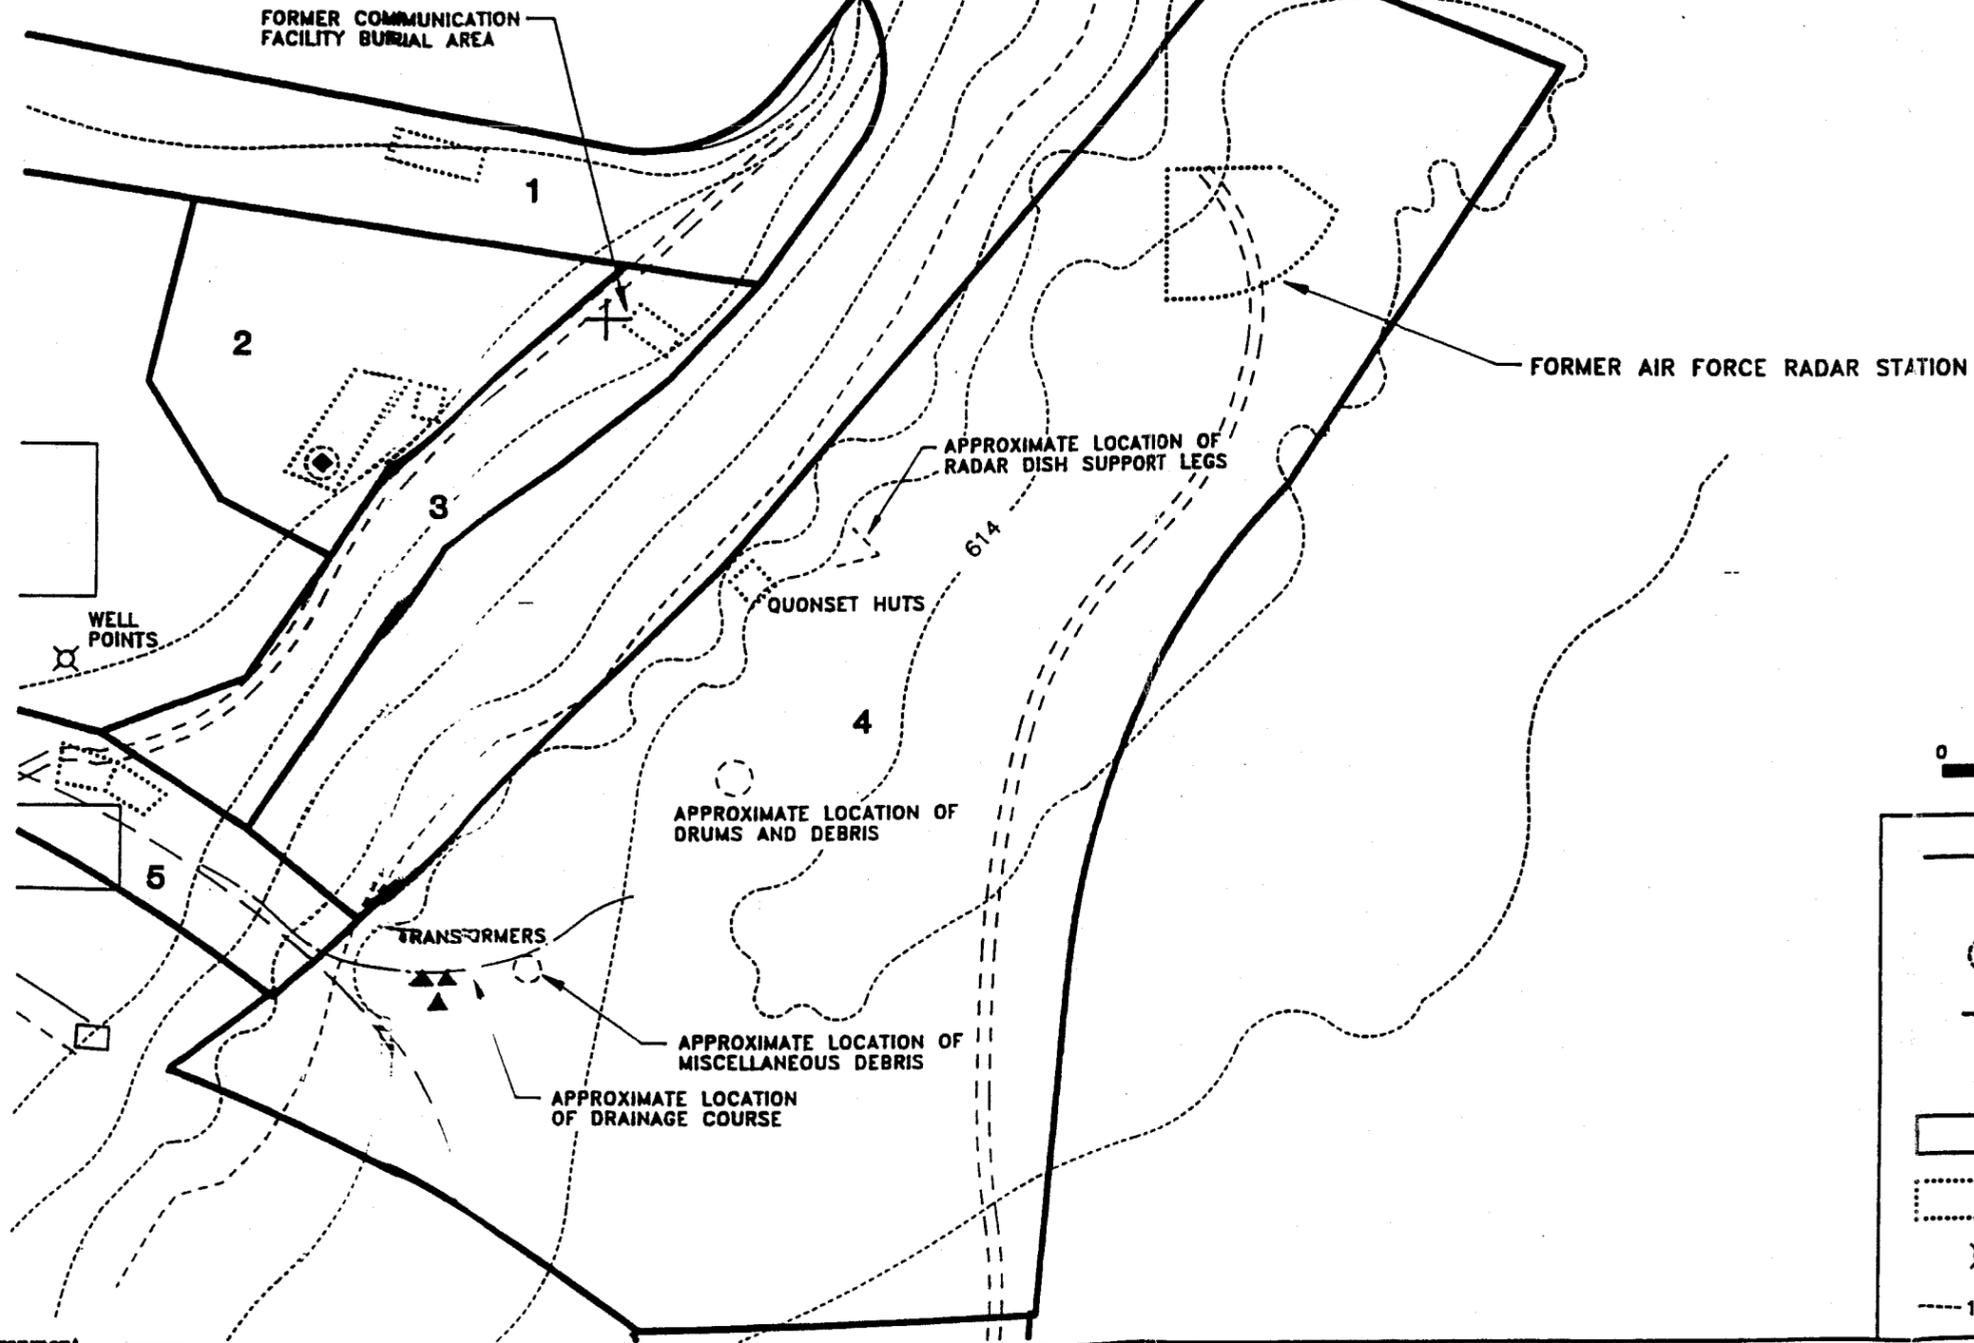
Figure 3-4

SITE 3, FORMER COMMUNICATION FACILITY AND SITE 4, SEVUOKUK MOUNTAIN LOCATION MAP

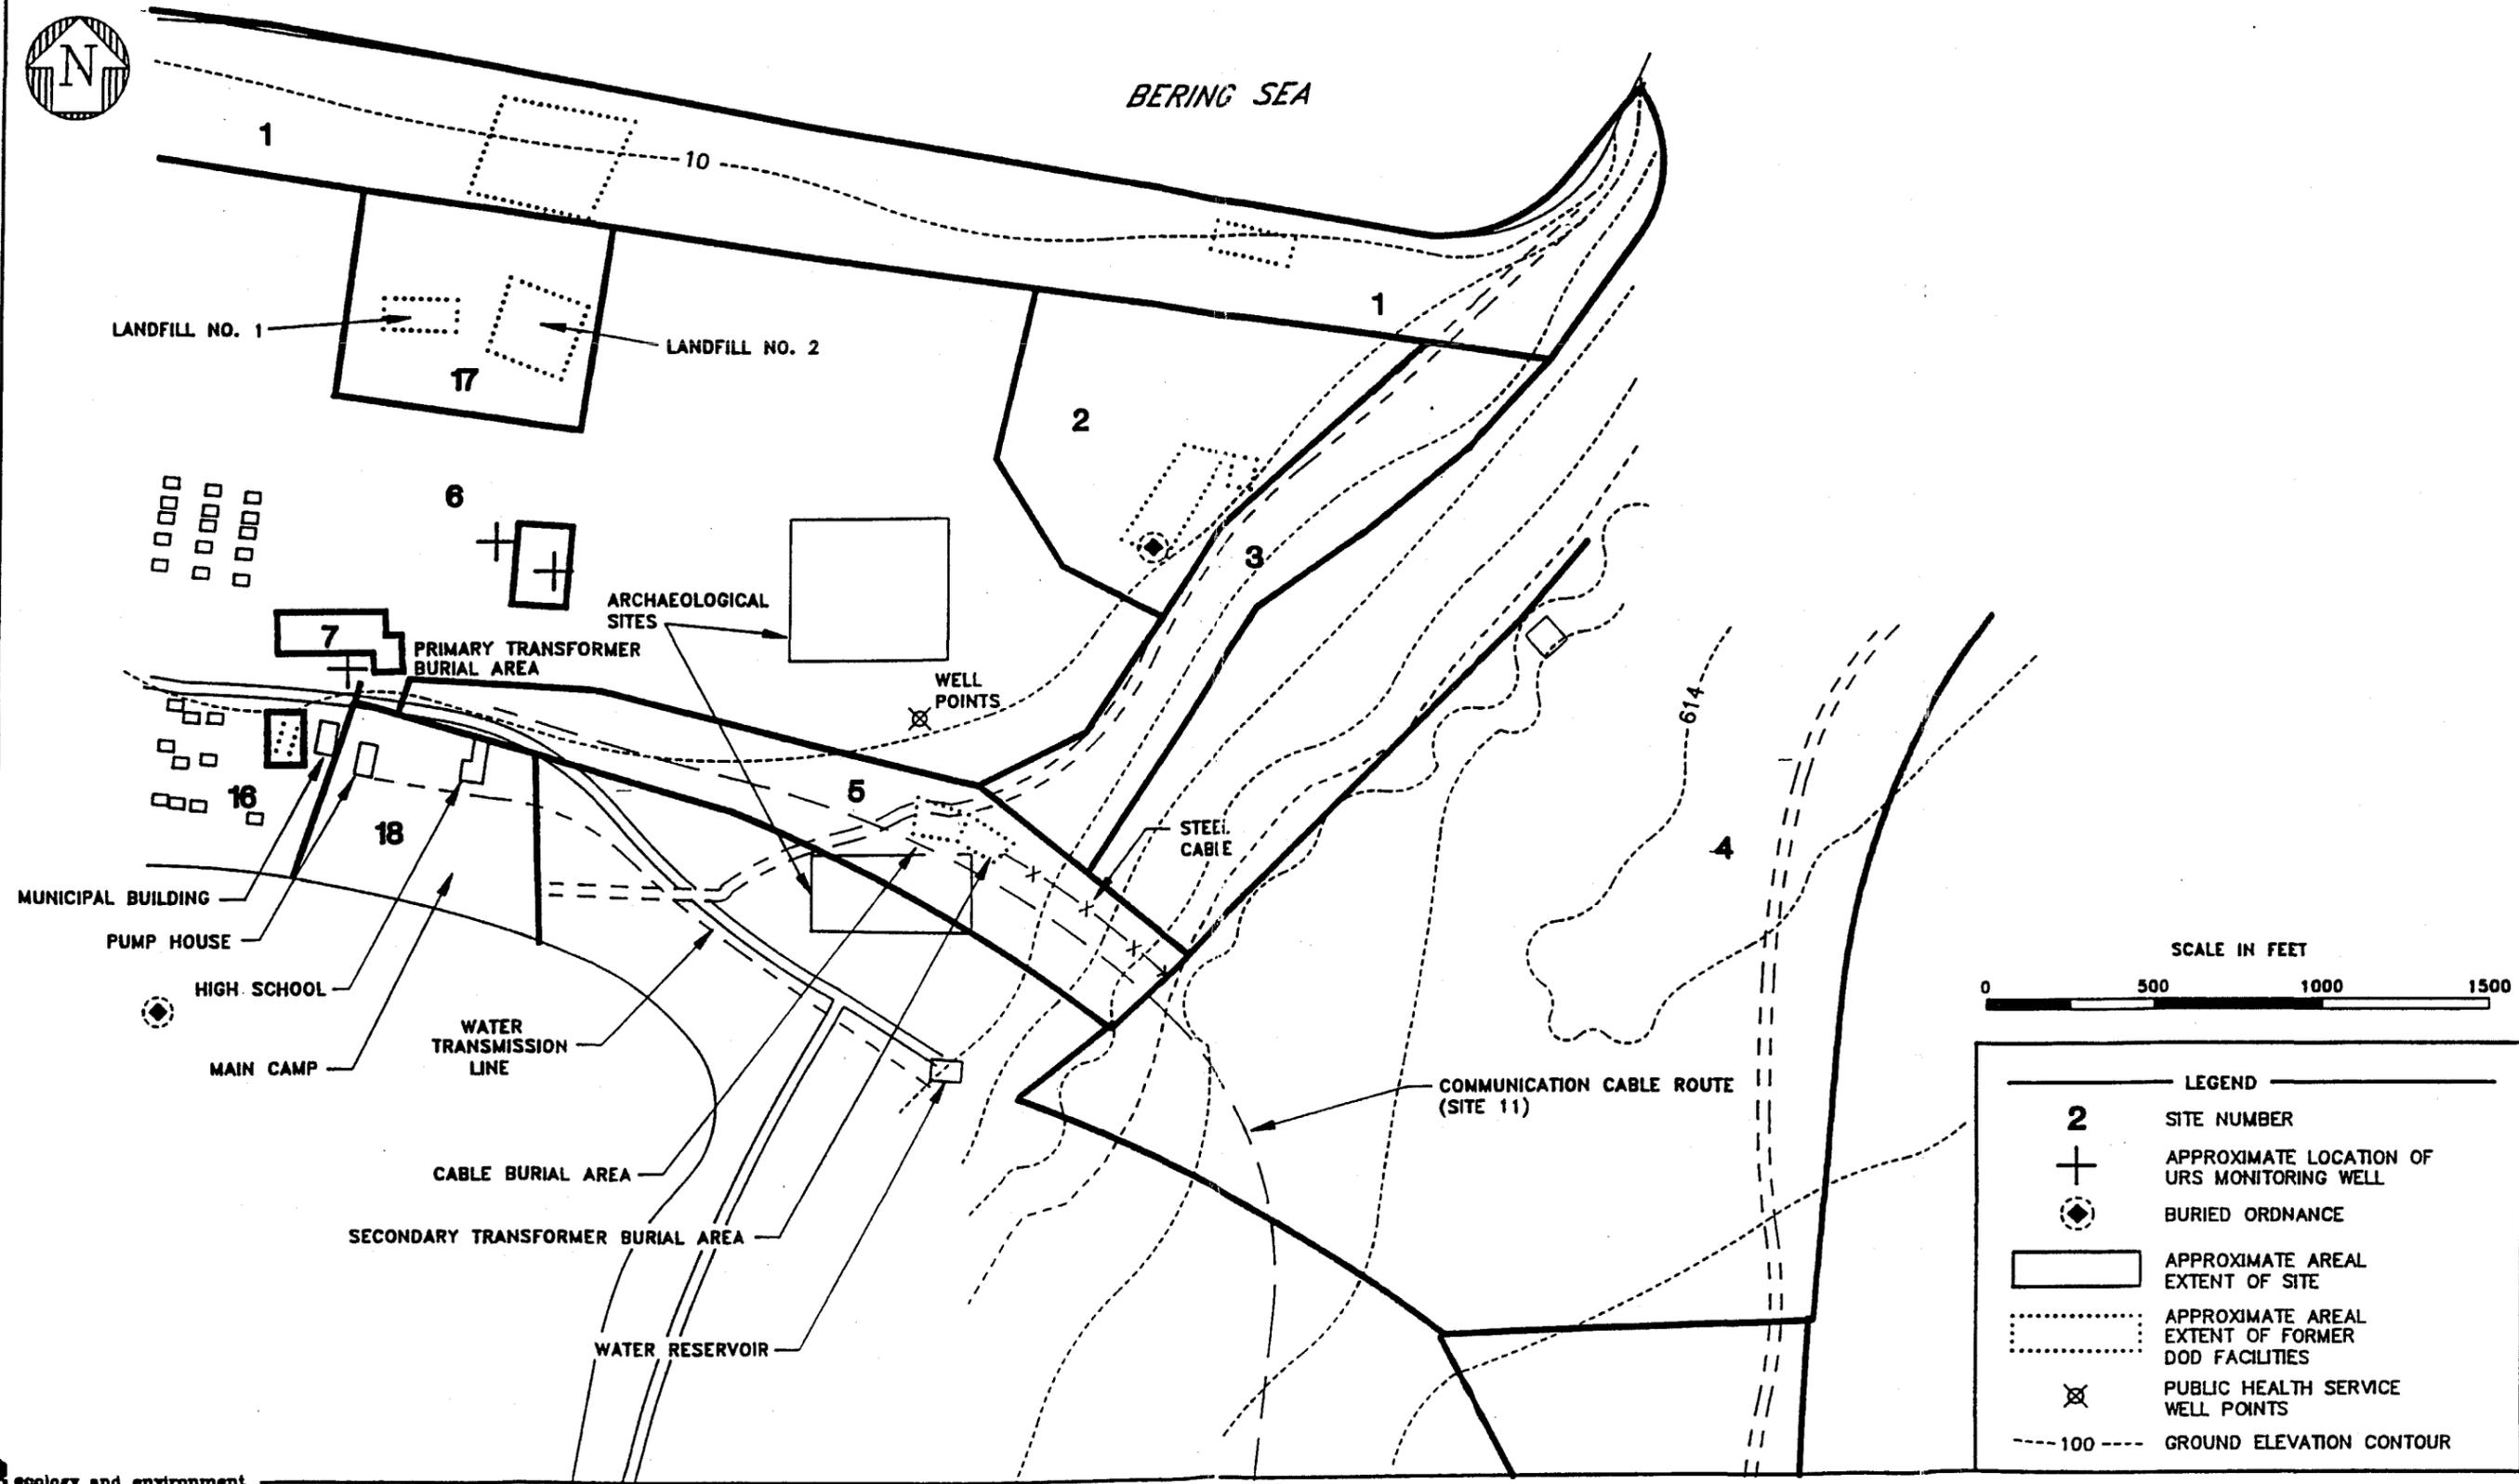
Figure 3-5

SITE 5, FORMER TRAMWAY SITE
 SITE 6, MILITARY LANDFILL SITE
 SITE 7, FORMER MILITARY POWER FACILITY
 LOCATION MAP

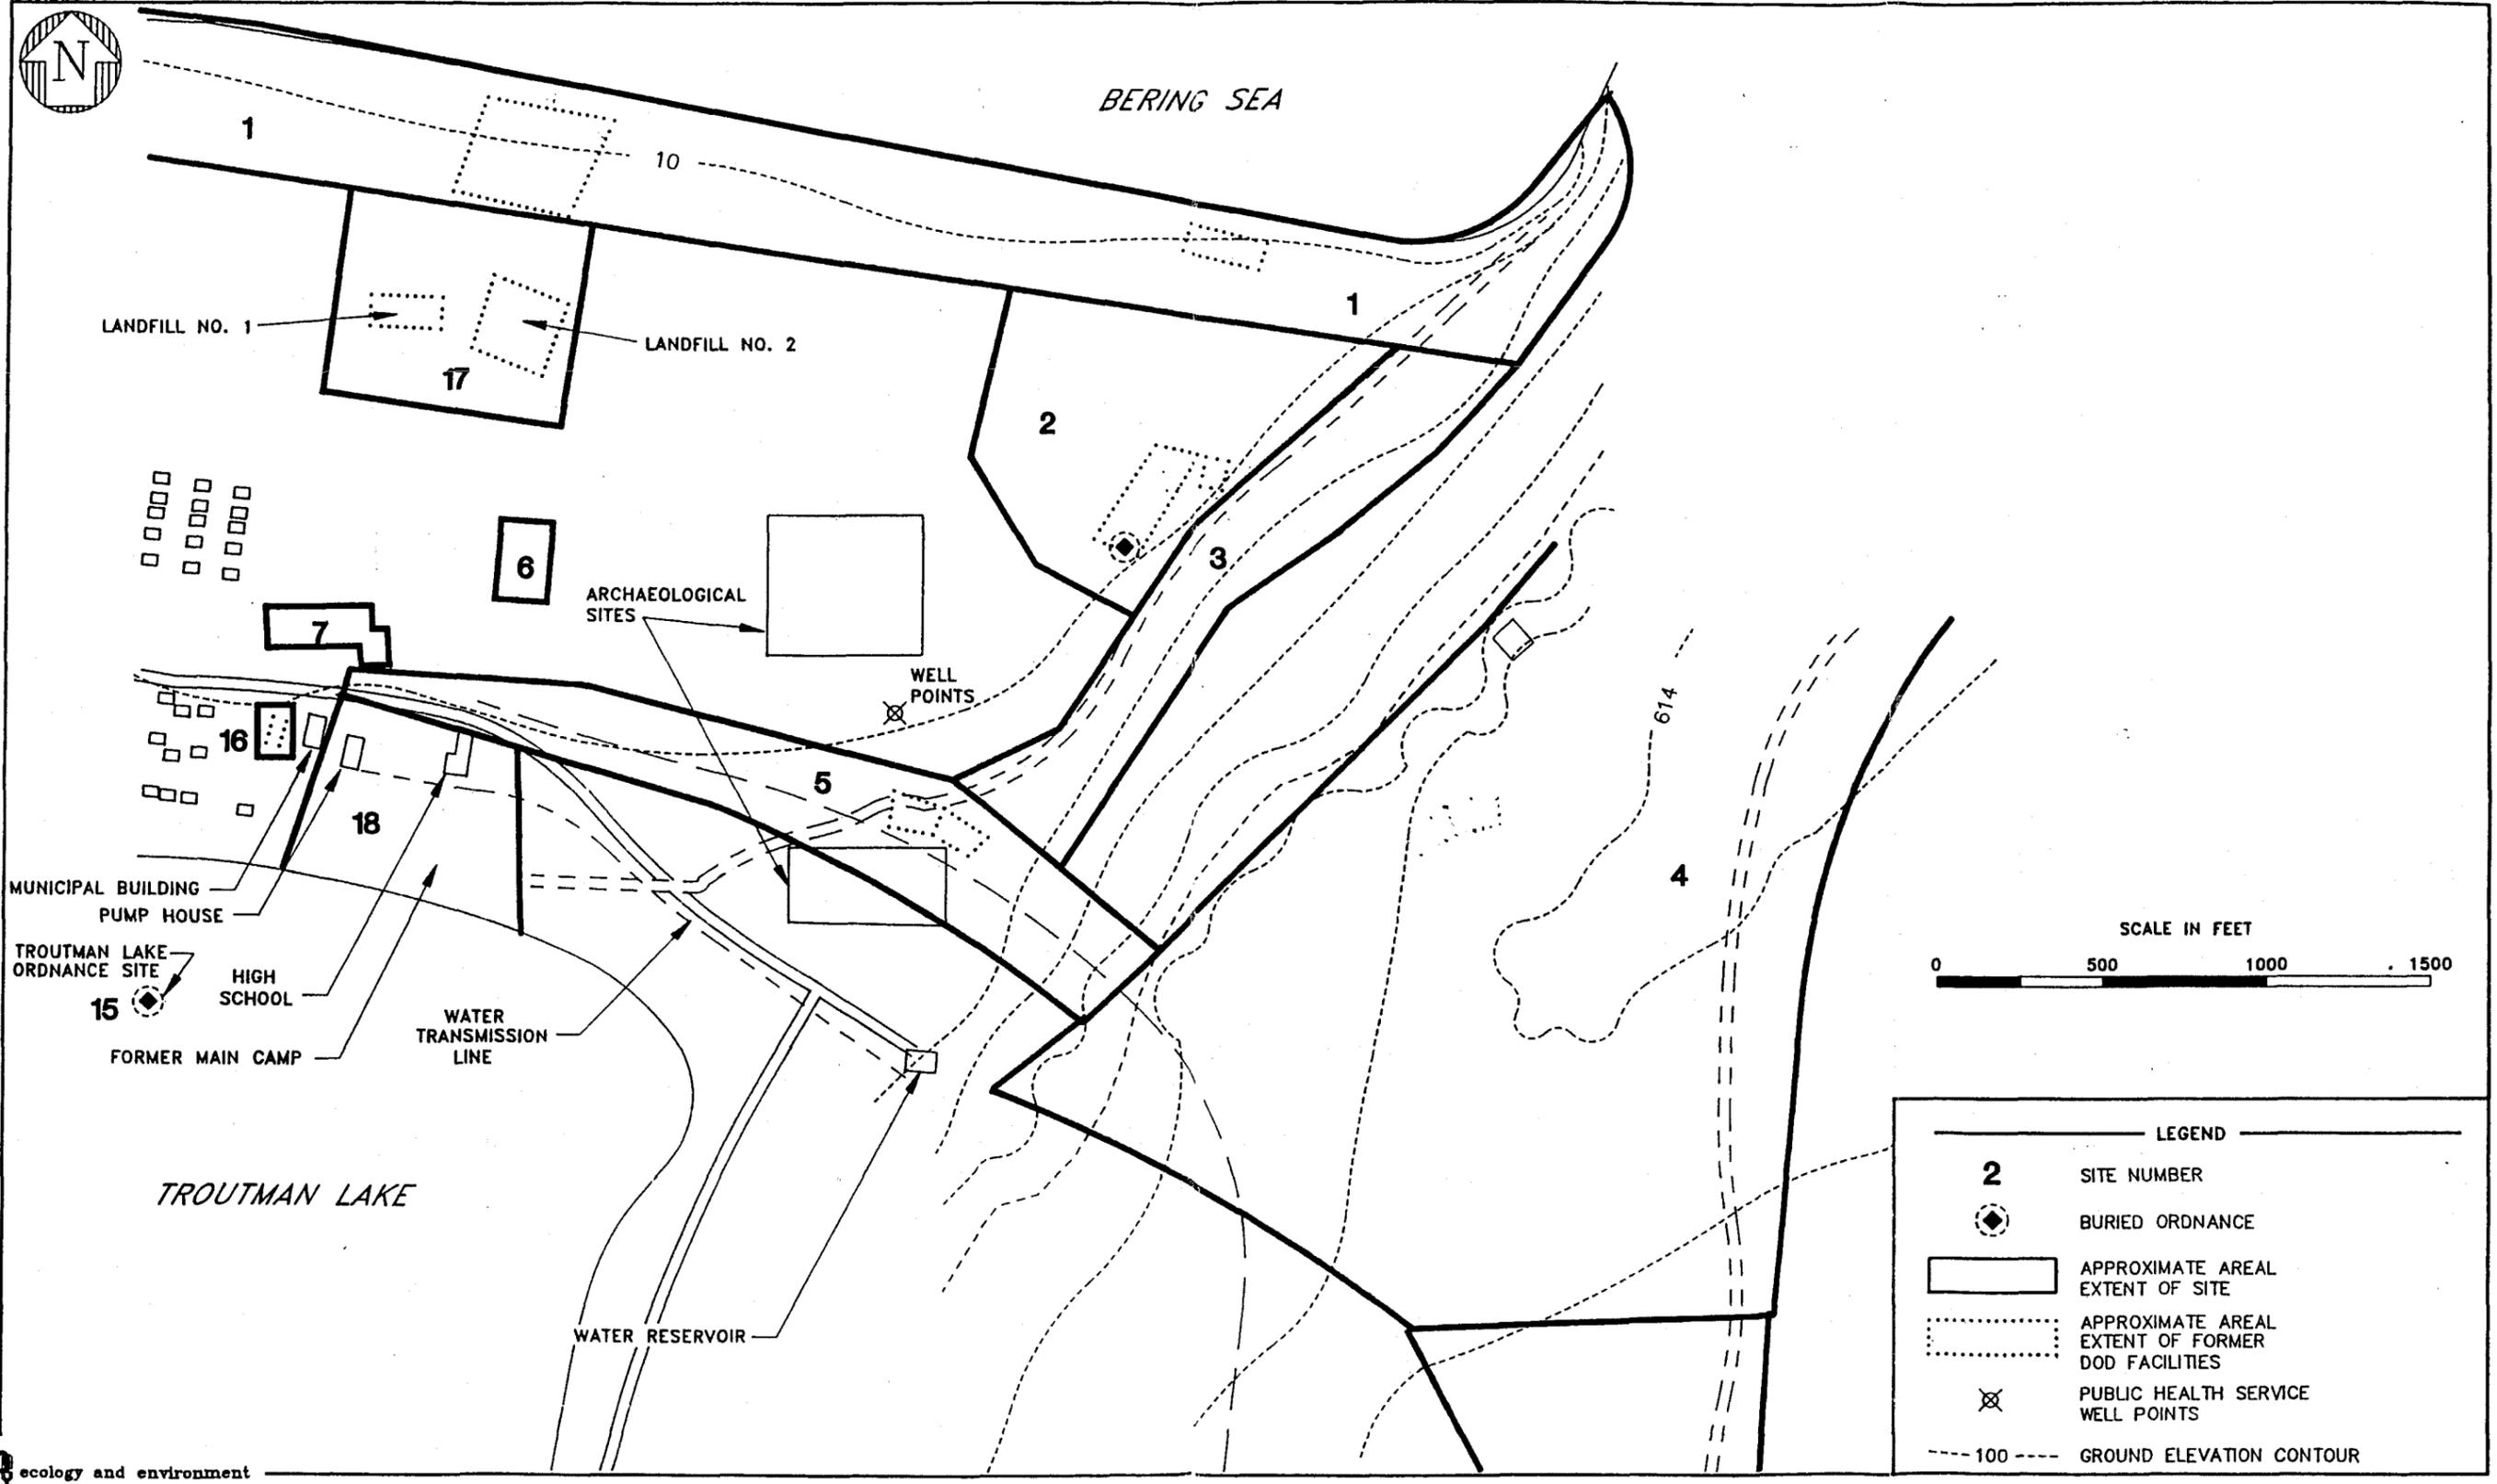
Figure 3-7

SITE 15, TROUTMAN LAKE ORDNANCE SITE,
 SITE 16, GAMBELL MUNICIPAL BUILDING SITE,
 SITE 17, ARMY LANFILLS,
 SITE 18, FORMER MAIN CAMP
 LOCATION MAP
