Trip Report

Gambell FUDS and NALEMP Site Visit
Gambell, Alaska
2 – 4 August 2005

Trip Report
Gambell FUDS and NALEMP Site
Gambell, Alaska
2-4 August 2005

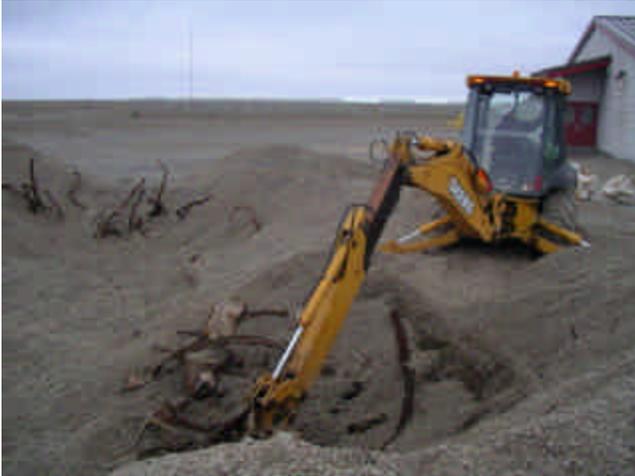
Photo 7: Excavation 18A, adjacent to School, view northeast towards school

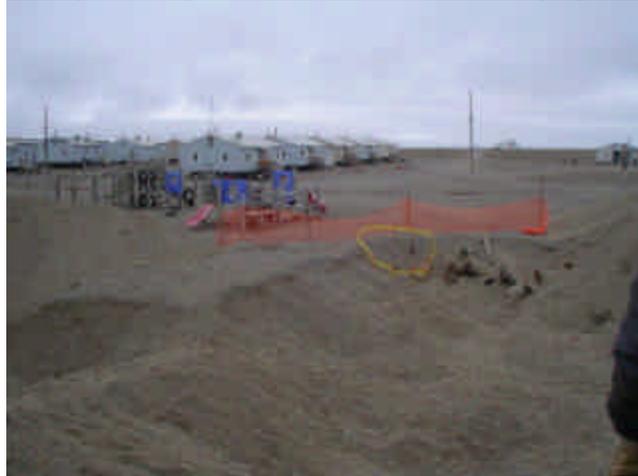
Photo 8: Excavation 18A, view northwest towards playground, yellow tape is area transformer was dug up

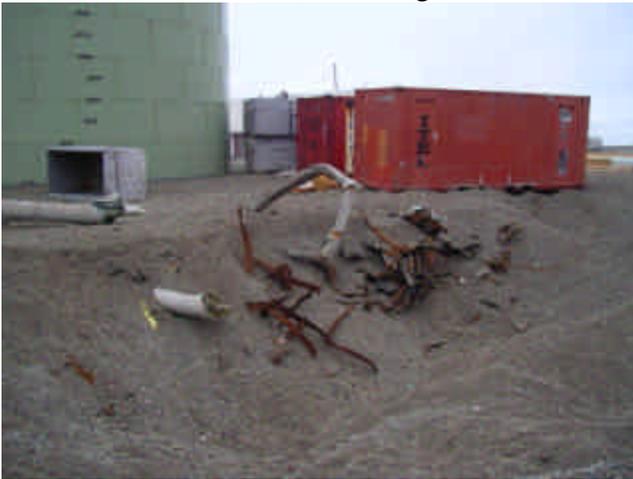
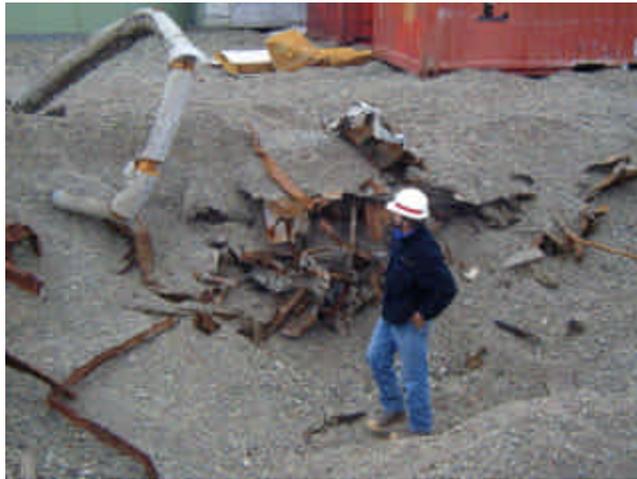
Photo 15: view northwest within Washeteria fence, Photo 16: close up view west towards water storage tank limits of Excavation 18B, cannot dig closer than 30 ft to tank.

The NALEMP crew was observed to arrive at the NVG office by 8:00 am. The crew did not depart the office until 8:50 am. Lisa and Carey met with the ADEC Village Safe Water representatives at Sivuqaq Lodge and discussed the status of the monitoring wells at Site 5. The VSW personnel recommended recapping and locking all the monitoring wells to ensure the safety of the community's water supply. The aquifer is very vulnerable to contamination and the wells must be secured. The VSW personnel had also observed the debris protruding from the open excavation inside the washeteria fence, adjacent to the large water tank. They were quite surprised that the water tanks had been apparently built on top of a buried debris pile. Carey explained that the NVG field crew planned to cut off the protruding debris and fill in the excavation. They could not excavate more debris, however, due to restrictions on digging less than 30 feet from the tank.

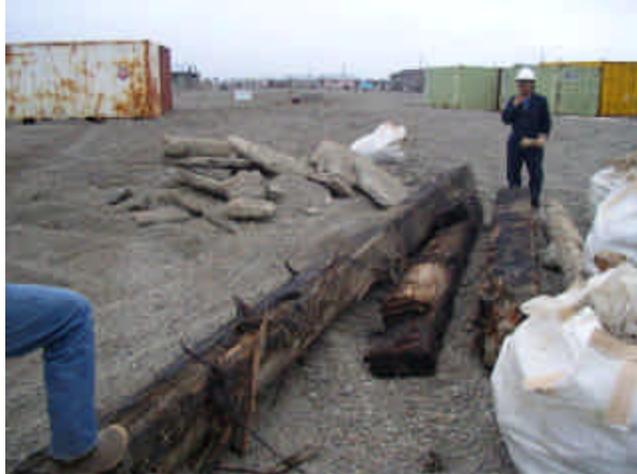
Photo 25: Creosoted timbers excavated from Site 18

The last site planned for cleanup activity is in town, identified as Site 7. In 2003, Montgomery Watson removed a large concrete slab from this area. The concrete was supported by creosote-treated timbers. Discolored gravel associated with the timbers had elevated levels of arsenic, a chemical used as a preservative in the timbers. This soil will be dug up and removed.

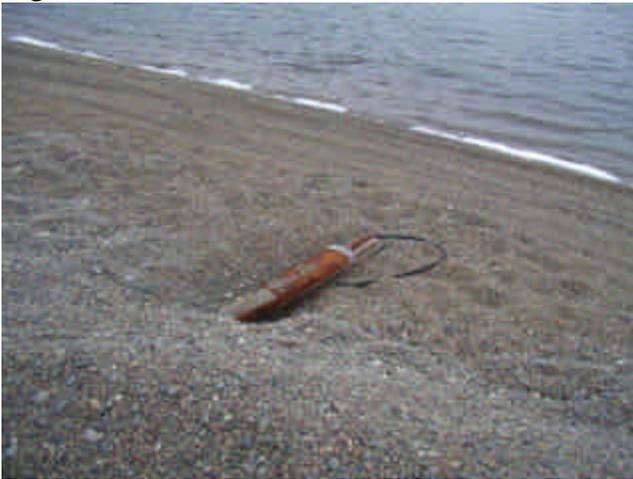
Photo 27: Protruding buried water pipe at edge of Troutman Lake and near Site 19

Carey and Lisa viewed Site 19, where the diatomaceous earth had been excavated earlier in the field season. An exposed water pipe is still present and may pose an impediment to future expansion of the water treatment plant and washeteria. This concern should be added to the Strategic Project Implementation Plan (SPIP) and can most likely be removed in the future through the NALEMP project. Gerald showed the team the location of the staged supersacks awaiting off-site transport, the connex with tools, scales (one scale has a broken LED and can only read some of the numbers), spare tires, and other equipment for the project. The team also visited the gravel pit where the non-hazardous, inert diatomaceous earth was placed, as well as the gravel soils excavated during the 2004 field season which were determined to be non-contaminated soil based on laboratory sampling results. This pit, several hundred feet east of the school, is a gently-sloped depression in the ground (gravel can't hold steep sidewalls) about 30 feet across and 6 feet deep.

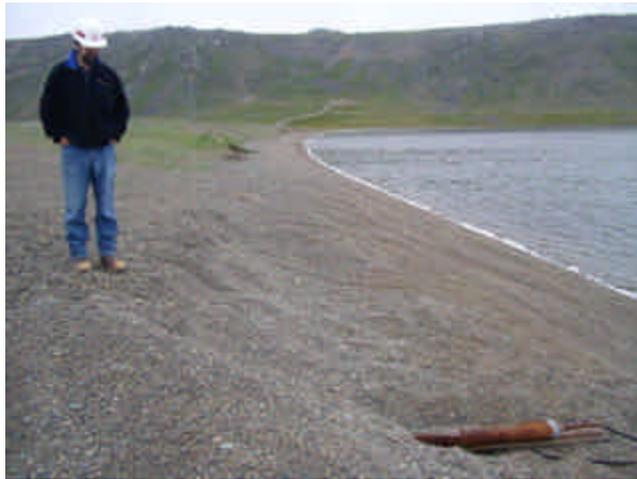
Photo 28: Water pipe at Site 19, view east

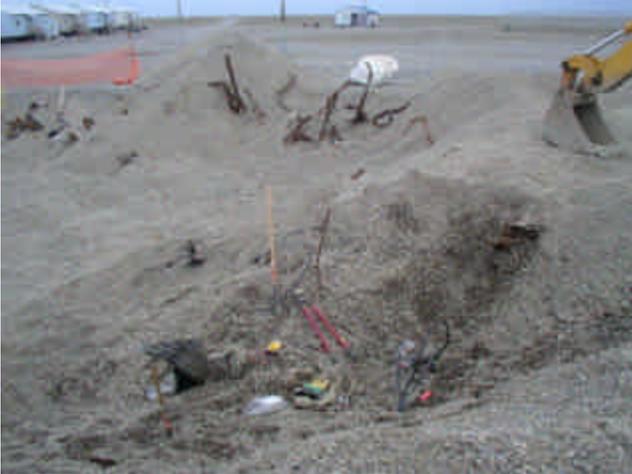
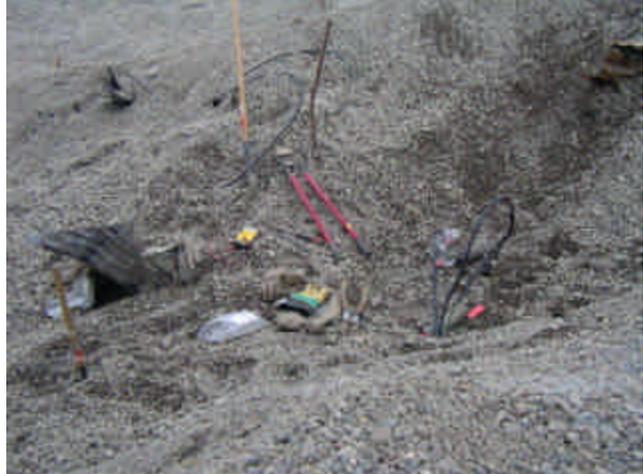
Photo 35: Excavation 18A, severed power line Photo 36: Excavation 18A, severed power line

Carey offered any assistance with the invoices and requests for advance they prepare and obtained receipts for the saw blades. While at the IRA Office, Gerald arrived to inform Tyler that the crew had severed a buried power line at the worksite.

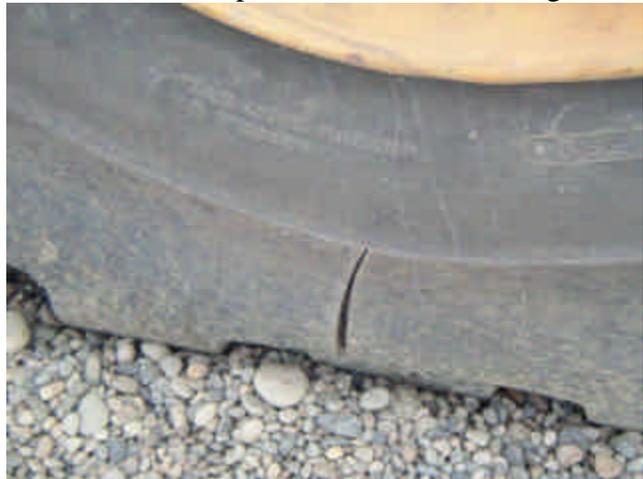
Photo 38: Close up view of loader tire with gash

Carey stressed that the ordering process needs to improve and the heavy equipment needs to be adequately maintained. Carey was concerned about the apparent lack of communication between the project manager, crew, and IRA office. Edmond feels that Robert Tungiyon is doing a good job. Carey mentioned that schedules are important and the project needs to get back on time. Carey asked if the NVG had a written contract with TPECI, Edmond replied no, just a notice to proceed. Carey said a written scope/contract protects both parties. [Post meeting note: Carey remembers reviewing a TPECI proposal that incorporated the SOW.]

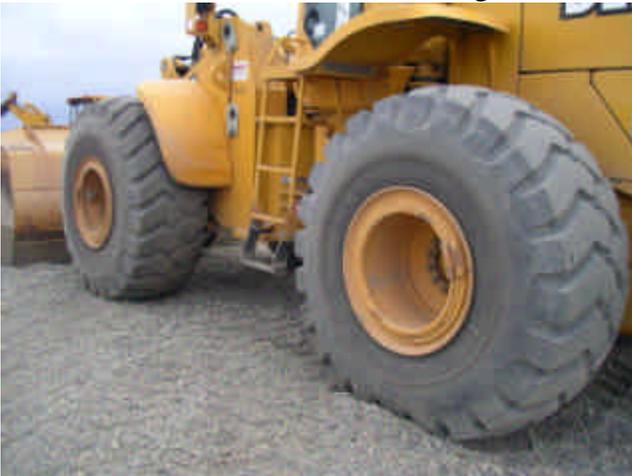
Photo 39: Loader with back tire needing air

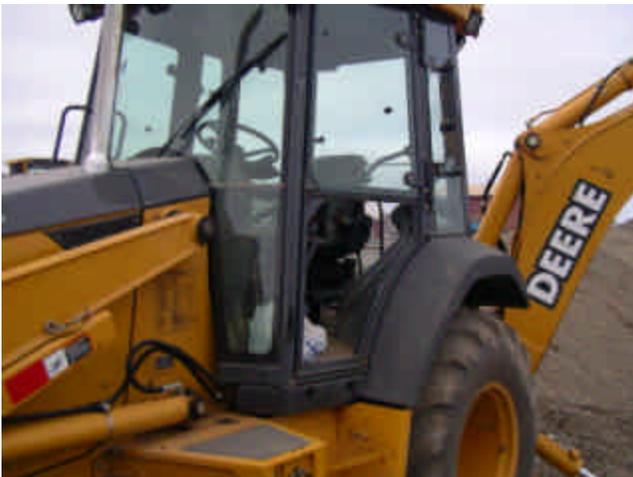
Photo 43: Loader with broken window

Two pieces of window glass for the heavy equipment were ordered last year and are still in crates at the office – apparently they are the wrong pieces of glass (wrong side of cab). Carey suggested that they should analyze whether or not it would be cost-effective to ship them back. If it costs as much to ship them back as they are worth, don't bother. A box of blades for the sawsall was also at the office, but were not the right ones according to the crew. Carey volunteered to bring the box back to Anchorage and return them to AIH for a credit to the NVG.

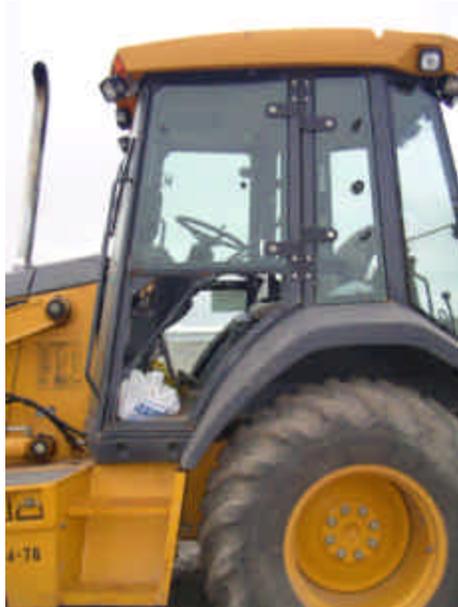
Photo 44: Loader with broken window

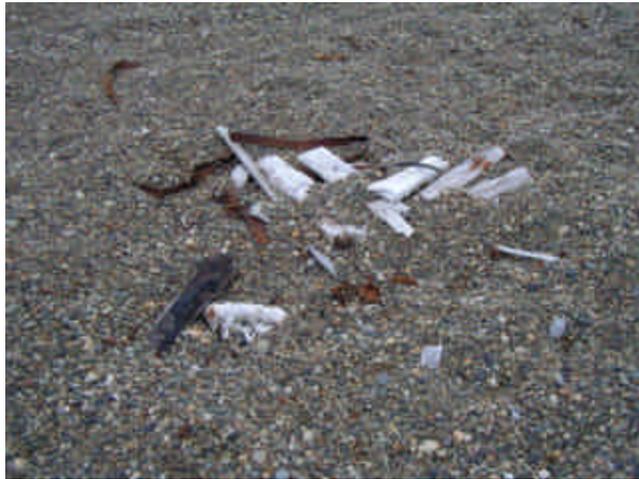
Photo 48: Exposed debris from weather station

After lunch, Carey and Lisa visited the site, observed the newly built weather observation tower north of Site 6, and walked to the base of Sevuokuk Mountain. A pile of marston matting and other debris was noted near the base of the guy wires, which had apparently been exposed when the weather station was installed. The power line was fixed by about 2 pm in the afternoon. The crew took a break at 3:00 pm and returned to the site at 3:30 pm. The crew was worried about hitting another power line and expensive phone line on the north side of the excavation at Site 18A. Carey and Lisa observed the general work operations. The backhoe removes a scoop of gravel from the pit, apparently to expose the large debris pieces, dumps it on a pile next to the pit, which the laborers then hand-pick out smaller pieces of debris from it. The larger Quonset hut pieces appeared more difficult to extract from the excavation. Gerald explained that the crew had attempted to use chains to pull the larger debris from the excavation, but they typically didn't work. The loader was used to backfill the area where the power line was exposed, and also flattened the gravel pile created by the backhoe. Mostly Quonset hut framing was excavated today.

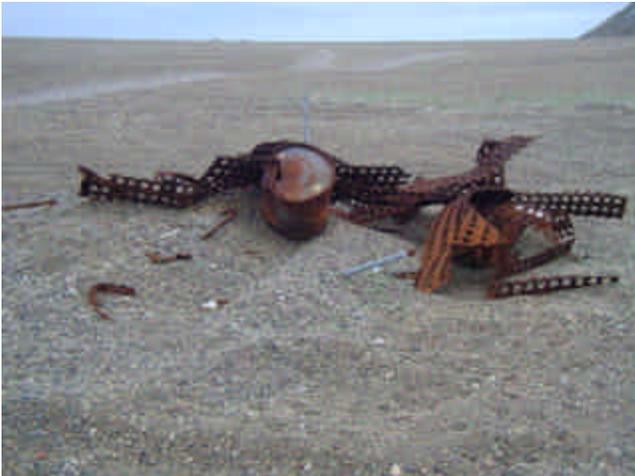
Photo 49: Debris exposed from weather station installation, view northeast

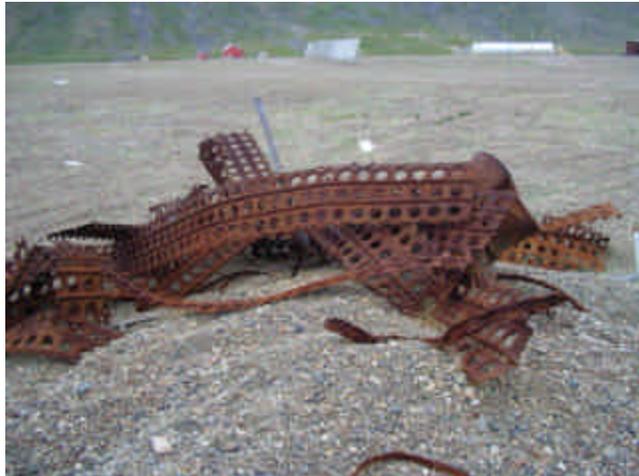
Photo 50: Debris exposed from weather station, view east

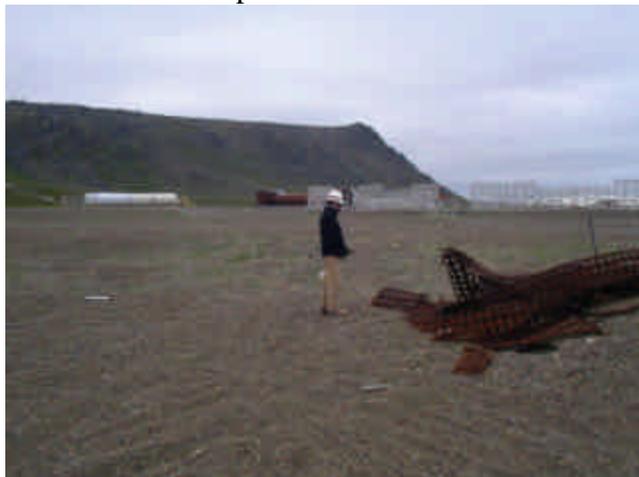
Photo 52: Debris pile from weather station installation

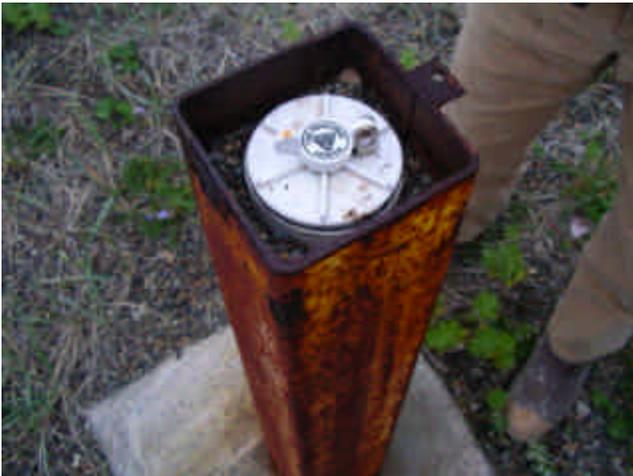
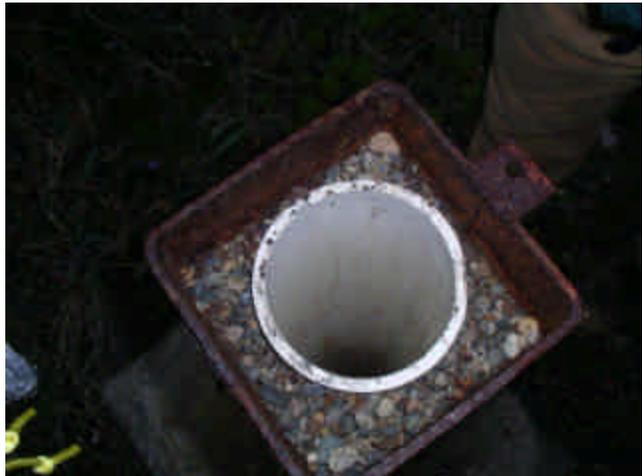
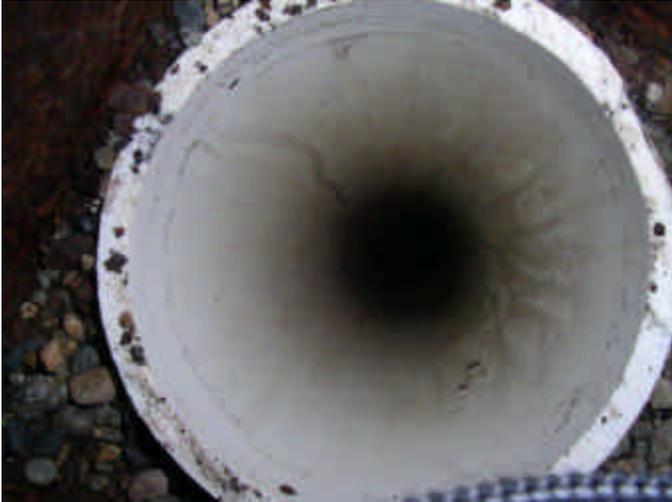
Photo 57: MW28

Carey and Lisa visited Site 5 and checked on the status of the groundwater monitoring wells. See photos in appendix and figure, below. MW28 was observed to contain gravel between the inner and outside well casing, but the well itself didn't contain visible gravel. The well was unlocked, but an interior cap was present on the PVC piping. MW31 was locked (rusted in place). MW29 was locked (rusted in place). MW32 was not locked, the outer casing cap could be lifted off, an inner cap on the piping was present. MW15 was not locked, but an inner cap was present. MW14 was not locked, and the inner cap was partially wedged between the casing the piping, from apparent frost jacking. MW30 was locked (rusted in place).
