TECHNICAL MEMORANDUM

RE: Monitoring Well Decommissioning Report
Contract No. W911KB-08-P-0074
Gambell, Alaska

Bristol Environmental Remediation Services, LLC (Bristol) has prepared this Technical Memorandum (Tech Memo) at the request of the U.S. Army Corps of Engineers (USACE). The Tech Memo presents the results of the groundwater monitoring well decommissioning project that was conducted at the Gambell Formerly Used Defense Site (FUDS) by Bristol in August 2008.

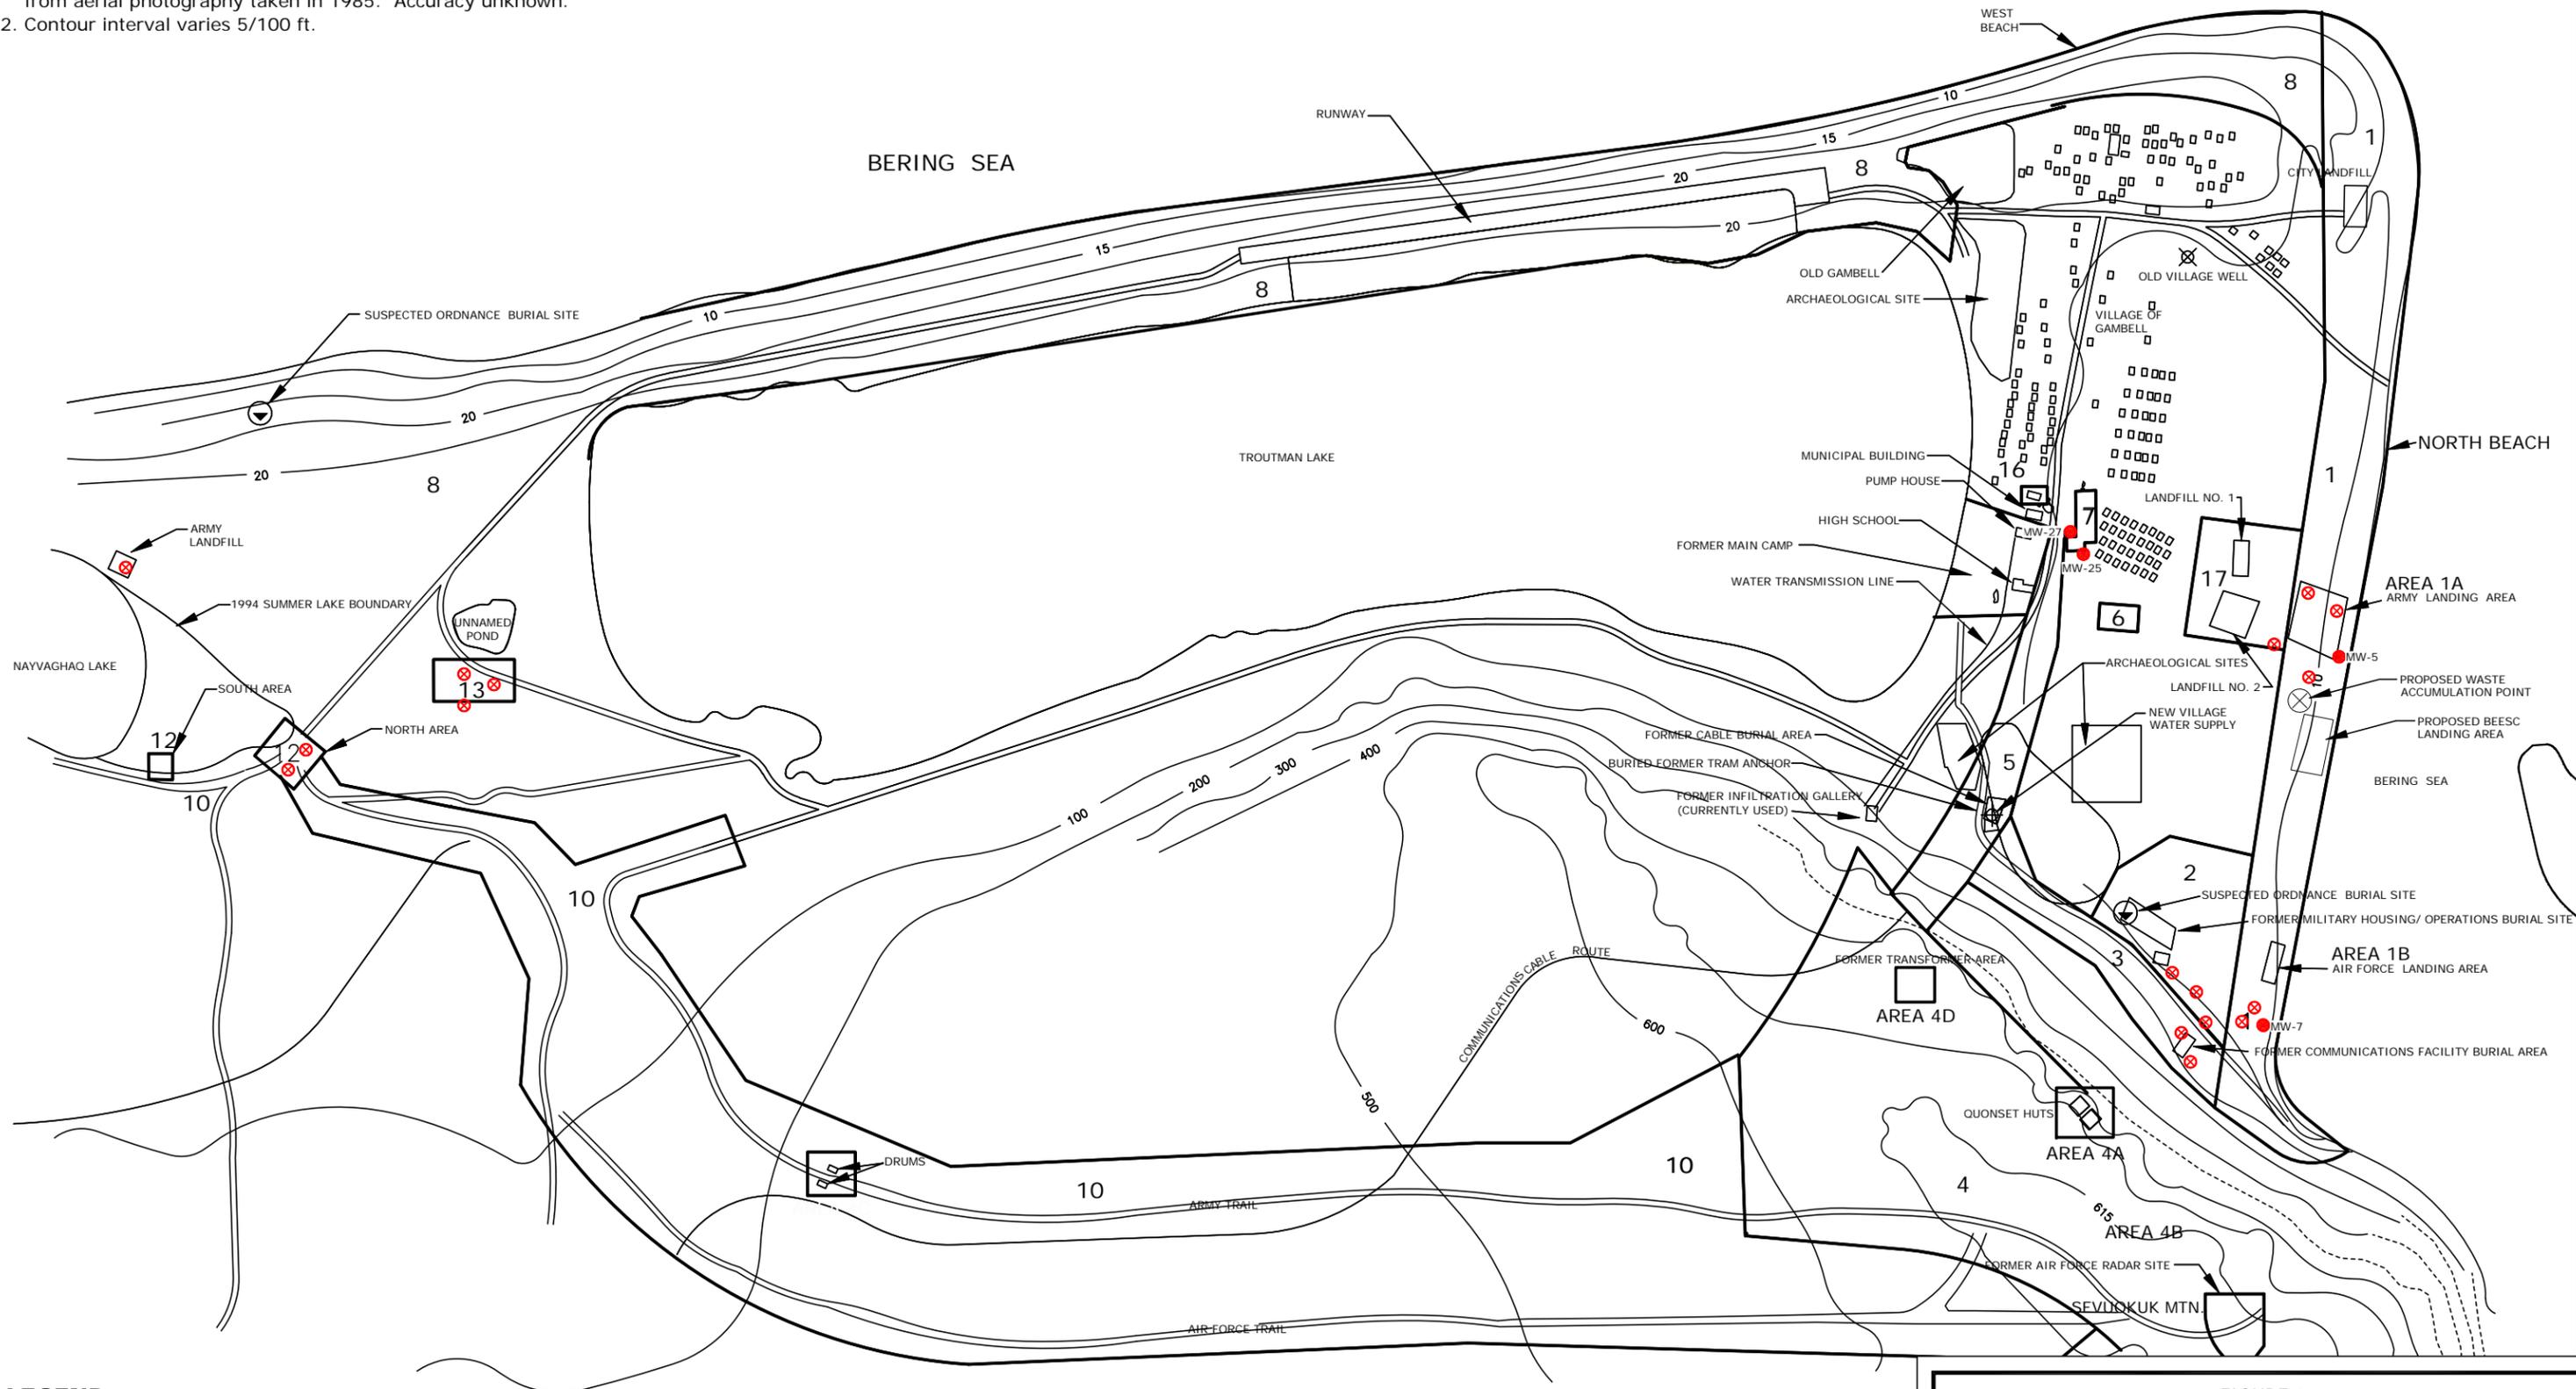
FIGURE 2
 GAMBELL, ST. LAWRENCE ISLAND, ALASKA
 MONITORING WELL DECOMMISSIONING
 MONITORING WELL LOCATIONS

Approximately 21 monitoring wells were reportedly located at the site at the beginning of site activities. Monitoring well locations are listed on Table 1 and are shown on Figure 2.

Bristol and the NVG crew were unable to locate four of the 21 monitoring wells reported to be located at the site. Two of these wells (MW-5 and MW-7) were located on the North Beach of the gravel spit on the northeastern tip of Saint Lawrence Island, while the other two (MW-25 and MW-27) were located within the community of Gambell (Figure 2).

Monitoring wells MW-5 and MW-7 appear to have been located below the storm surge line on the North Beach (Figure 2). This determination was made by Bristol personnel using aerial photographs and a GPS unit. The monitoring wells were reported to have been constructed as aboveground completions protected by stick-up steel casings. For each of the two wells, a search grid with dimensions of 100-feet by 100-feet was established. Each grid was centered on the reported location of the well (as determined using the GPS unit) and was screened using a metal detector in east to west and north to south passes. All anomalies indicated by the metal detector were investigated by hand-digging and determined to be metal debris unrelated to the monitoring wells. Each grid was also investigated by using a backhoe to dig down approximately one to two feet below the ground surface at the reported location of the well. No evidence of either monitoring well was found.

Monitoring wells MW-25 and MW-27 were located within the community of Gambell (Figure 2). The monitoring wells were reported to have been constructed as flush-mount completions protected by steel covers. For each of the two wells, a search grid with dimensions of 120 feet by 120 feet was established. Each grid was centered on the reported location of the well (as determined using the GPS unit) and was screened using a metal detector in east to west and north to south passes. All anomalies indicated by the metal detector were investigated by hand-digging and determined to be metal debris unrelated to the monitoring wells. Due to the presence of shallow utilities in the area, a decision was made by Bristol to not investigate the area using heavy equipment. No evidence of either monitoring well was found.

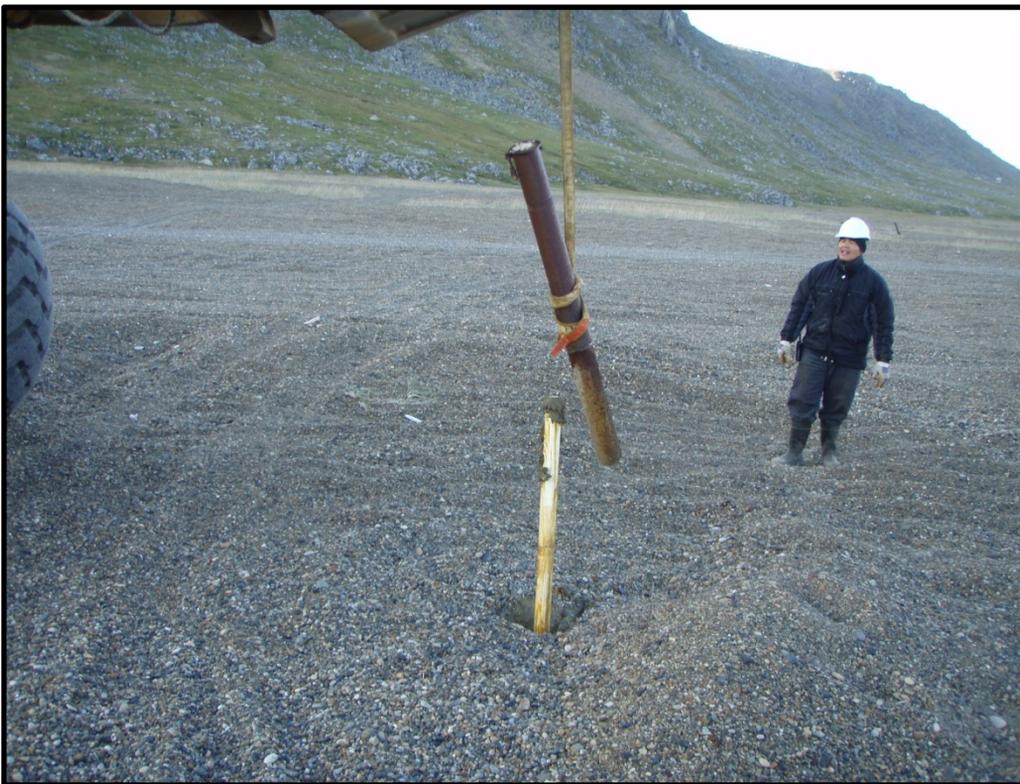
Photograph No. 1

Description: Removing protective well cover from MW-12.

Monitoring wells were located using a global positioning system (GPS) unit and aerial photographs. Bristol's procedure for decommissioning the wells was to first pull the protective steel casing from the ground using a chain attached to a loader bucket. Once the protective casing had been removed, the polyvinyl chloride (PVC) well casing was removed using the same method. Once the PVC had been removed, each bore hole was backfilled with bentonite pellets, taking care to minimize void spaces. The bentonite was then hydrated to plug the bore hole.

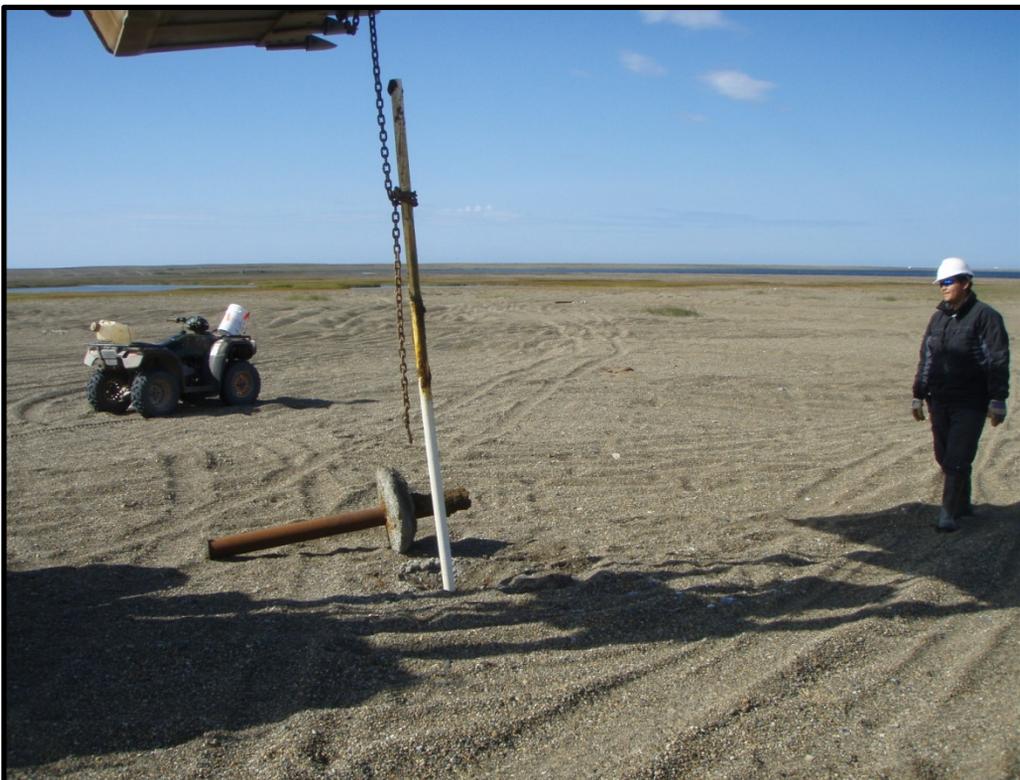
Photograph No. 2

Description: Pulling PVC well casing from MW-22.

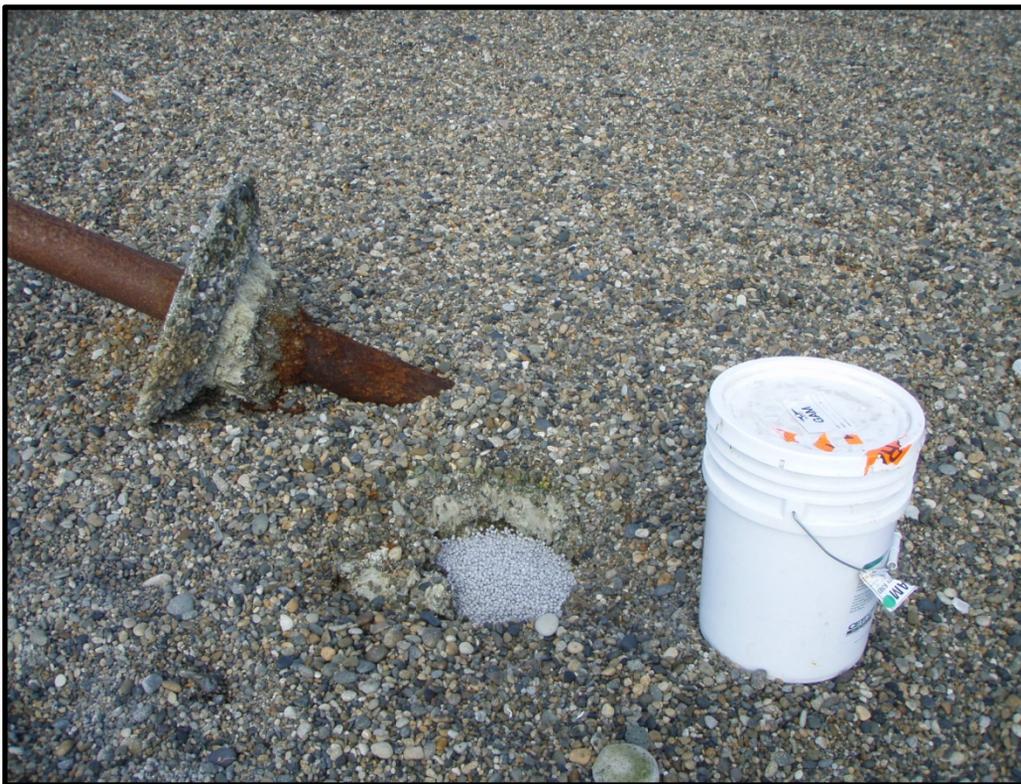
Photograph No. 3

Description: Bentonite pellets in MW-3 (prior to hydration of pellets) following removal of well casing.

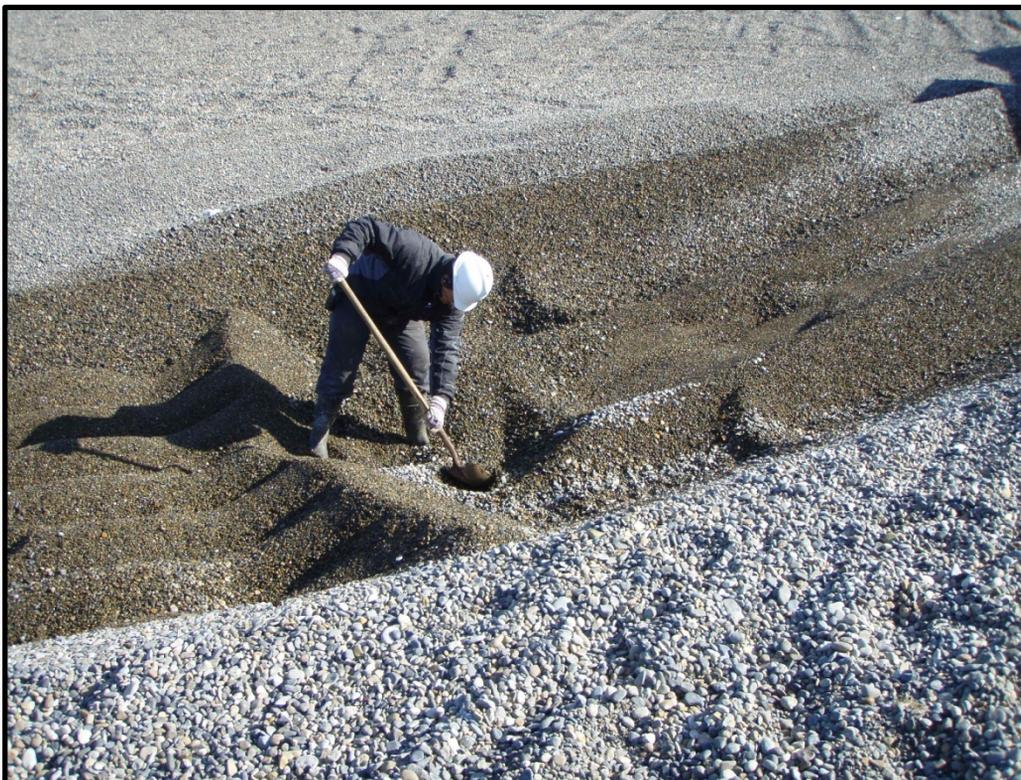
Photograph No. 4

Description: NVG personnel looking for MW-7. Crew utilized a metal detector, heavy equipment, and hand-digging while attempting to find MW-5 and MW-7.

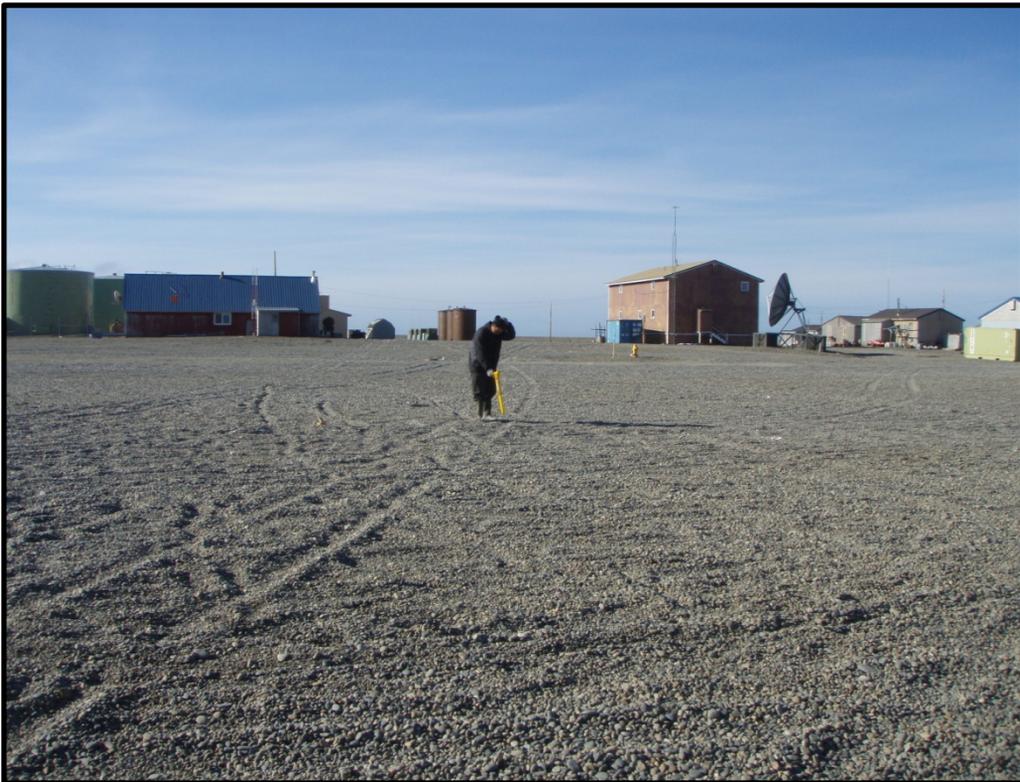
Photograph No. 5

Description: NVG personnel looking for MW-27. Crew utilized a metal detector and hand-digging while attempting to find MW-25 and MW-27.

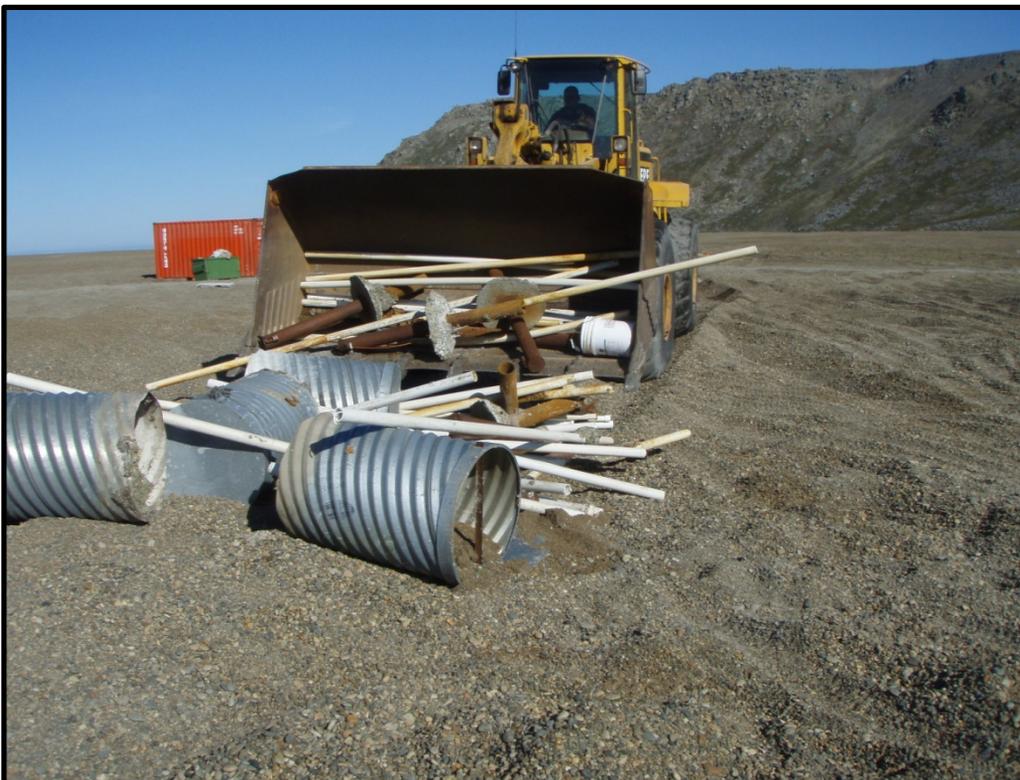
Photograph No. 6

Description: NVG heavy-equipment operator consolidating well construction materials at the end of the monitoring well decommissioning effort.

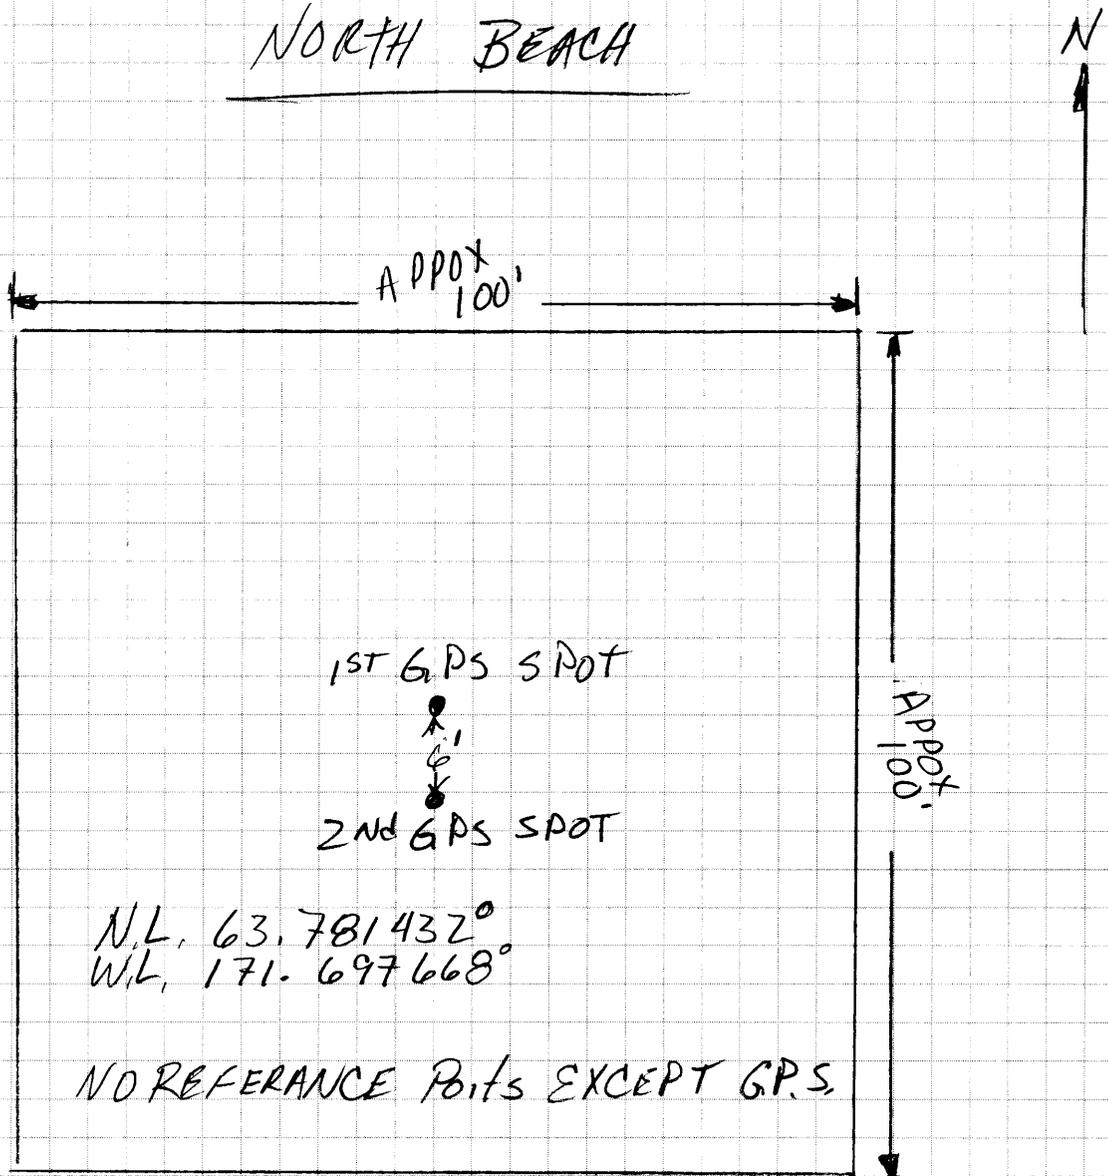
| Subject: <u>MW-07</u> | Checked: | Date: |

| Task: <u>TRY TO LOCATE MW-07</u> | | Sheet <u>1</u> of <u>1</u> |

THIS GRID WAS SWEEPED EAST/WEST AND NORTH/SOUTH WITH METAL DETECTORS

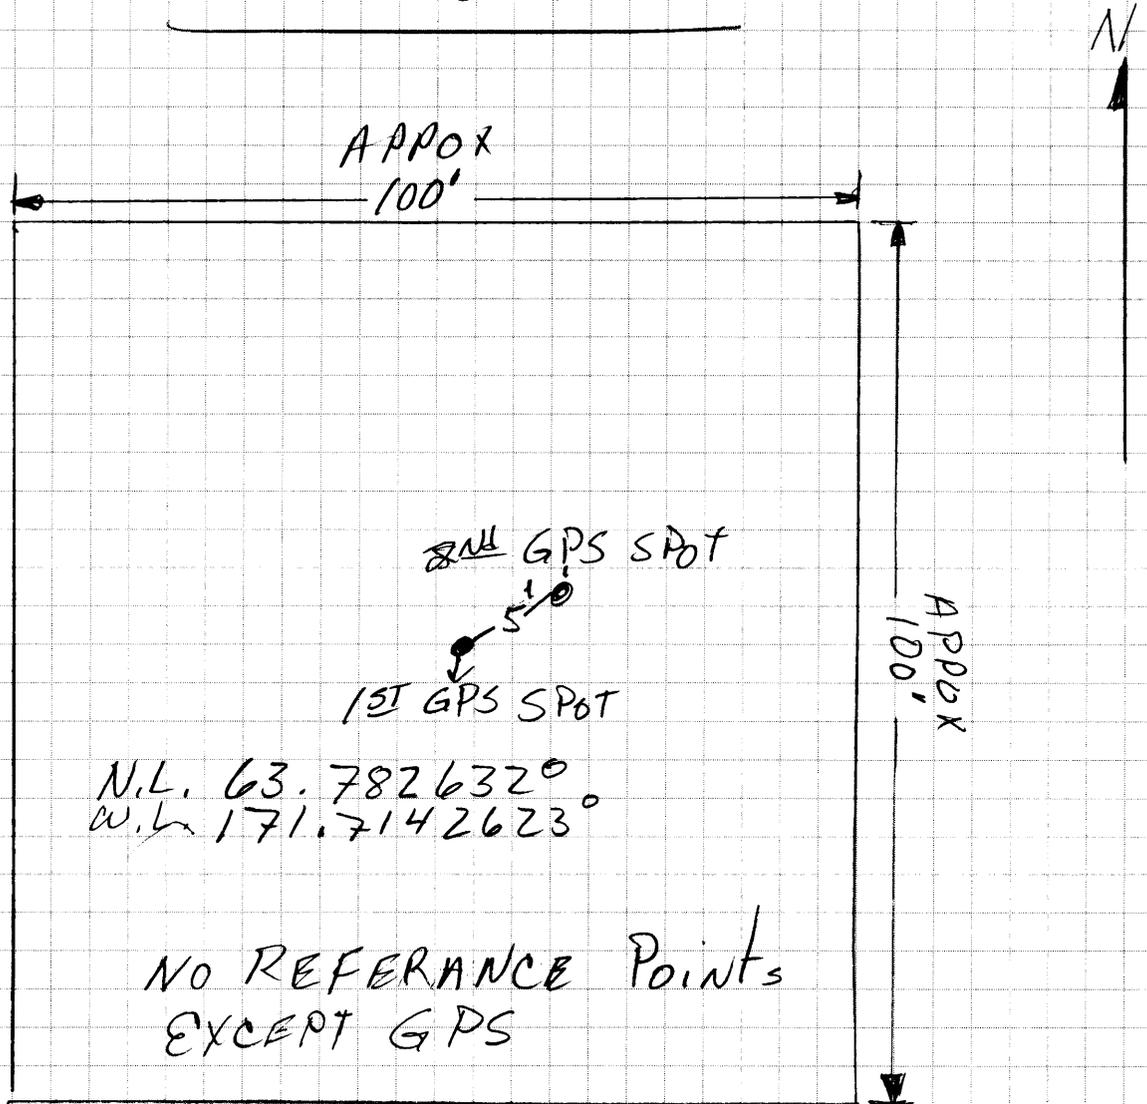
| Subject: <u>MW-05</u> | Checked: | Date: |

| Task: <u>TRY TO LOCATE MW-05</u> | | Sheet <u>1</u> of <u>1</u> |

THIS GRID WAS SWEEPED EAST/WEST
AND NORTH/SOUTH WITH METAL DETECTORS

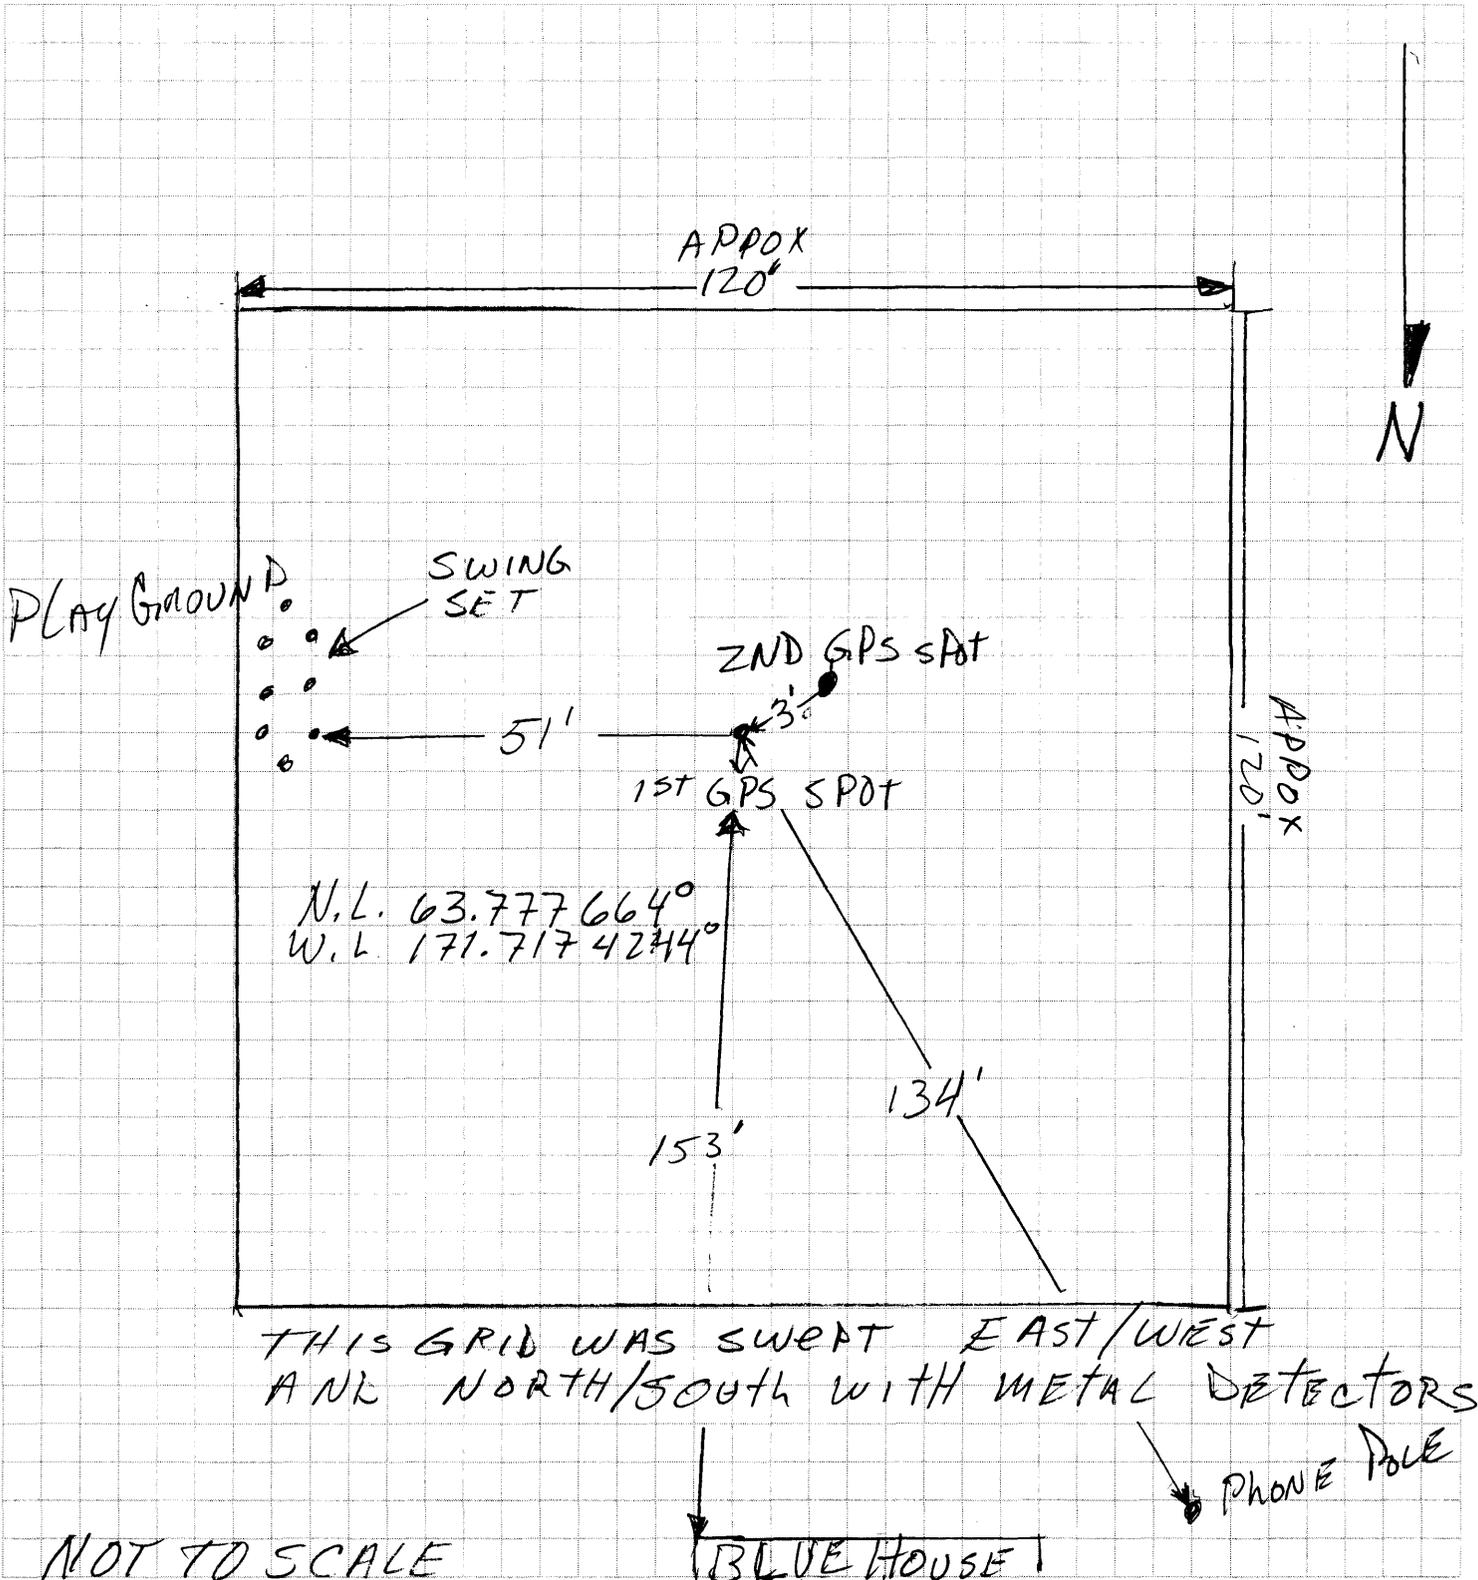
| Subject: <u>MW-25</u> | Checked: | Date: |

| Task: <u>TRY TO LOCATE MW-25</u> | | Sheet <u>1</u> of <u>1</u> |

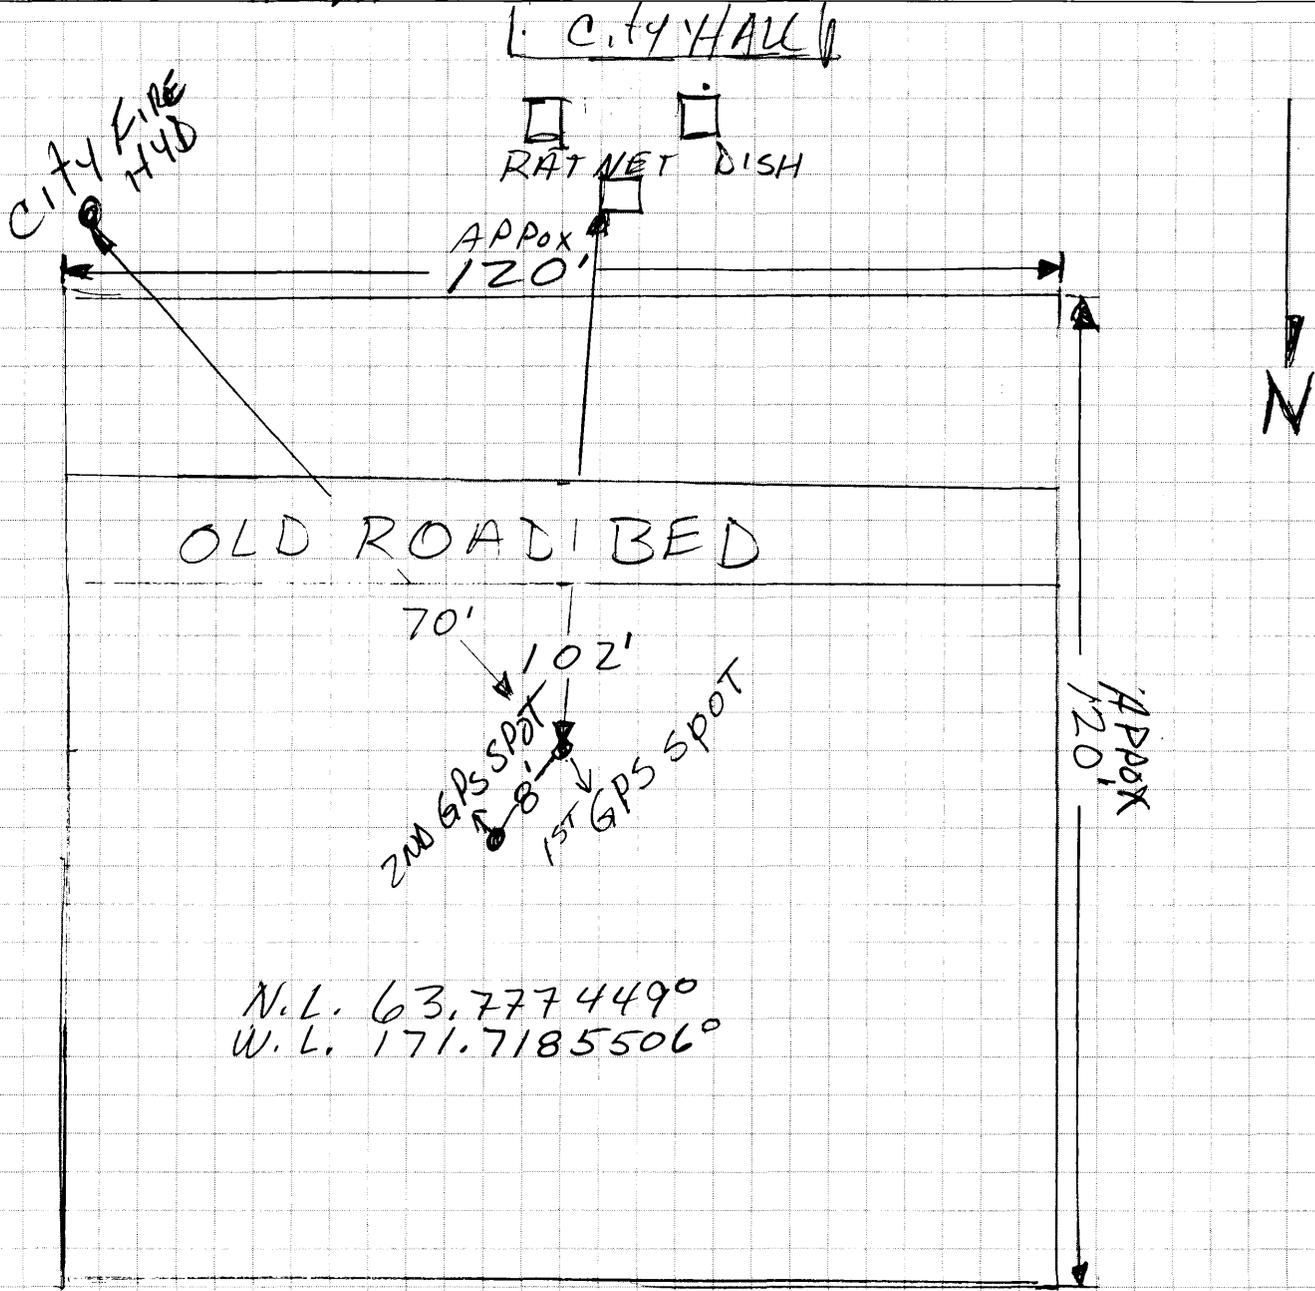
| Subject: <u>MW-27</u> | Checked: | Date: |

| Task: <u>TRY TO LOCATE MW-27</u> | | Sheet <u>1</u> of <u>1</u> |

THIS GRID WAS SWEEPED EAST/WEST
AND NORTH/SOUTH WITH METAL DETECTORS
