2013 SAMPLING CONDUCTED IN CONJUNCTION WITH THE 2013 FIVE-YEAR REVIEW AT NORTHEAST CAPE

NORTHEAST CAPE
ST. LAWRENCE ISLAND, ALASKA

FUDS No. F10AK0969-05

Final
February 2014

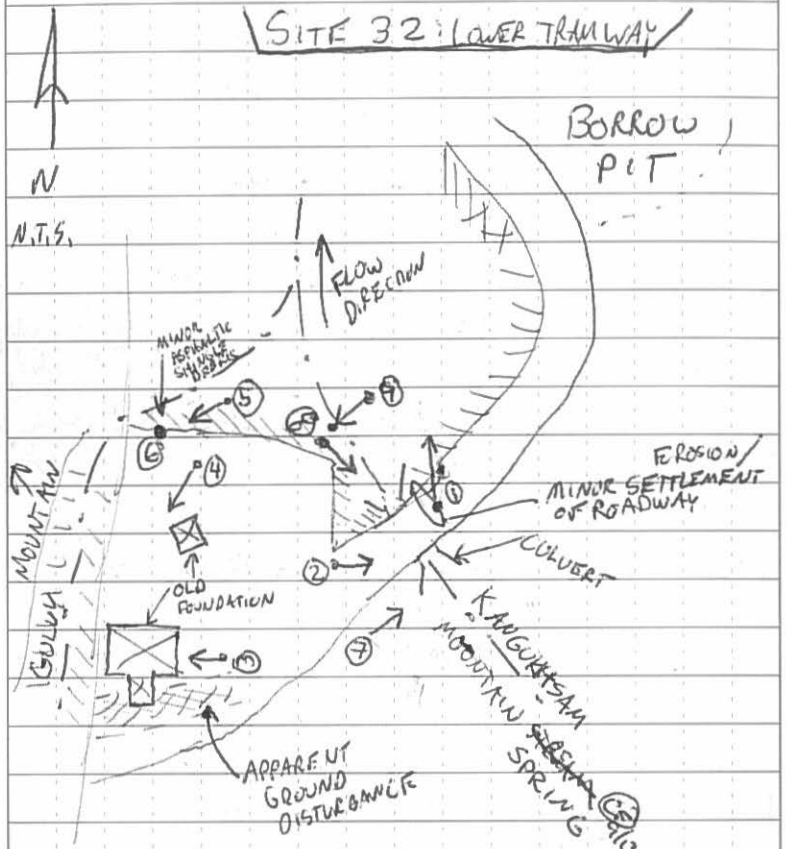
SITE 32: LOWER TRAMWAY

1313 OBSERVED MINOR WOOD AND METAL DEBRIS ON SITE

1321 OBSERVED MINOR ASPHALTIC SHINGLE DEBRIS 1x2 FT TO 2x2 FT (APPROX) DIMENSIONS ON THE GROUND WEST OF THE OLD FOUNDATION

1325 OBSERVED APPARENT GROUN DISTURBANCE (RECENT) TO THE EAST OF THE OLD FOUNDATION, THIN VEGETATION IS GROWING ON THE EXTREMELY ROCKY SOIL

1327 NO GROUNDWATER MONITORING WELLS WERE OBSERVED

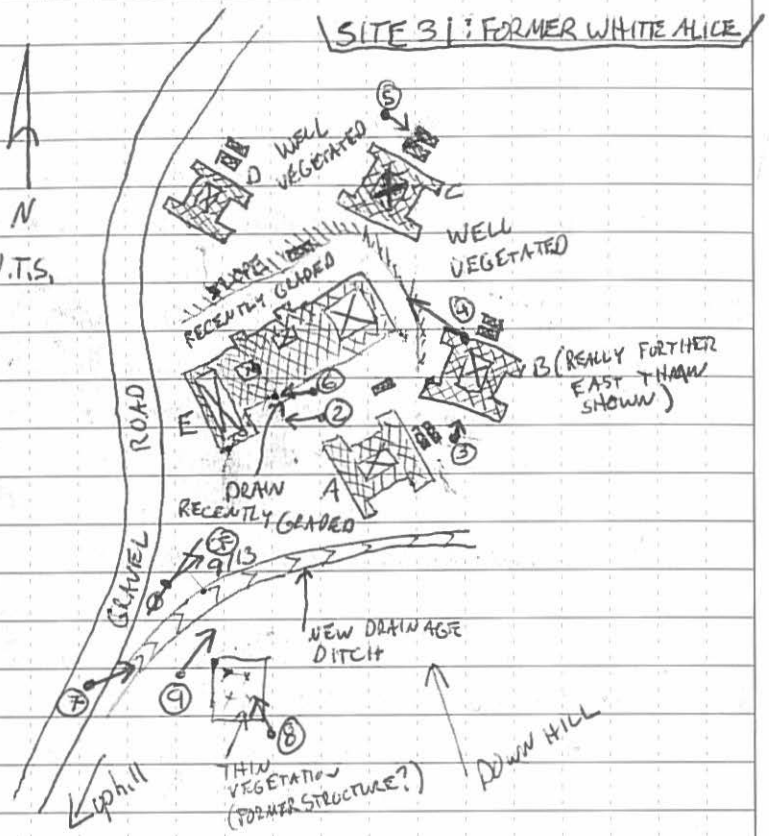
1347 ARRIVED AT SITE 31: FORMER WHITE ALICE

1404 OBSERVED MINOR WOOD/METAL/WIRING DEBRIS NEAR ANTENNA FOUNDATION "C"

1405 OBSERVED A DRAIN COVER (RUSTED) ON THE SOUTH SIDE OF FOUNDATION "E" WITH AN UNFILLED VOID UNDERNEATH (APPROX 6 FT DEEP, 5 WIDE, 9FT LENGTH) DRAIN IS APPROX 4FT LONG & 6INCHES WIDE. SAFETY ISSUE

1415 AREA AROUND FOUNDATION "E" AND ANTENNA FOUNDATION "A" HAVE BEEN RECENTLY GRADED, COMPACTED, AND SEEDED. NEW VEGETATION IS JUST SPROUTING. AREA APPEARS TO BE GRADED TO PROMOTE POSITIVE DRAINAGE AND MITIGATE EROSION

1416 HOLES IN FOUNDATIONS HAVE BEEN FILLED WITH SOIL
↳ NO STAINING OF CONCRETE OBSERVED

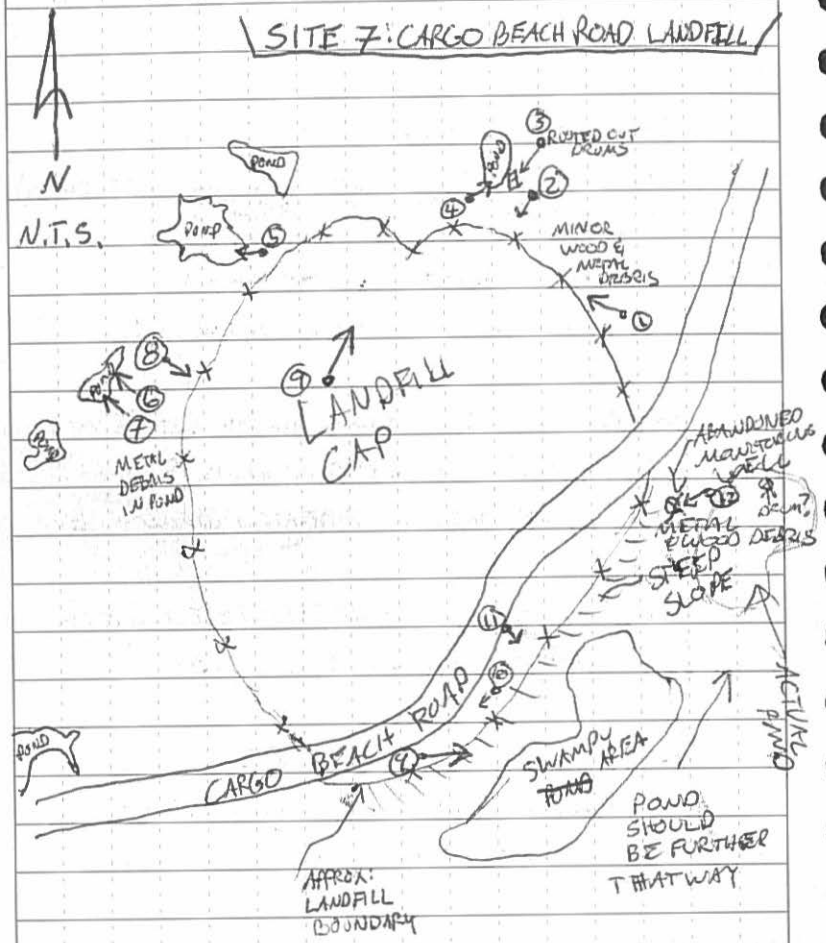
SITE 7: CARGO BEACH ROAD LANDFILL

1517 THE LANDFILL COVER APPEARS TO CONSIST OF FINE AND COARSE GRAVEL AT THE SURFACE WITH PATCHY GRASS COVER

1523 CARGO BEACH ROAD CROSSES THE LANDFILL CAP. NO SETTLEMENT OBSERVED GRADING/DRAINAGE APPEARS ADEQUATE

1546 OBSERVED 2 RUSTED OUT DRUMS NEAR THE EDGE OF THE POND NEAR THE NE CORNER OF THE LANDFILL (55gal?)

1547 OBSERVED METAL/WOOD/PLASTIC DEBRIS IN THE NORTHEAST POND

1552 OBSERVED METAL DEBRIS IN THE POND AT THE NW CORNER OF THE LANDFILL WHERE PICTURE ⑤ WAS TAKEN

1553 LANDFILL CAP DOES NOT HAVE OBSERVED SIGNS OF SETTLEMENT/EROSION OR LANDFILL DEBRIS STICKING THROUGH THE CAP

1554 OBSERVED METAL DEBRIS IN THE POND TO THE WEST OF THE LANDFILL (METAL ROOFING?) → PICTURES 6 & 7

1615 OBSERVED AN ABANDONED MONITORING WELL NEAR THE SE CORNER OF THE LANDFILL - ABANDONED WITH HYDRATED BENTONITE

1616 OBSERVED ~~MINOR~~ (P 9/10) METAL DEBRIS AND OTHER DEBRIS IN THE POND NEAR THE SE CORNER OF THE LANDFILL
↳ OBSERVED A SUBMERGED OBJECT W/ A ROUND OPENING (DRUM?)

1633 ITEMS OF INTEREST
- DEBRIS PROTRUDING THROUGH CAP ON SSIDE (MINOR)
- SIGNIFICANT METAL & WOOD DEBRIS IN THE SURROUNDING PONDS (INCLUDING A FEW RUSTED OUT DRUMS

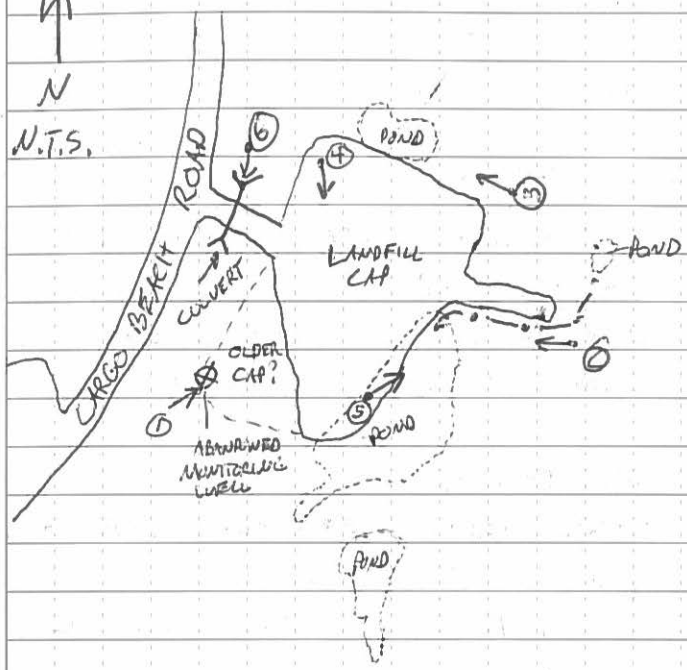
SITE 9: HOUSING & OPERATIONS LANDFILL

1642 DRAINAGE IN EXCELLENT CONDITION - NO VEGETATION IN DITCH

1649 LANDFILL CAP APPEARS TO BE IN GOOD CONDITION WITH THIN GRASSY VEGETATION. CAP IS COMPOSED OF COARSE MATERIAL (GRAVEL) THAT MAKES VEGETATIVE GROWTH DIFFICULT.

1651 EROSION & SETTLEMENT WERE NOT OBSERVED. GRADING APPEARS TO ALLOW DRAINAGE

1657 OBSERVED AN ABANDONED MONITORING WELL AT THE SW CORNER OF THE OLD LANDFILL CAP.

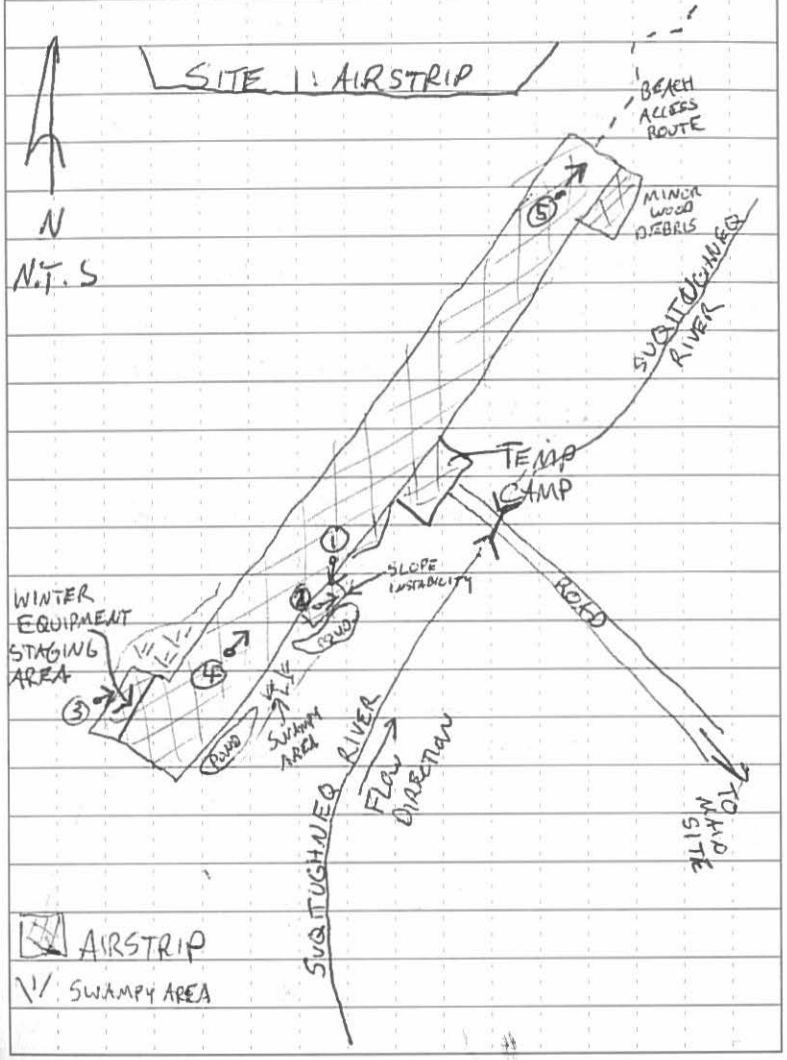
0955 OBSERVED 1 TO 6 INCH TENSION CRACKS IN THE SLOPE OF A SIDING OFF THE SIDE OF THE RUNWAY. THE NORTHEAST CORNER OF THE PAD HAS APPROXIMATELY 1FT OF SETTLEMENT AT THE TOP OF THE SLOPE.

1000 RUNWAY SURFACE WAS OBSERVED TO BE IN GOOD CONDITION AND WAS FREE OF RUTTING, SETTLEMENT, OR EROSION DAMAGE

↳ SLOPES IMMEDIATELY ADJOINING THE RUNWAY SURFACE WERE GENERALLY FREE OF SIGNS OF SLOPE INSTABILITY, HOWEVER ARE SLOPED BETWEEN 1 1/2 TO 1 AND 3/4 TO 1 WHICH MAY LEAD TO EROSIVE DAMAGE OVER TIME

↳ SMALL TENSION CRACKS ON 3/4 TO 1 SECTIONS

1014 A FEW SHIPPING RACKS ARE STAGED ON THE END OF THE RUNWAY AT THE WINTER STORAGE AREA
↳ NO SOIL STAINING OBSERVED AT STORAGE AREA

1033 MINOR WOOD DEBRIS NOTED ALONG THE EAST SIDE OF THE RUNWAY NEAR THE NORTH END

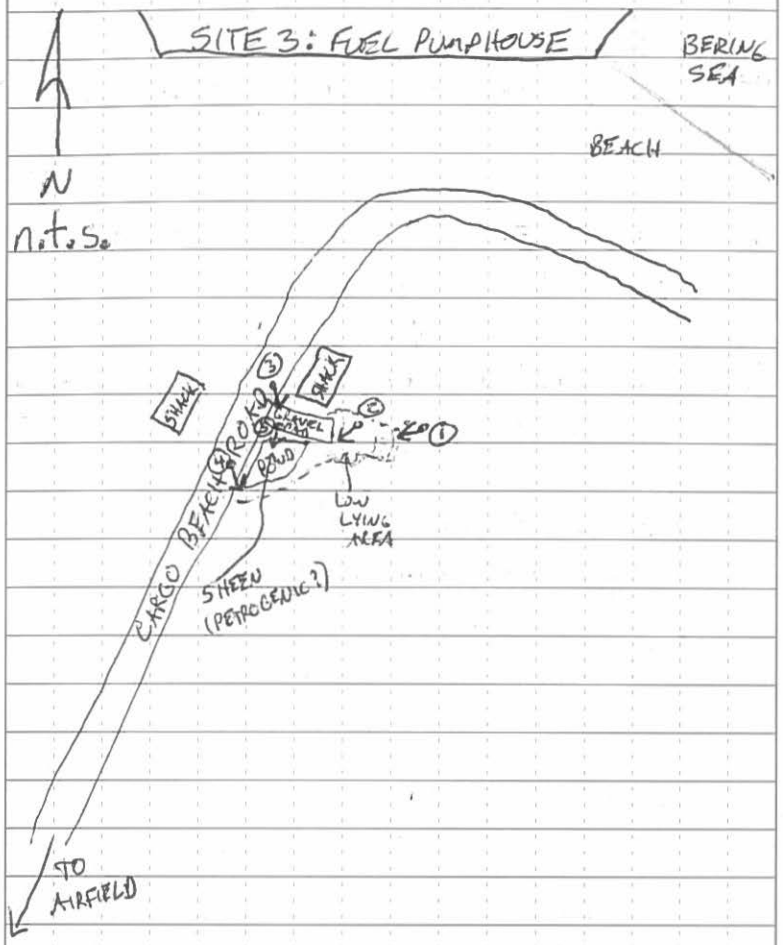
1055 ARRIVED AT SITE 3: FUEL PUMPHOUSE

1112 OBSERVED A SALVAGED PIECE OF RUSTED OUT EQUIPMENT STAGED FOR REMOVAL

1113 EXCAVATION AREA NOTED IN THE ROD APPEARS TO NOW BE A POND

1114 BIOGENIC SHEEN (BRITTLE) NOTED ON SOME WATER IN FROM THE ROAD

1116 FORMER PIPELINE WAS NOT OBSERVED (REMOVED?) FORMER PUMPHOUSE STRUCTURE HAS BEEN REMOVED.

1119 SHEEN NOTED ON PONDED WATER NEAR THE GRAVEL PAD. SHEEN WAS NOT BRITTLE AND FLOWED BACK TOGETHER AFTER BEING DISTURBED (LIGHT SHEEN)

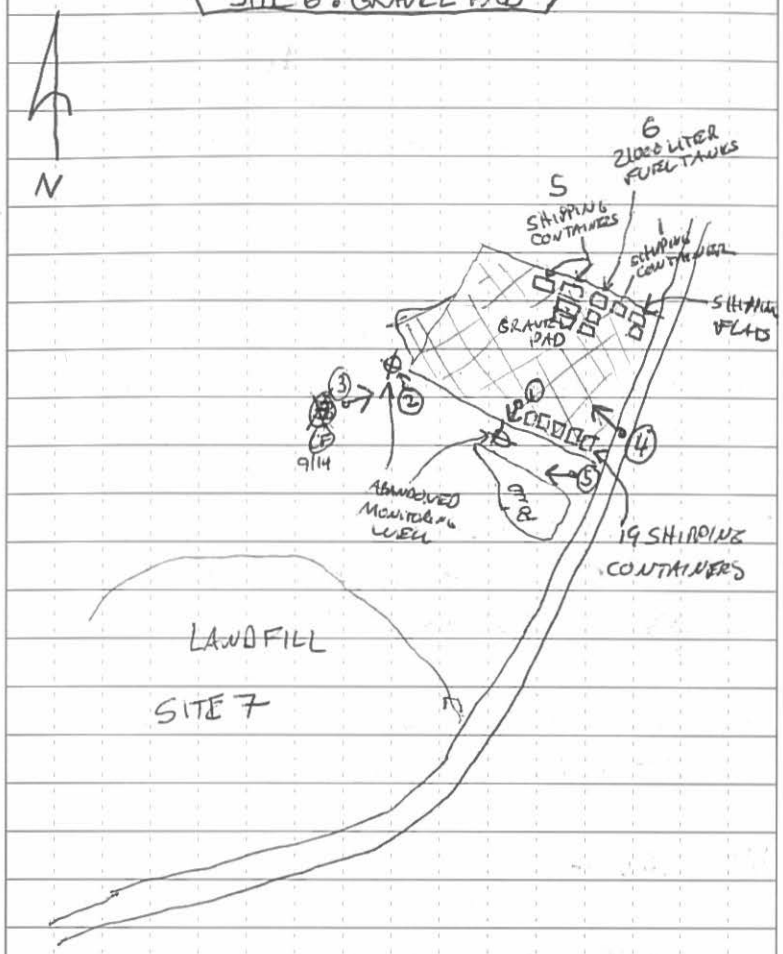
SITE 6: GRAVEL PAD

1140 OBSERVED AN ABANDONED MONITORING WELL ON THE SW SIDE OF THE SITE. (HYDRATED BENTONITE)

1143 A SECOND ABANDONED MONITORING WELL OBSERVED ON THE WEST CORNER OF THE PAD (HYDRATED BENTONITE)

1148 DID NOT OBSERVE STAINING ON THE NEWLY GRADED GRAVEL PAD THAT IS CURRENTLY BEING USED TO STORE SHIPPING CONTAINERS.

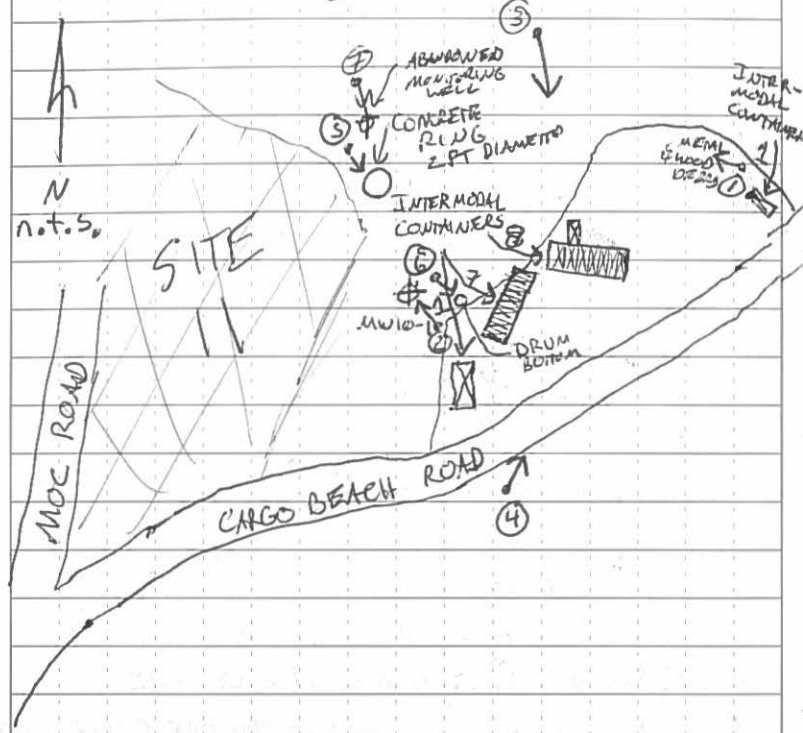
SITE 10: BURIED DRUMS

1547 OBSERVED WOOD AND METAL DEBRIS (MINOR) AT THE NE CORNER OF THE SITE

1550 OBSERVED MONITORING WELL 00-1, WELL CASING HAS JACKED 1 FOOT ABOVE THE PROTECTIVE STEEL CASING. NO LOCKING CAP OR PROTECTIVE BOLLARDS.

1554 ~~EVADEN~~ EM 9/14 OBSERVED EVIDENCE OF RECENT SOIL BORINGS & SAMPLING ACTIVITY

1604 OBSERVED A DRUM BOTTOM AT BASE OF SLOPE

1608 2ND MONITORING WELL SHOWN ON THE FIGURE IN THE ROD WAS NOT FOUND.

↳ JEREMY CRAMER INDICATES IT WAS DECOMMISSIONED (USACE) ↳ OBSERVED THE ABANDONED WELL

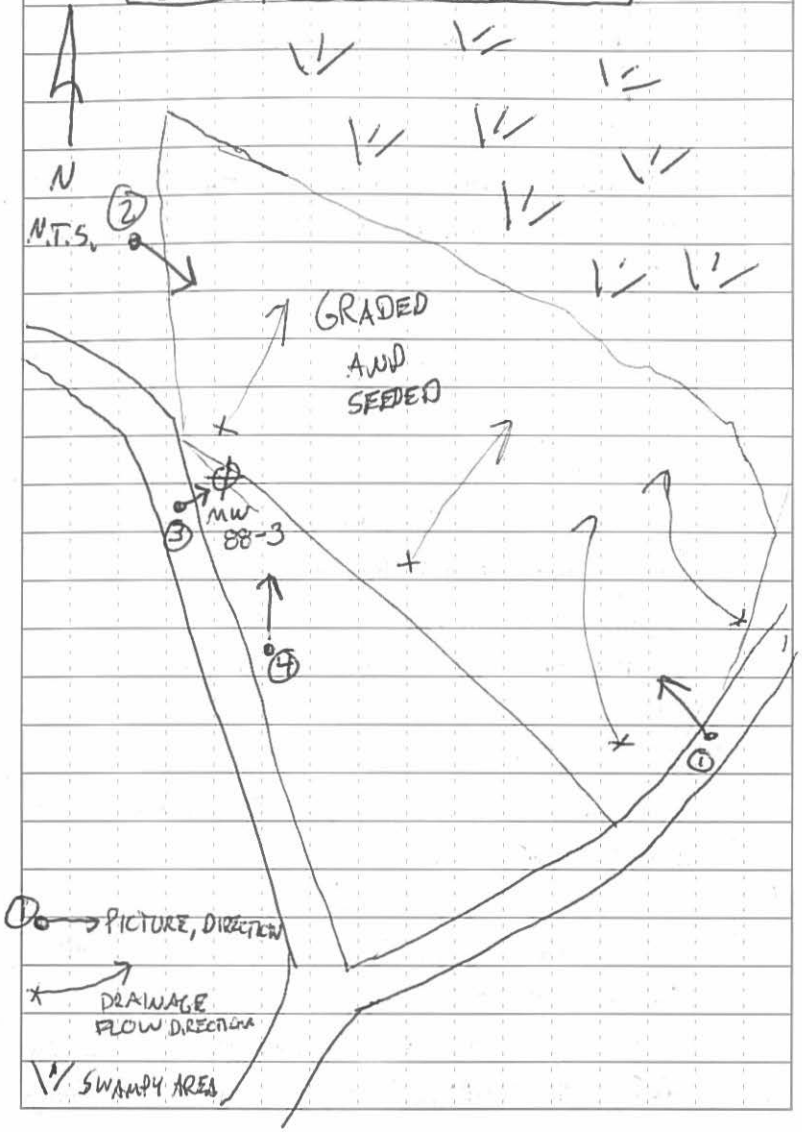
SITE 11: FUEL TANKS

1635 OBSERVED MONITORING WELL MW88-3.
↳ CASING HAS A LOCKING CAP - WITH NO LOCK
↳ FLUSH MOUNT MONUMENT DOES NOT CLOSE AS THE WELL APPEARS TO HAVE FROST JACKED

1643 SITE HAS BEEN GRADED/COMPACTED/AND SEEDED TO PROMOTE POSITIVE DRAINAGE AND MITIGATE EROSION.
↳ OBSERVED THE REMEDIAL CONTRACTOR (BRISTOL) SPREADING SEED ON THE AREA

1650 DEBRIS NOT OBSERVED ONSITE OR AROUND THE PERIMETER

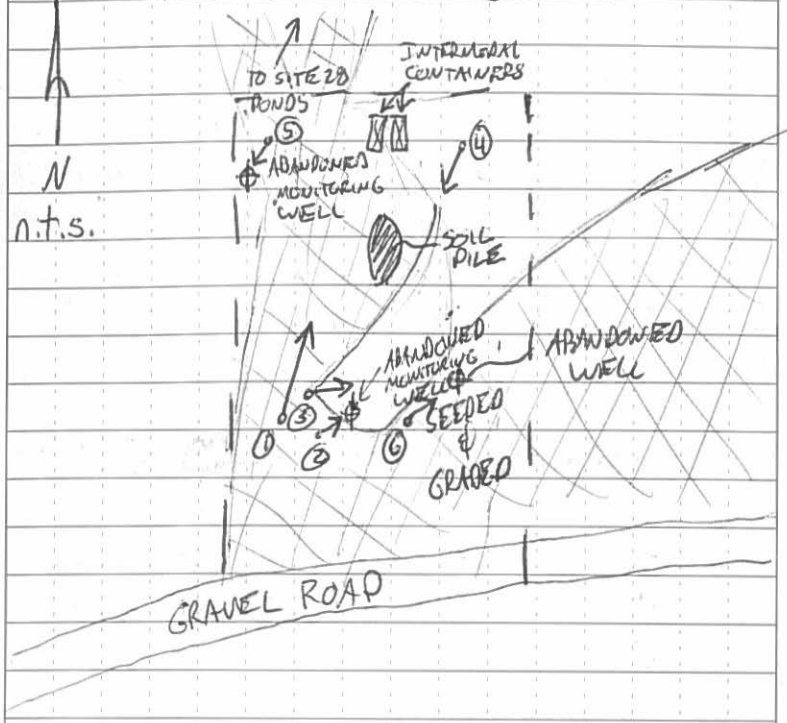
SITE 16: ~~HEAT & POWER PLANT~~ PAINT & DOPE STORAGE CP

1300 SITE HAS BEEN RECENTLY GRADED AND SEEDED ON THE SE PORTION

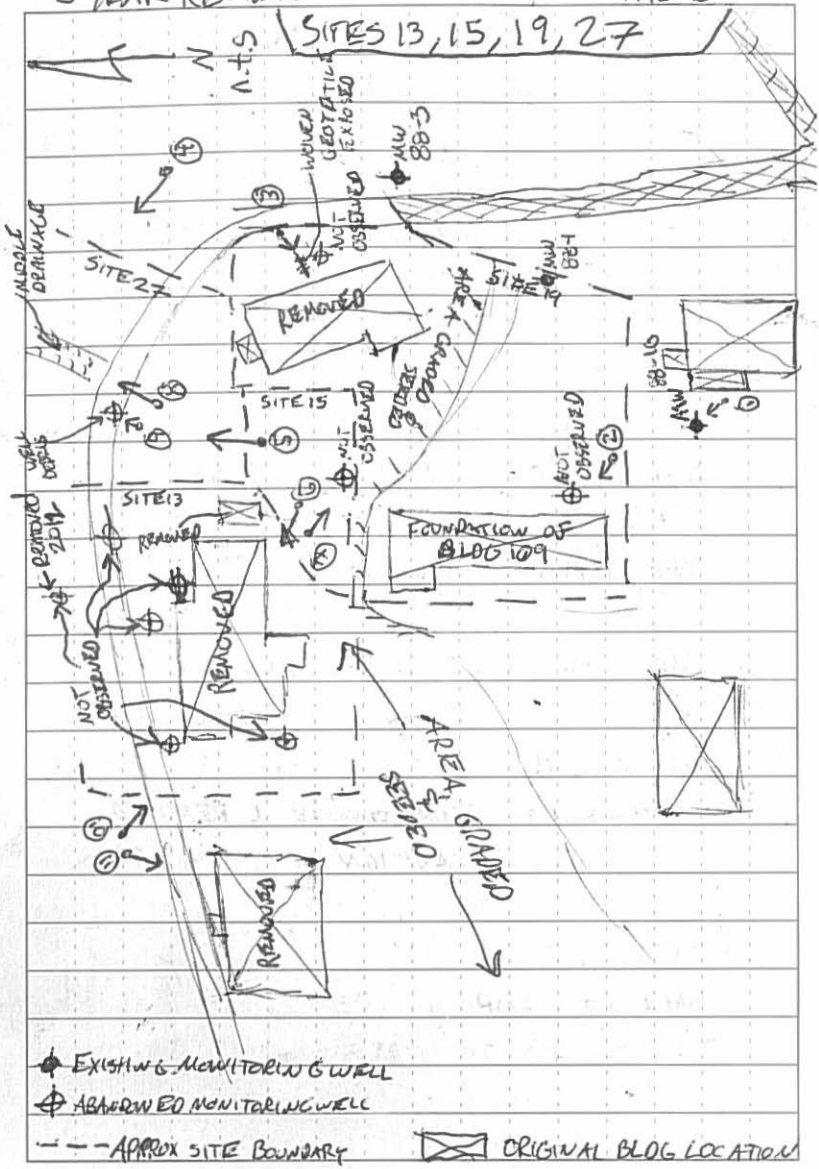
SITES 13, 15, 19, 27

1350 BUILDING AT SITE 13 HAS BEEN REMOVED ALONG WITH THE FOUNDATION

1353 BUILDING & FOUNDATION ON THE NE PORTION OF SITE 19 HAS BEEN REMOVED. THE FOUNDATION FOR THE BUILDING ON THE SW PORTION OF SITE 19 REMAINS.

1356 MONITORING WELLS IN THE CENTRAL PORTION OF THE MAIN OPERATIONS COMPLEX (MOC) WERE NOT OBSERVED
↳ LIKELY DECOMMISSIONED OR REMOVED DURING EXCAVATION
