United States Army  
Corps of Engineers

# Trip Report

Gambell FUDS Site  
Gambell, Alaska  
21 – 22 July 2004

**Trip Report  
Gambell FUDS Site  
Gambell, Alaska  
21-22 July 2004**

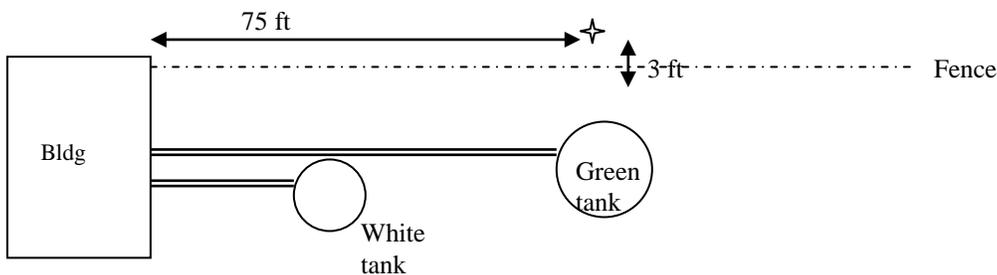
Figure 1 – Well point installation at Site 18A.

At 9:25 am, the well point was driven 14.5 feet below ground surface. The well point was tested for water using the bailer. The top of casing was measured at 45 inches. The water recovered in the bailer had a slight odor of fuel, with grey silty water. The well point was pounded in an additional 1.5 feet. At 9:45 am, the well point was completed. The final top of casing measurement was 31 inches above ground surface. The well point was

tested again for water. A strong fuel odor was present in the bailer. The well point was left to rest for several hours.

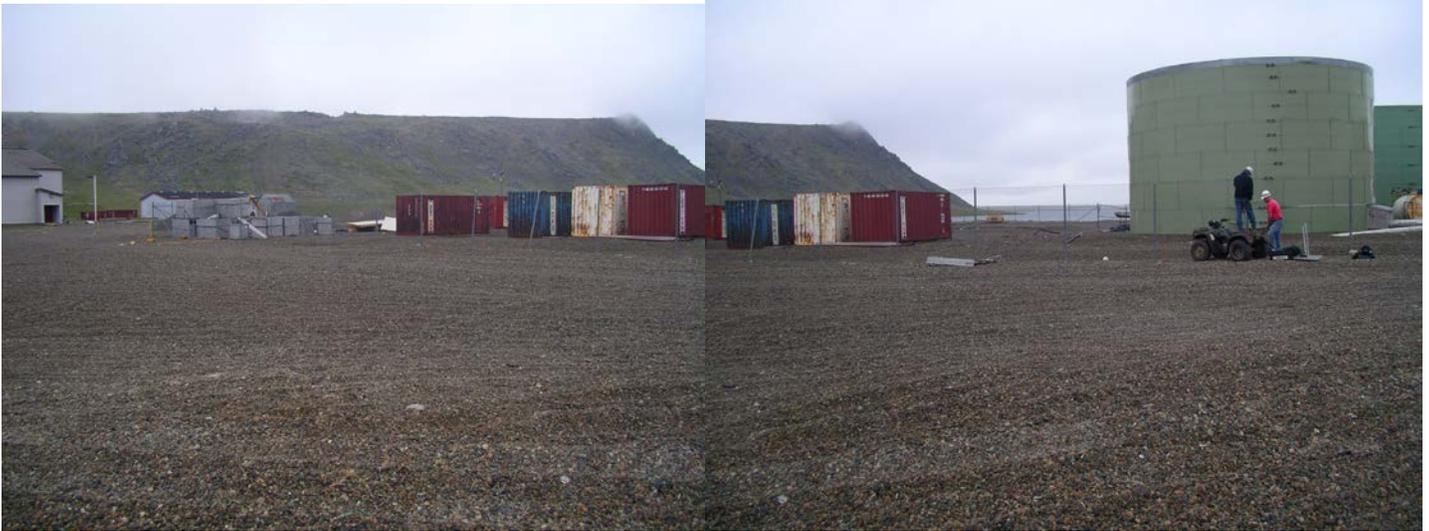
Photos 5 and 6 - view southeast

Photos 5-8: Vicinity of well point 18A

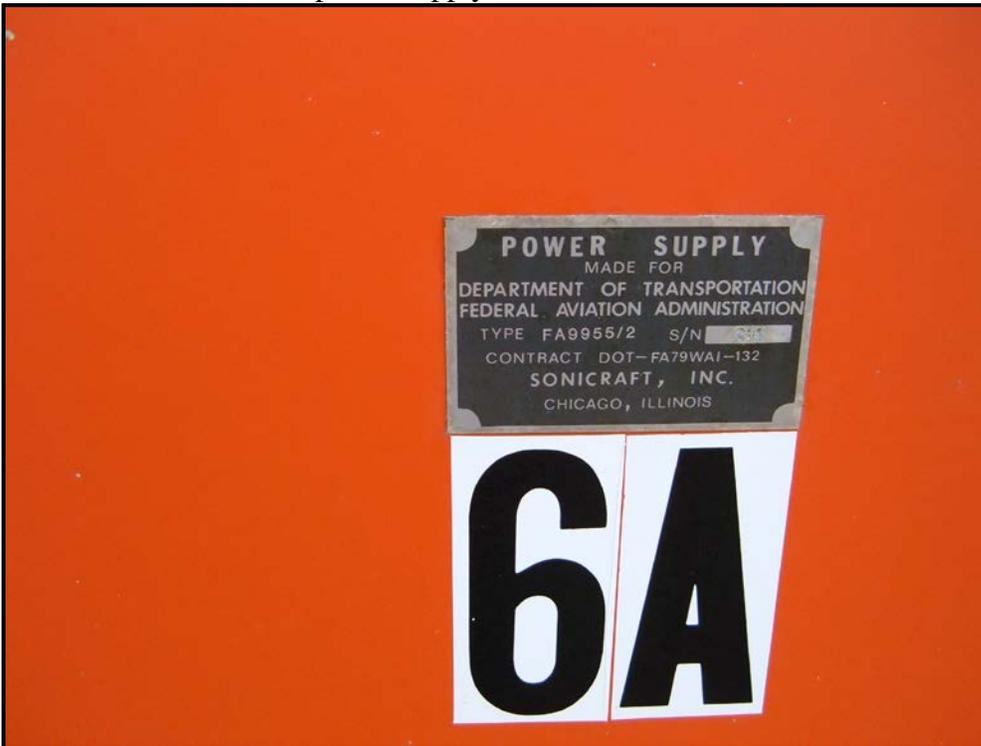
At 10:00, Lisa Geist and Scott Kendall traveled to the airstrip to view the exposed marsten matting. At 10:30 am, the team encountered Bruce B., the local airport maintenance employee. Bruce mentioned that Pat Kellerer was the FAA/DOT contact in Nome. The exposed marsten matting is concentrated along the southern half of the eastern side of the runway. Towards the southern end of the runway, an exposed group of wires was observed (see photo log). According to Bruce, the power lines for the runway lights are buried underneath the asphalt runway. However, the FAA's navigation aids appear to be connected by wiring which runs east of the runway (see sketch).

Photo 17: detail view of power supply

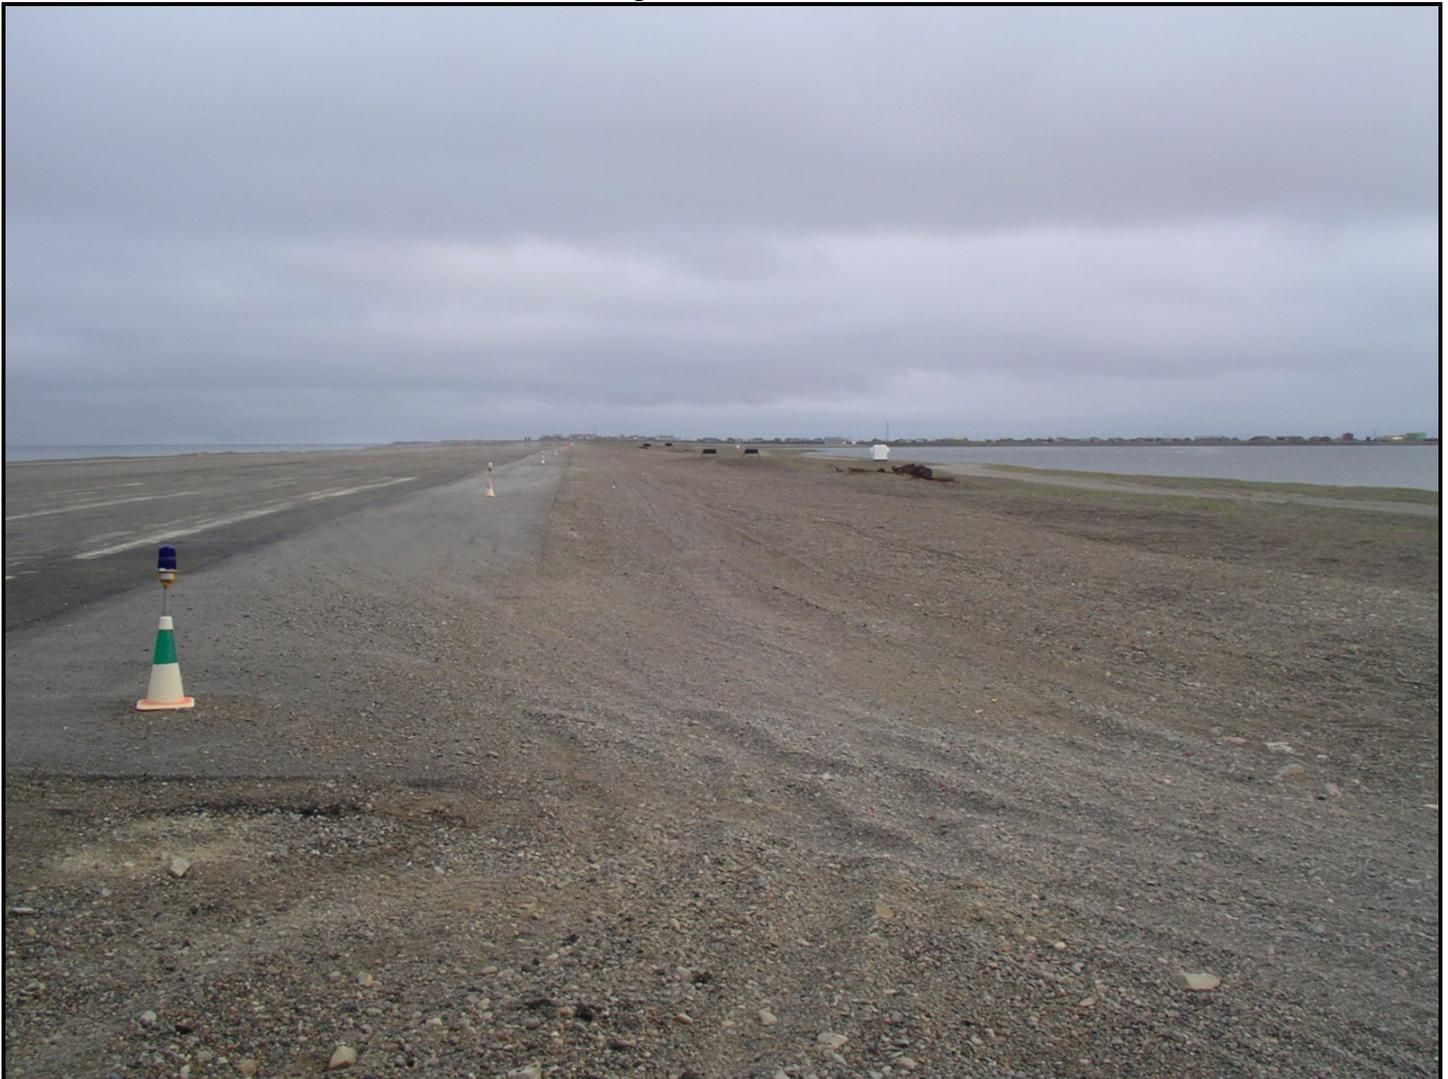
Photo 23: view north from southern end of airstrip

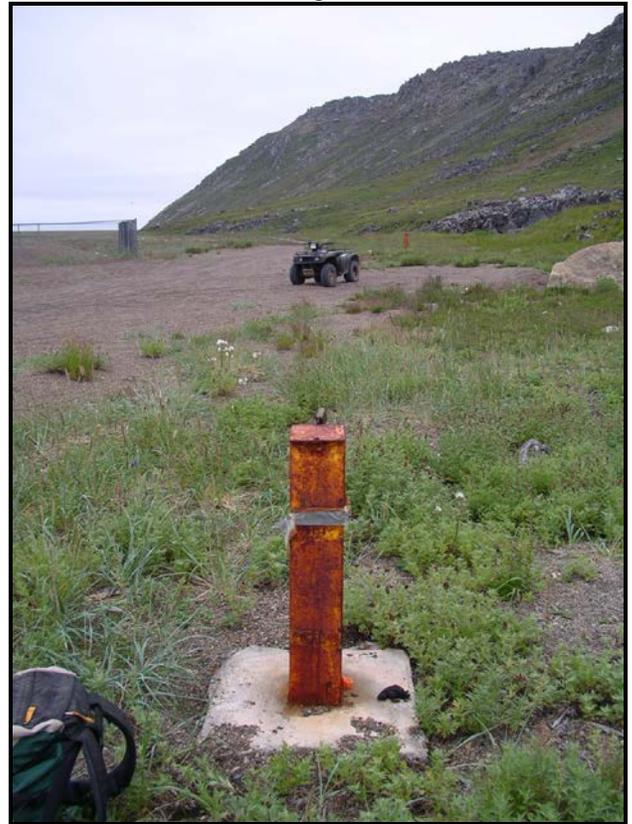
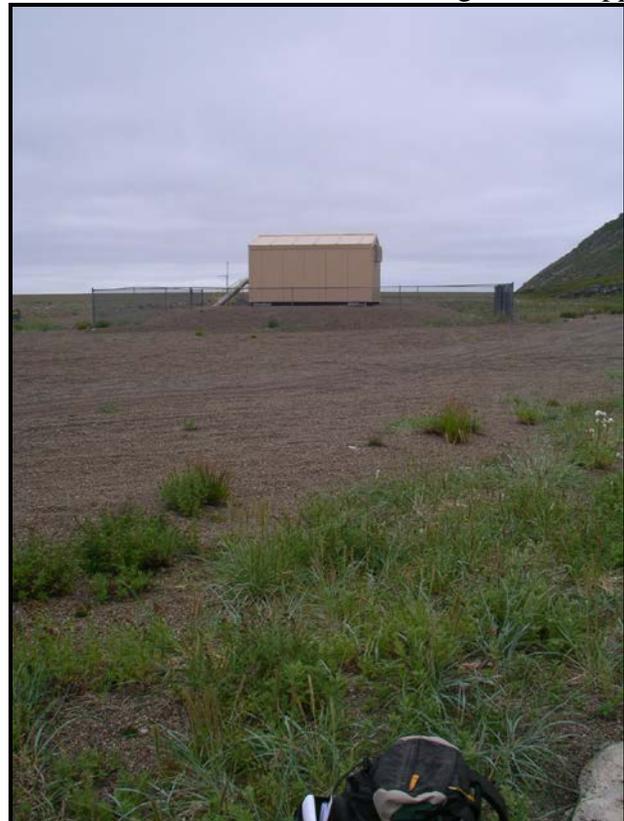
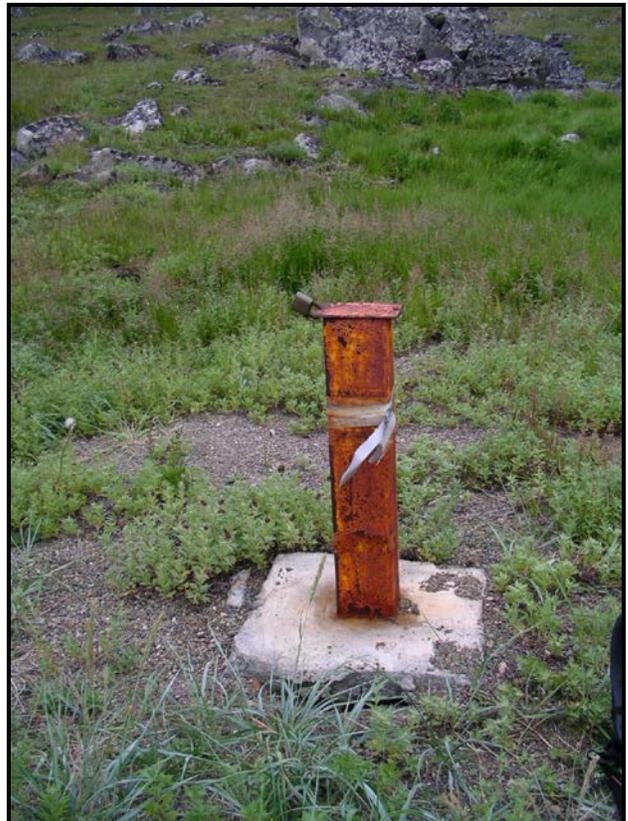
Photos 37 - 40: Site 5, Monitoring Well #29

At 12:30 pm, the field team traveled to Site 5 to conduct an inventory the existing monitoring wells. MW28 was located southwest of the fenced Village water supply well building, and found filled with gravel. MW29 was located east of the ATV trail, and southeast of the water supply building. The well was locked, but would

require cutting of the lock to be opened. Slight frost jacking was observed. MW 32 was located due southeast of the water supply building. The top of the well was resting on the casing, no lock was present. Otherwise, the well seemed in good condition. MW 15 was located northeast of the water supply building. This well is an older vintage. No lock was present on the outer casing, but the interior well was capped with a white plastic PVC cap. MW30 was located northwest of the water supply building. The well was locked, but weathered in place and would require cutting. Another monitoring well not related to previous remedial investigations was documented due north of the water supply building. MW 14 was located further north from MW15. A plastic tie secured the top of the protective casing, the lock had been previously removed. The protective casing of MW14 was also loose.
