#### SUMMARY REPORT Phase III Remedial Investigation Northeast Cape, St. Lawrence Island, Alaska

#### FINAL

Contract No. DACA85-98-D-0007 Task Order No. 026 MWH Job No. 1850574.260130

Department of the Army United States Army Engineer District, Alaska Corps of Engineers P.O. Box 898 Anchorage, Alaska 99506-0898

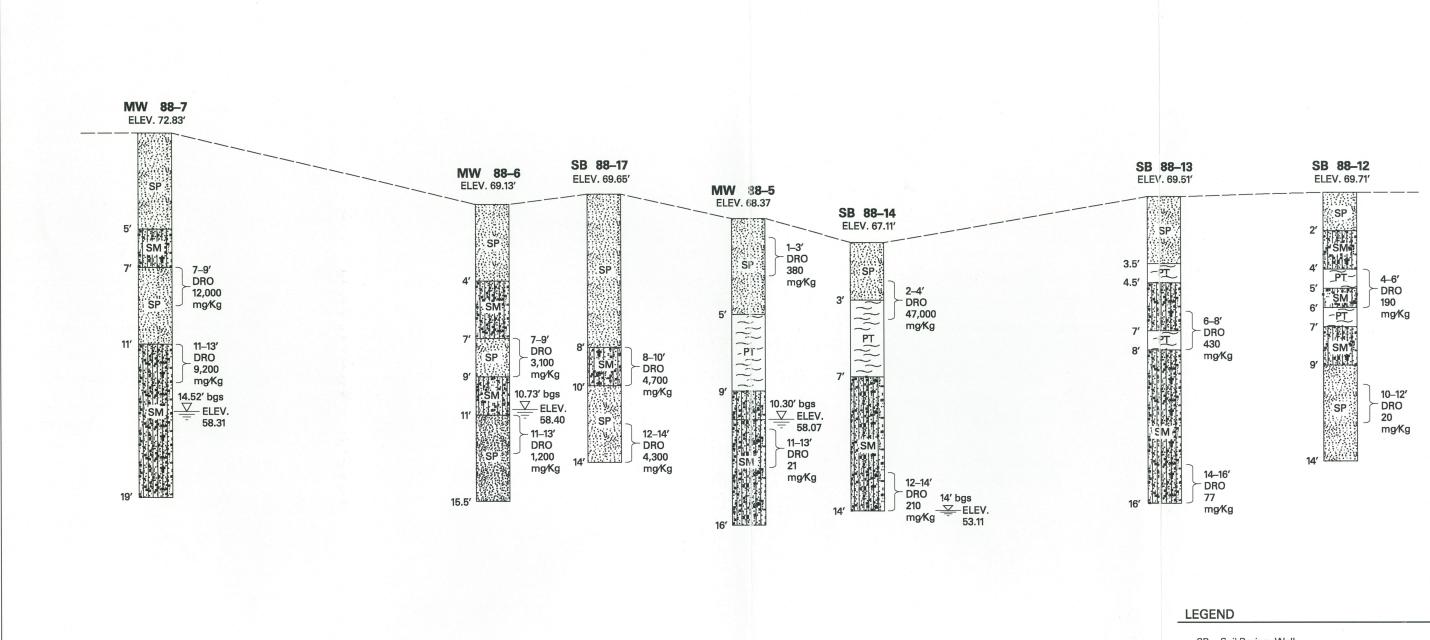
SB	Soil Boring Well
MW	Monitoring Well
7'–9'	Depth of Sample Below Grade Surface (bgs)
DRO	Diesel Range Organics
Elev.	Elevation
SP	Gravelly Sands
SM	Sand/Silt Mixtures
PT	Peat
FIGURE	2–7

2002 PHASE III REMEDIAL INVESTIGATION SITE 88 (SITES 13, 15, 19, 20, & 27) – MAIN OPERATIONS COMPLEX SECTION A-A'

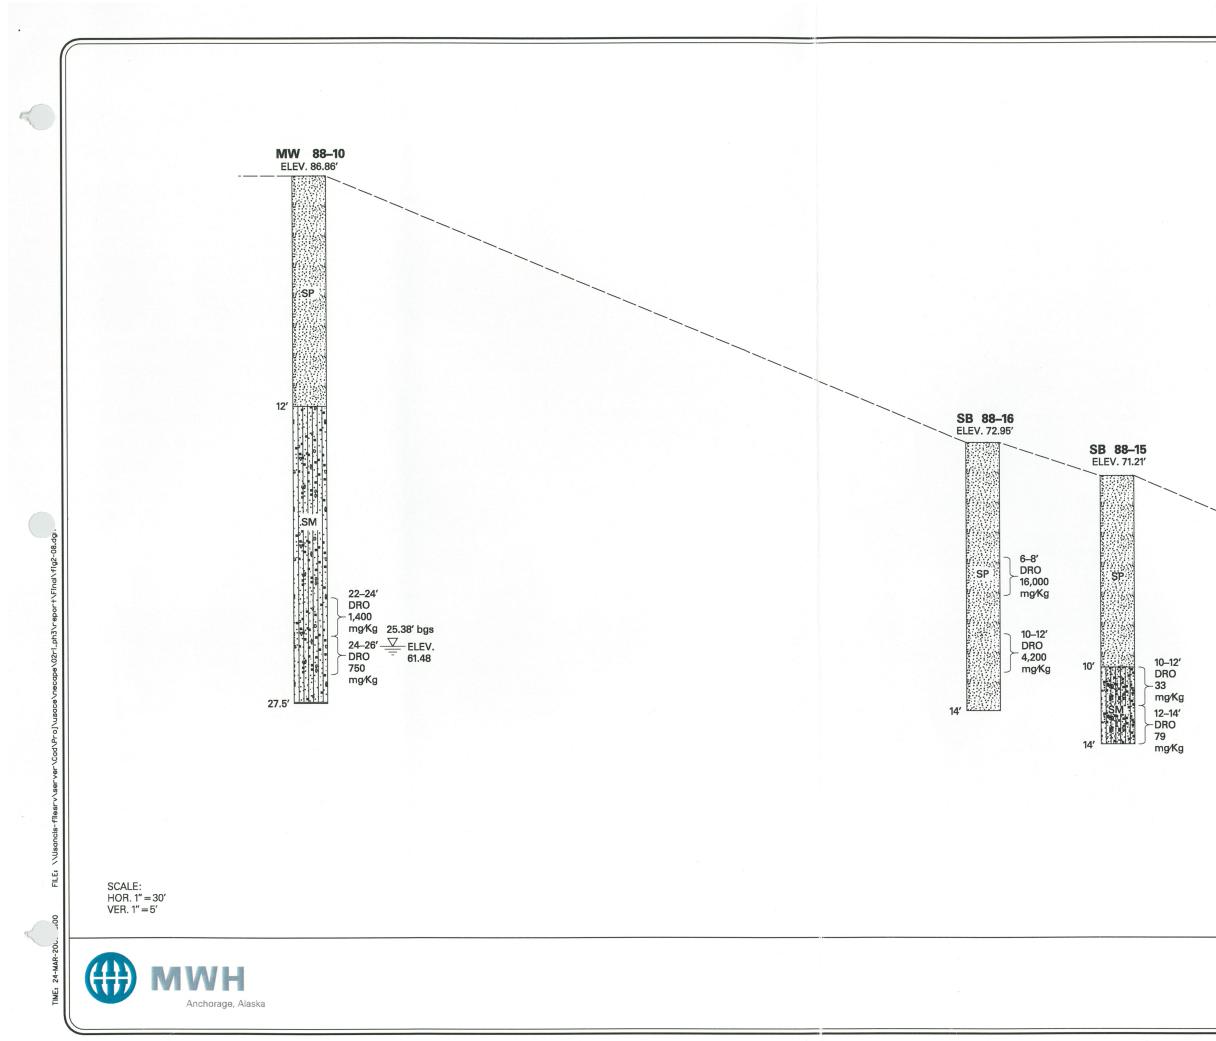
FIGURE 2–8 U. S. ARMY ENGINEER DISTRICT, ALASKA – N. E. CAPE, ALASKA 2002 PHASE III REMEDIAL INVESTIGATION SITE 88 (SITES 13, 15, 19, 20, & 27) – MAIN OPERATIONS COMPLEX SECTION B–B'

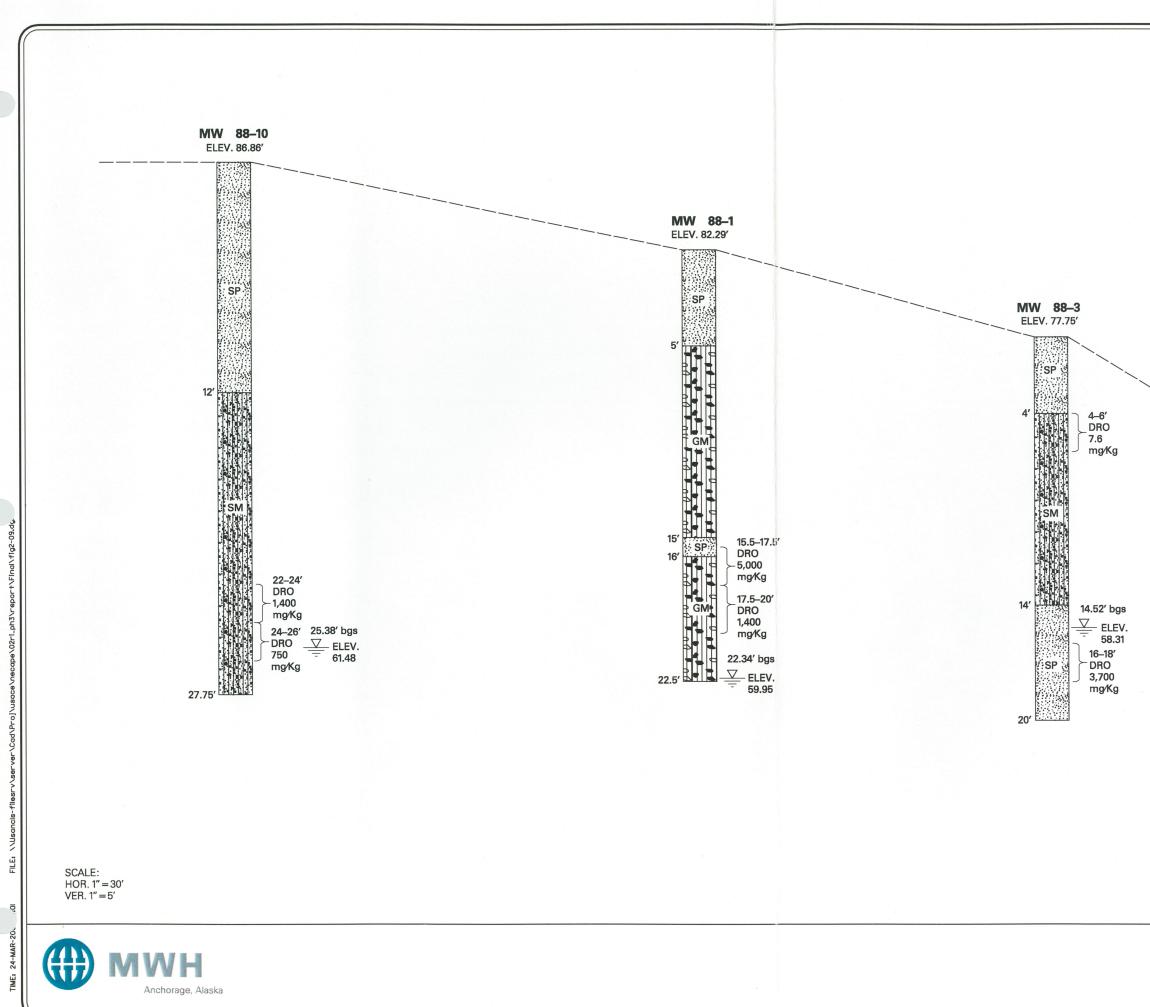
FIGURE 2-9 U. S. ARMY ENGINEER DISTRICT, ALASKA – N. E. CAPE, ALASKA 2002 PHASE III REMEDIAL INVESTIGATION SITE 88 (SITES 13, 15, 19, 20, & 27) - MAIN OPERATIONS COMPLEX SECTION C-C'

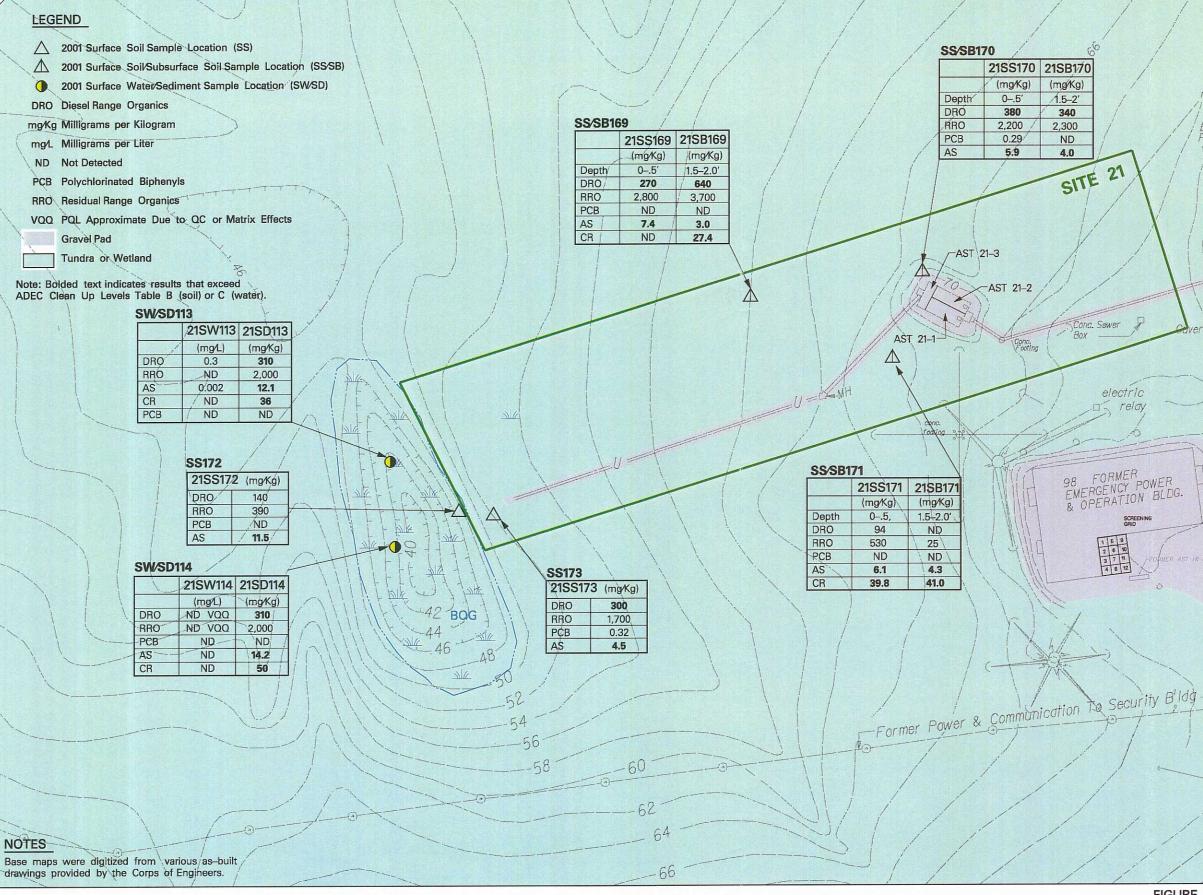
511 NORTH SCALE IN FEET Concrete filler pipes & Vents Electric Relay 17 FORMER SUPPLY WAREHOUSE Prefab Bldg. MES DORMITORY DORMITORY M.H. PP 90 FIGURE 2-12 U. S. ARMY ENGINEER DISTRICT, ALASKA – N. E. CAPE, ALASKA 2002 PHASE III REMEDIAL INVESTIGATION SITE 21 - WASTEWATER TREATMENT FACILITY 2001 SAMPLING LOCATIONS & SELECTED RESULTS

In the area adjacent to the septic tanks, three co-located surface and subsurface soil samples were collected (Figure 2-12). Photos of sample locations are provided in Appendix C. One of these samples was collected to confirm PCB results near the location of 1994 Soil Sample SS168, where PCBs were detected at a concentration of 1.92 mg/kg. Two surface soil samples, SS172 and 173, were collected downgradient of the outfall pipe. Soil samples were analyzed for DRO, RRO, GRO, VOCs, PCBs, and metals.
