**United States Army Corps of
Engineers, Alaska District**

**Phase II Remedial Investigation
Gambell,
St. Lawrence Island, Alaska**

Photographs - August, 1996

**Phase II Remedial Investigation
Northeast Cape,
St. Lawrence Island, Alaska**

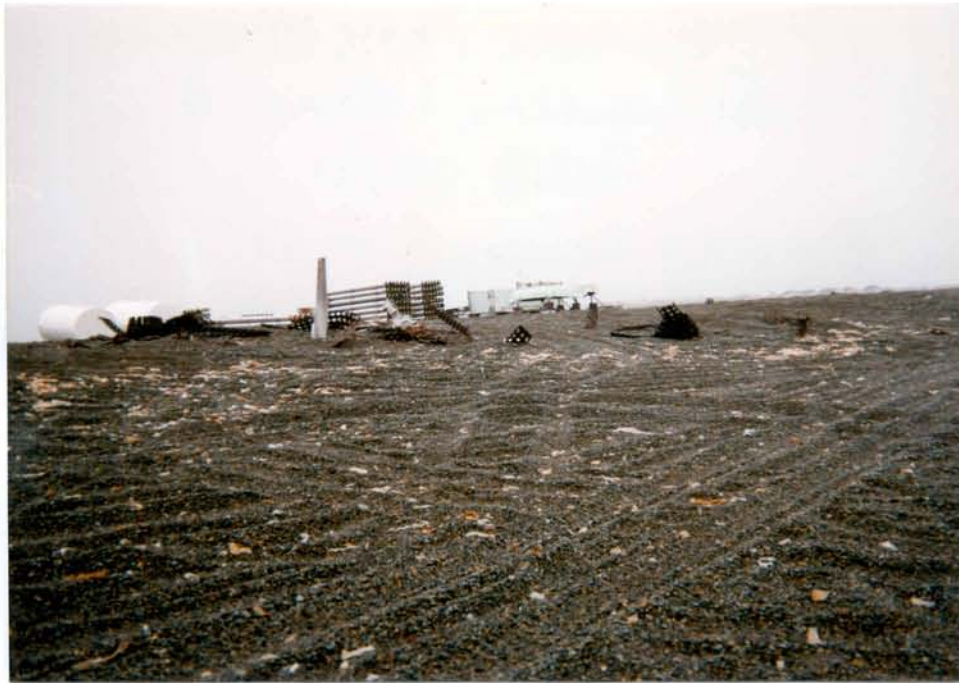
Exposed landing mat at barge landing area

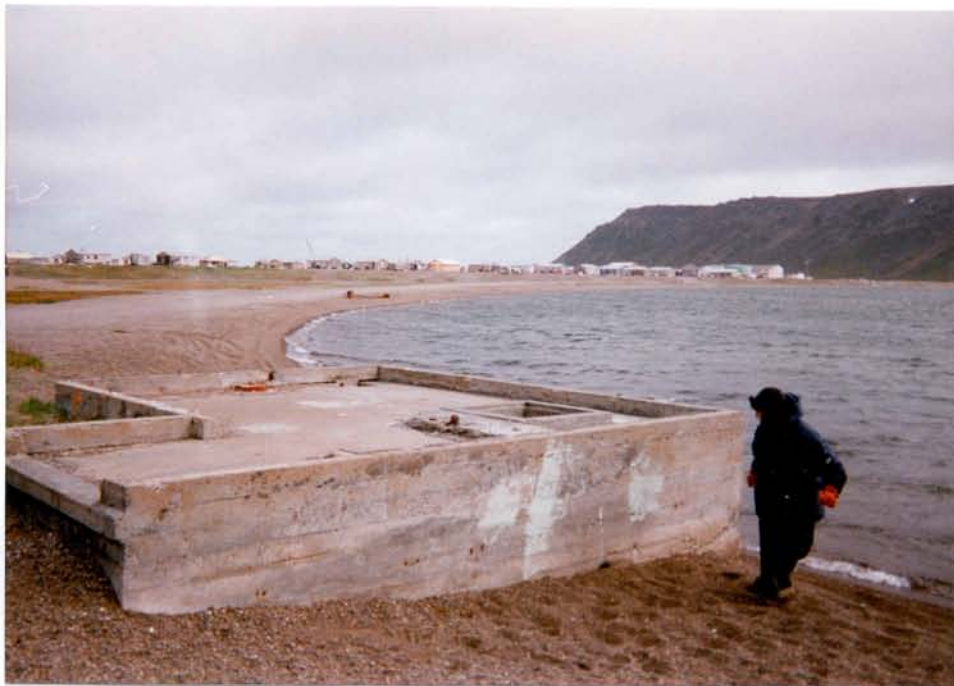
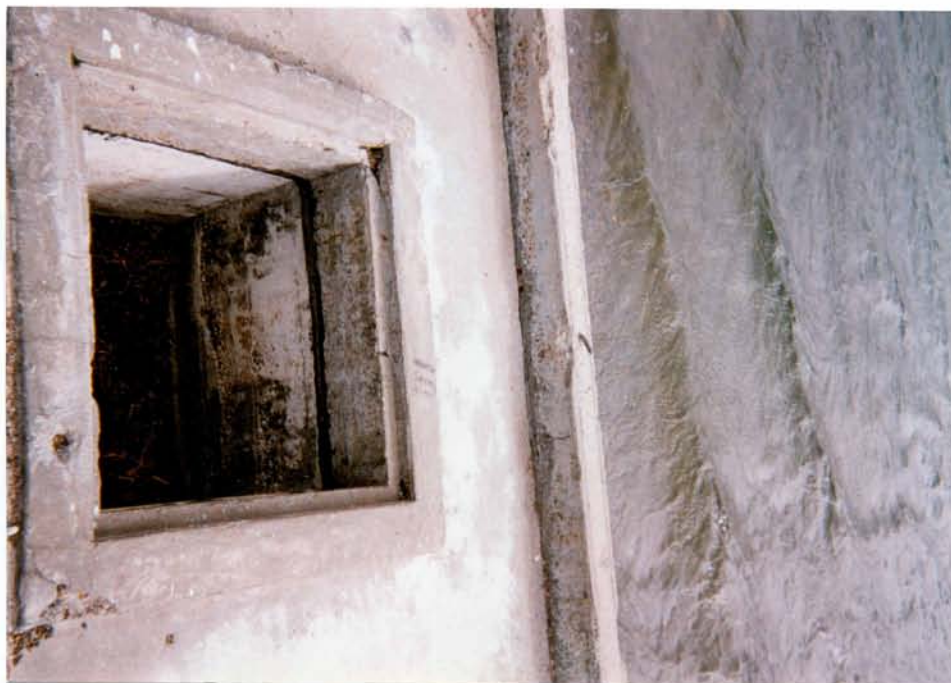
Small Bunker East of Troutman Lake

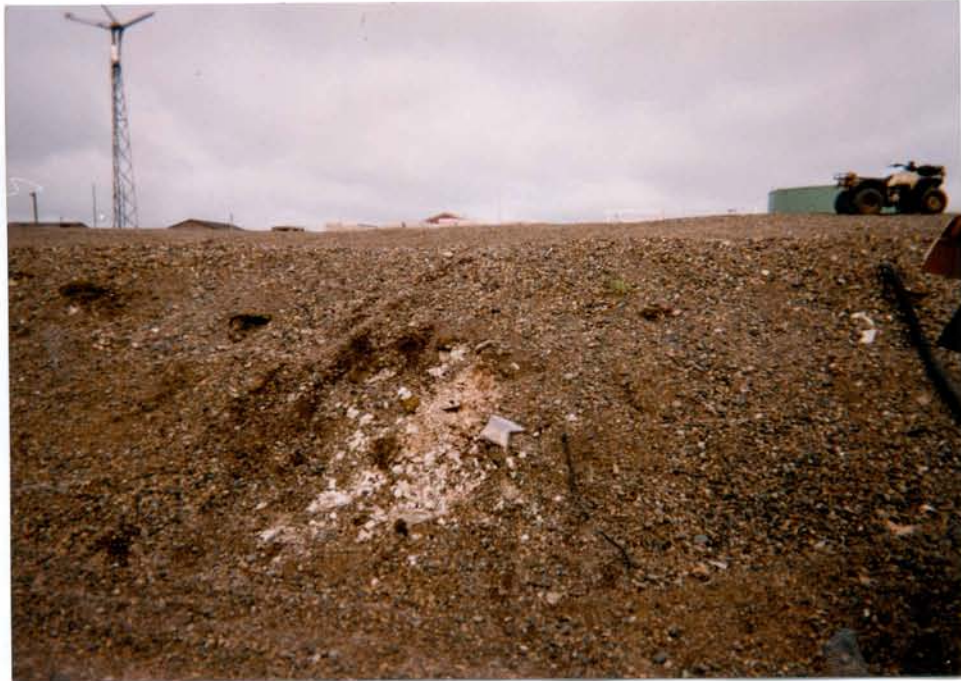
Filter material near Troutman Lake

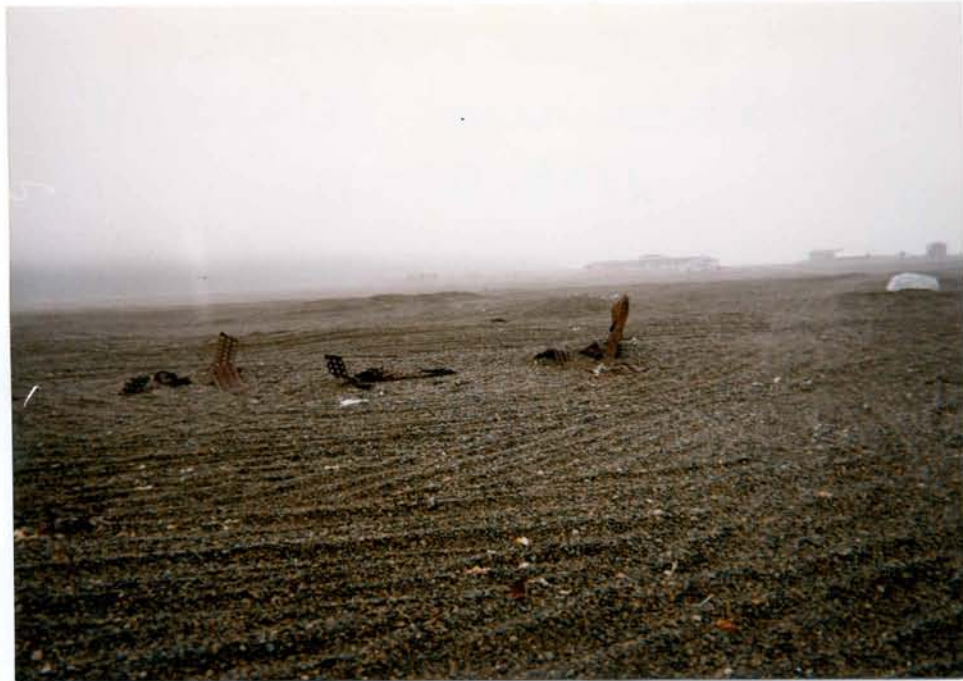
Exposed Landing Mat at Site 1/Area 1A, facing Southeast

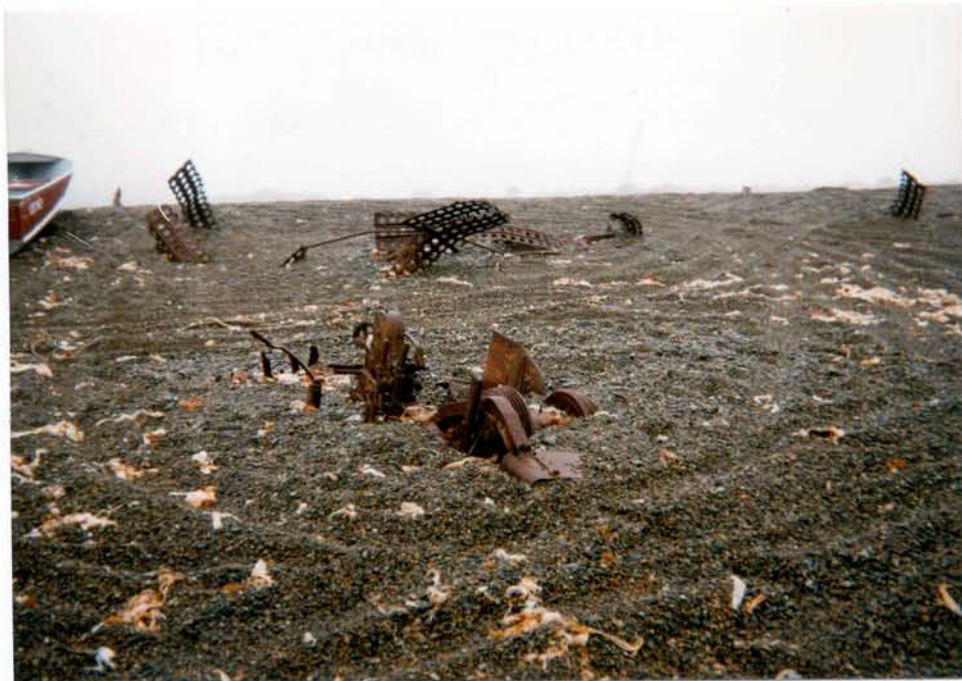
Exposed Landing Mat at Site 1/Area 1A, facing South

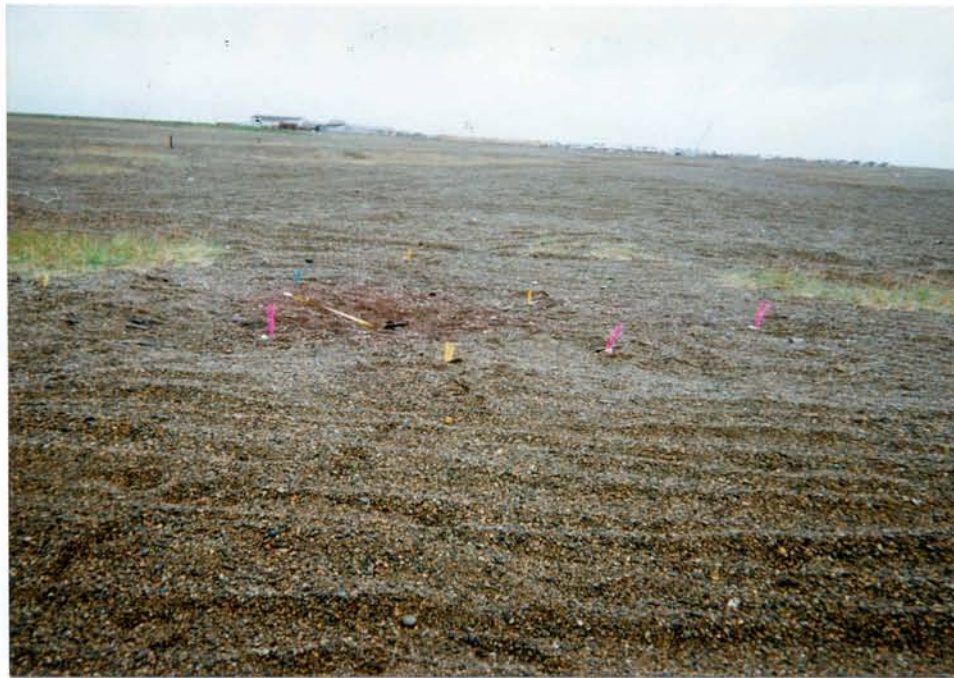
Surface soil sampling st stained area at site 2

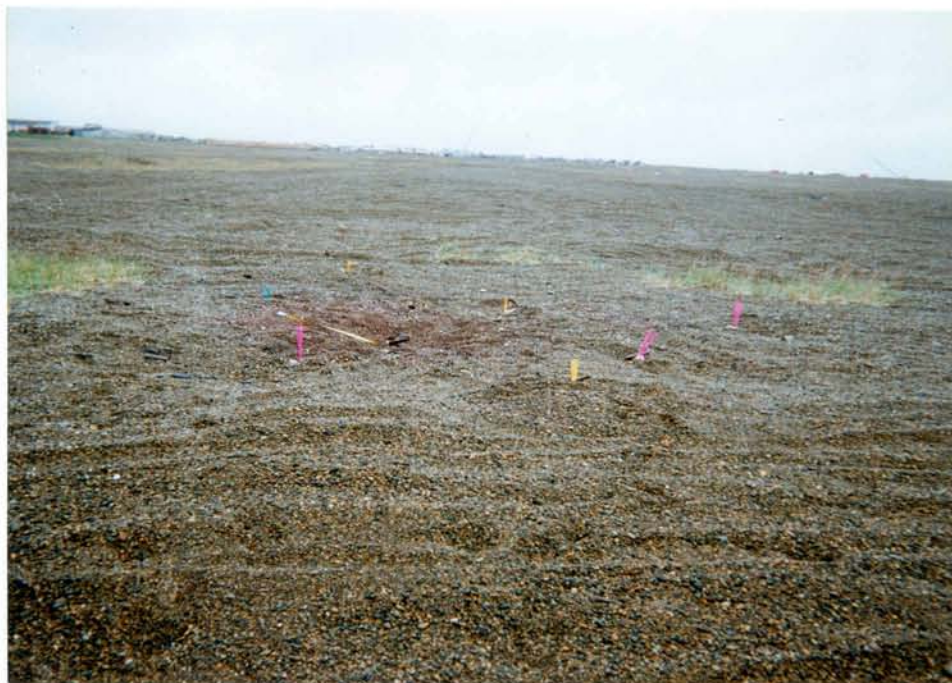
Surface soil sampling at stained area at Site 2

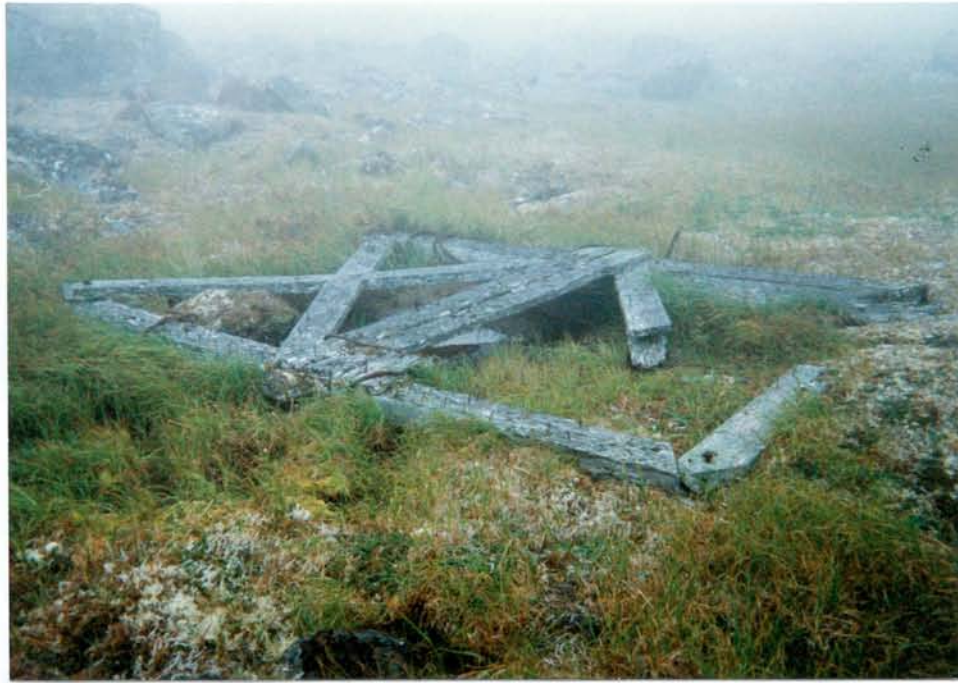
Wooden debris at Site4/Area 4B

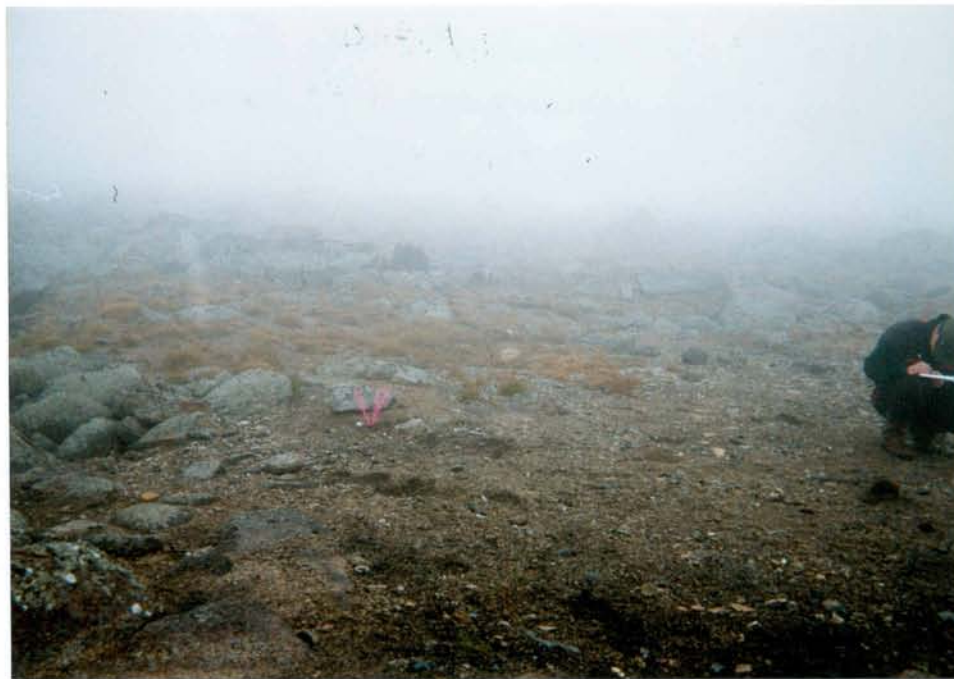
Surface Soil Sampling at Site4/Area 4B. Foreground is 96GAM003SS4B, background is motor and burned wood

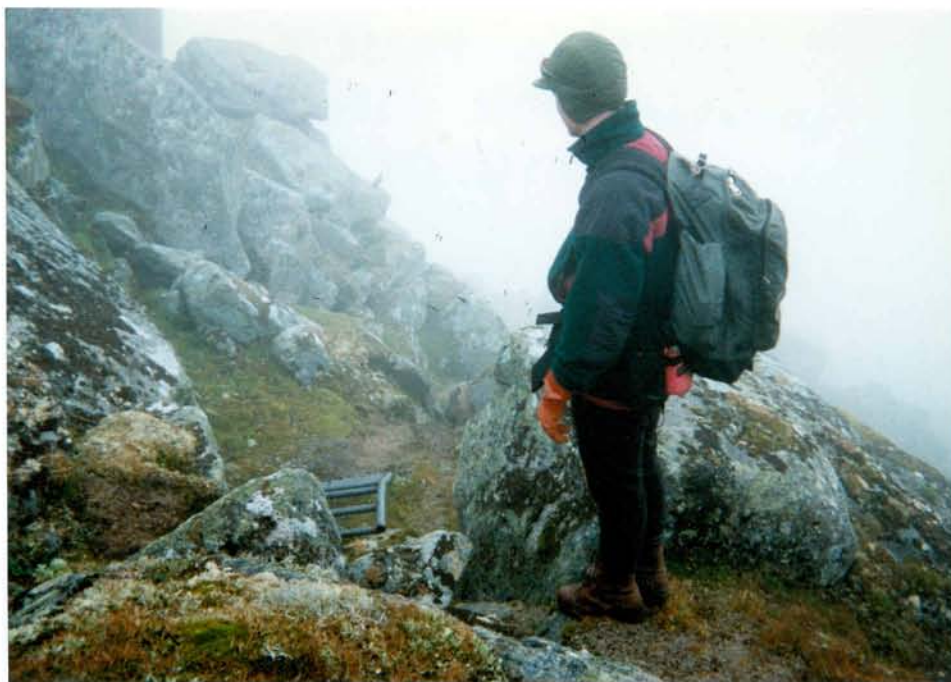
Ladder approximately 300 feet West of stained area at Site 4/Area 4B at edge of mountain

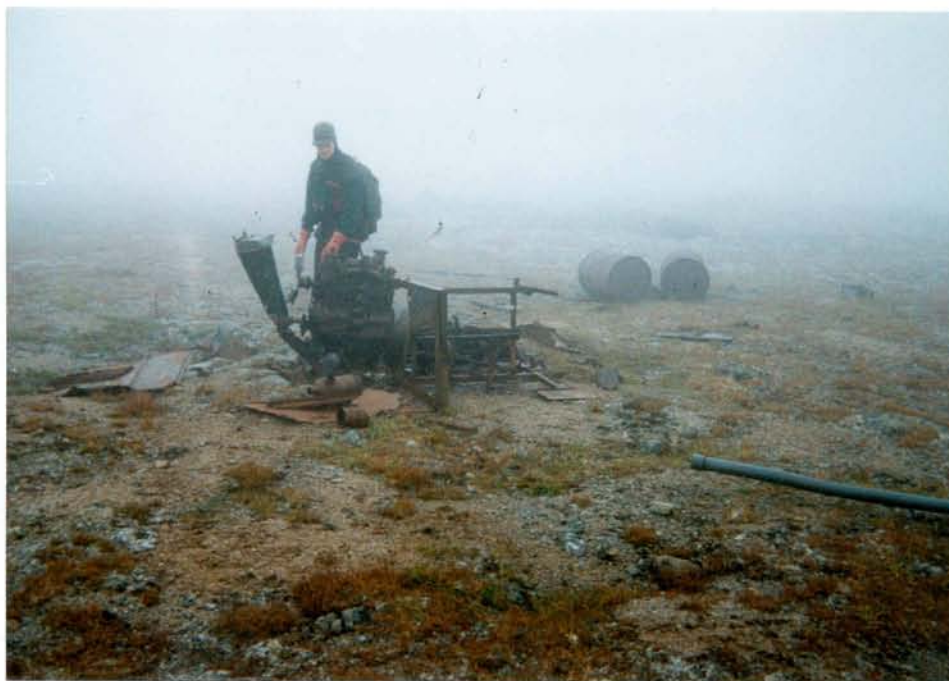
Car part found on top of mountain below Site 4/Area 4B and 4D

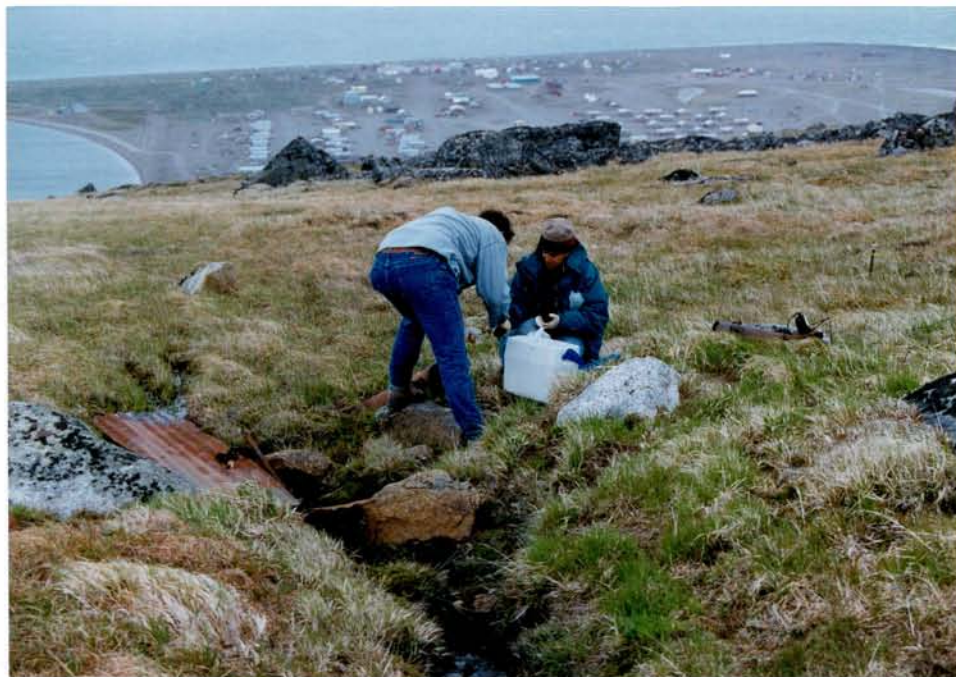
Wipe sampling of Transformers at Site 4/Area 4D

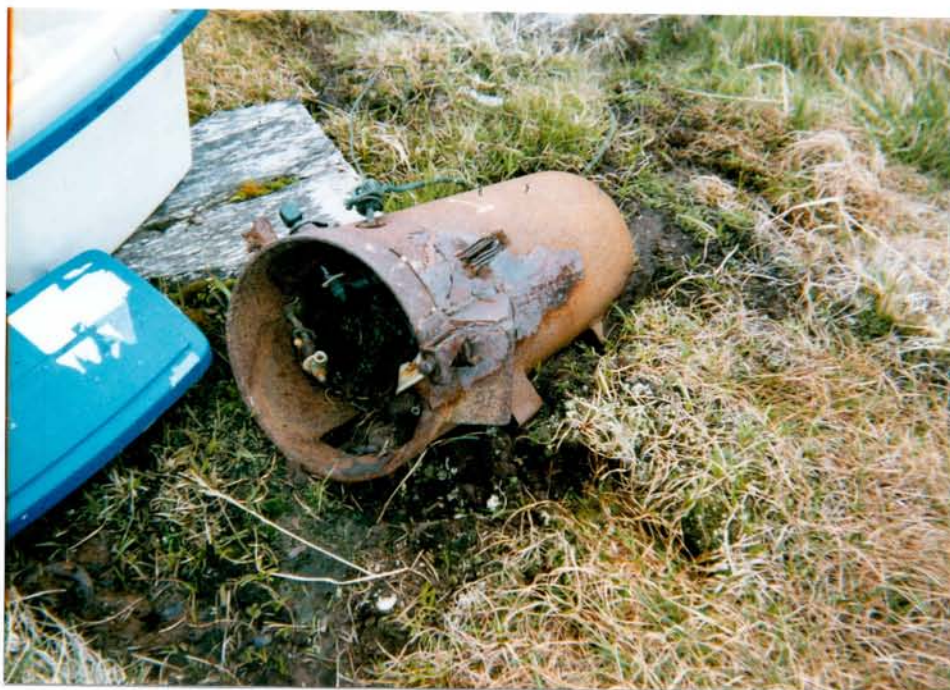
Wipe Sampling at Transformer 1 at Site 4/Area 4D. Sample #96GAM001WI

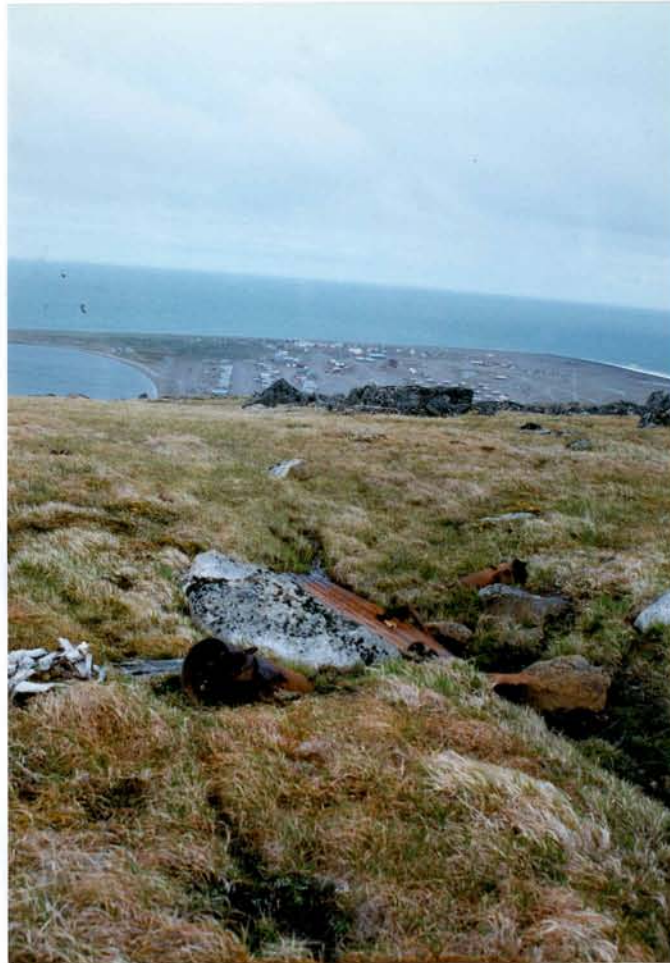
Transformers 1 & 2 at Site 4/Area 4D, facing West

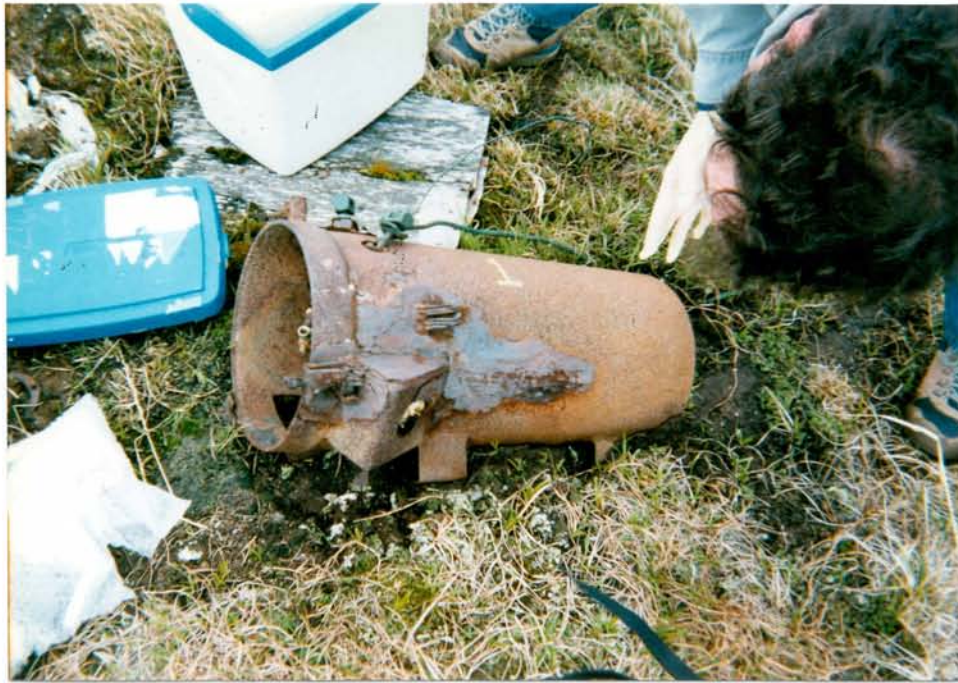
Wipe Sampling at Transformer 1 at Site 4/Area 4D. Sample #96GAM001WI

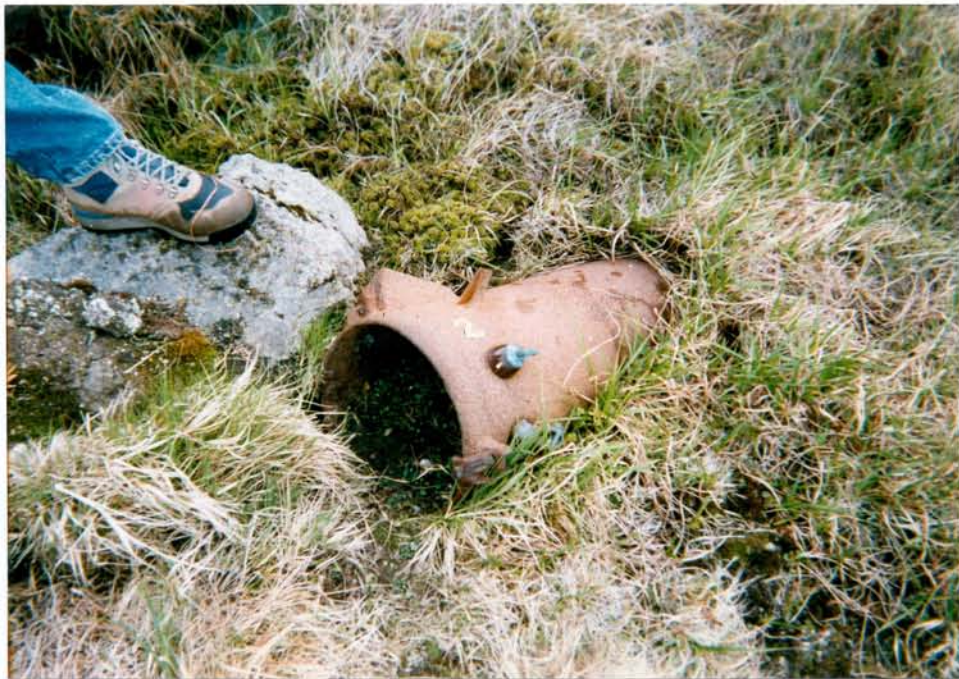
Wipe Sampling of Transformer 2 at Site 4/Area 4D

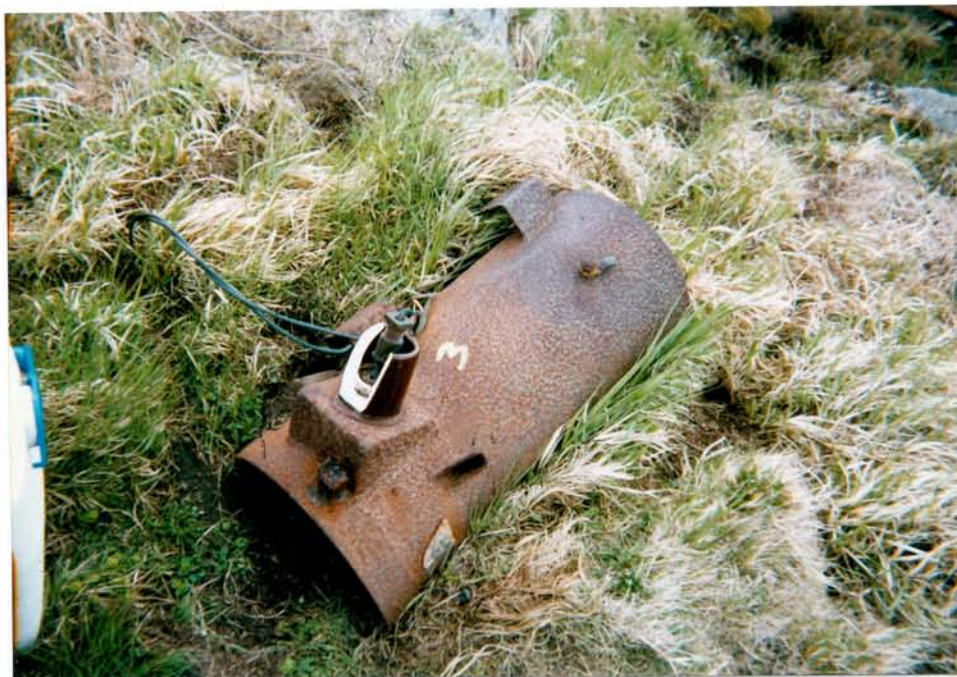
Wipe Sample of Transformer 3 at Site 4/Area 4D. Sample #96GAM003WI

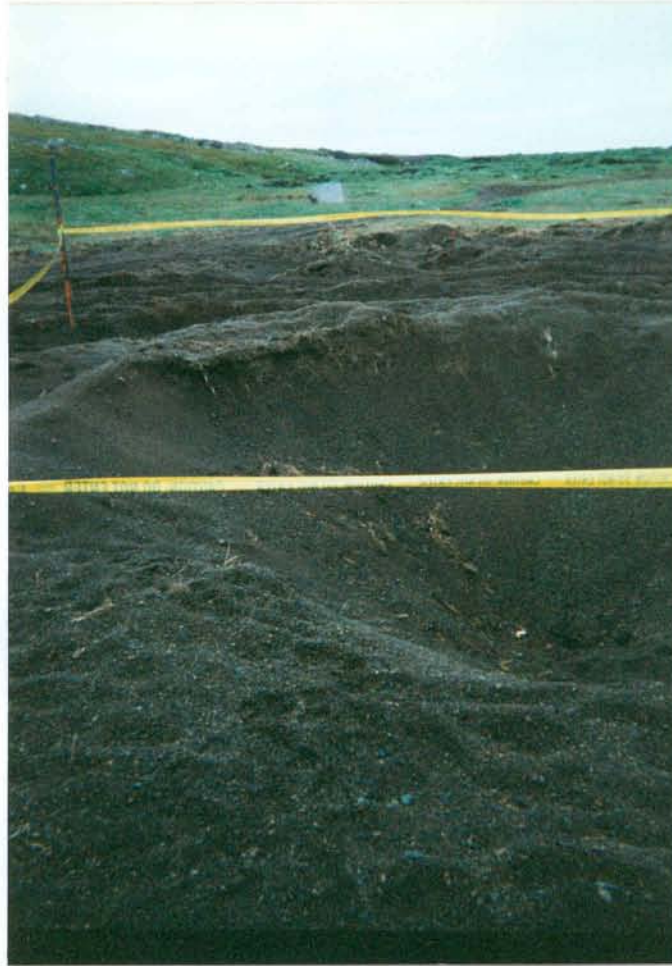
VSW pit South of Connex

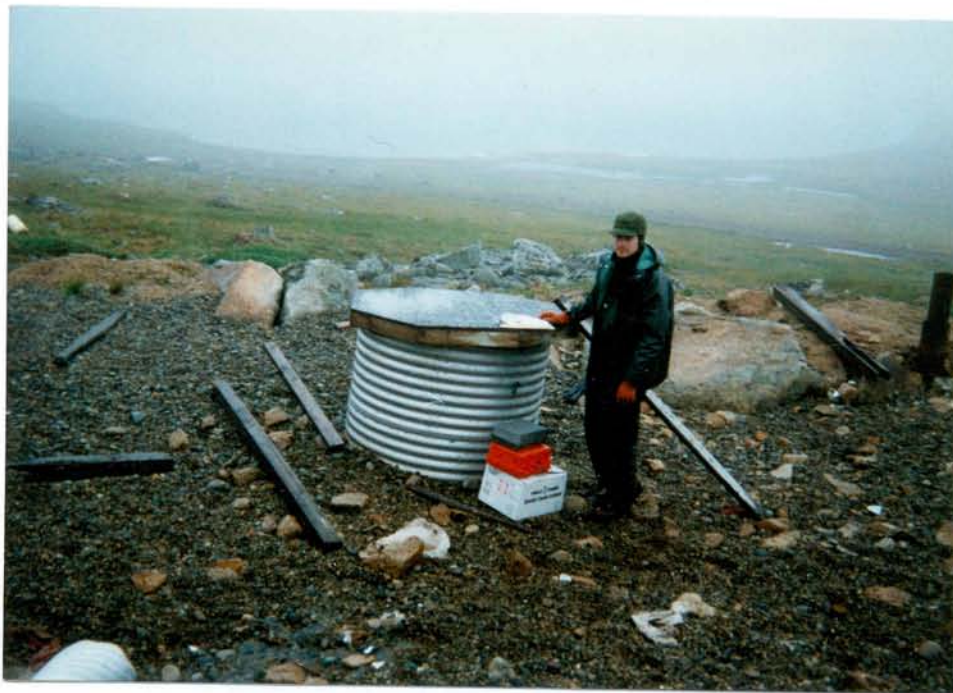
Water sampling of infiltration gallery for PCBs and BTEX. Sample #96GAMPMPHS003

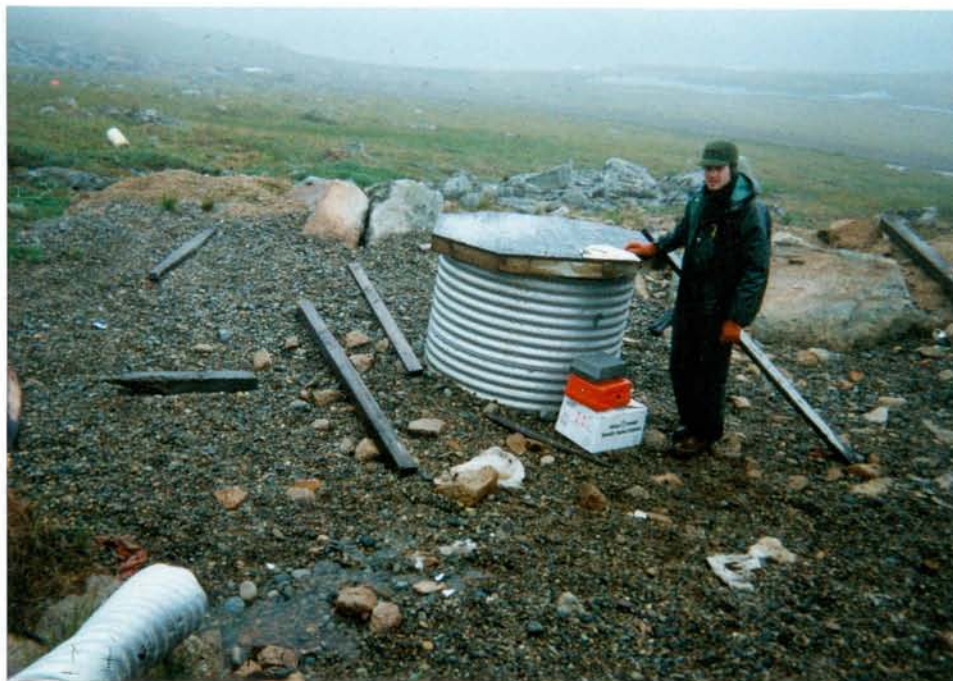
Water Sampling of infiltration gallery for PCBs and BTEX. Sample #96GAMPMPHS003

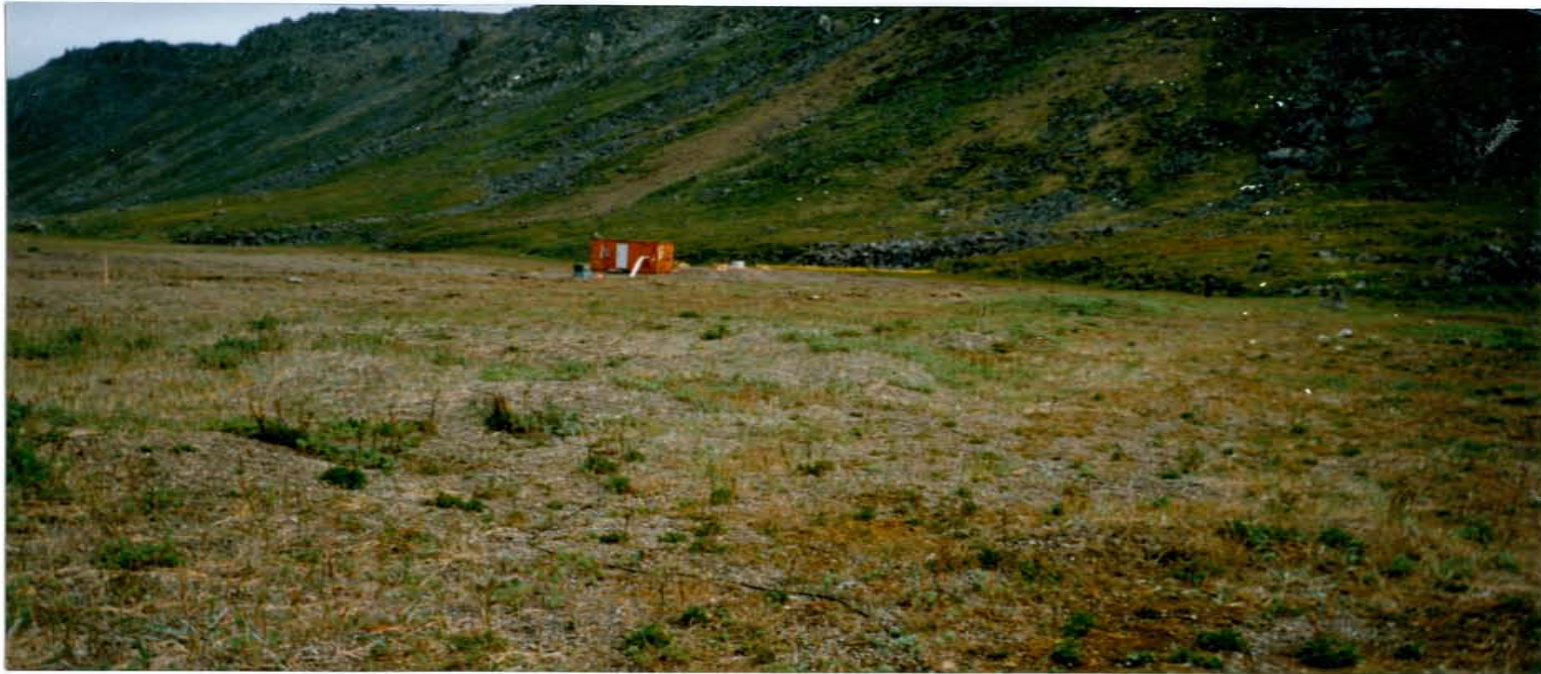
Site 5 Geophysical Grid (right side of photo shows large boulder that tramway cables were reportedly tied down to.)

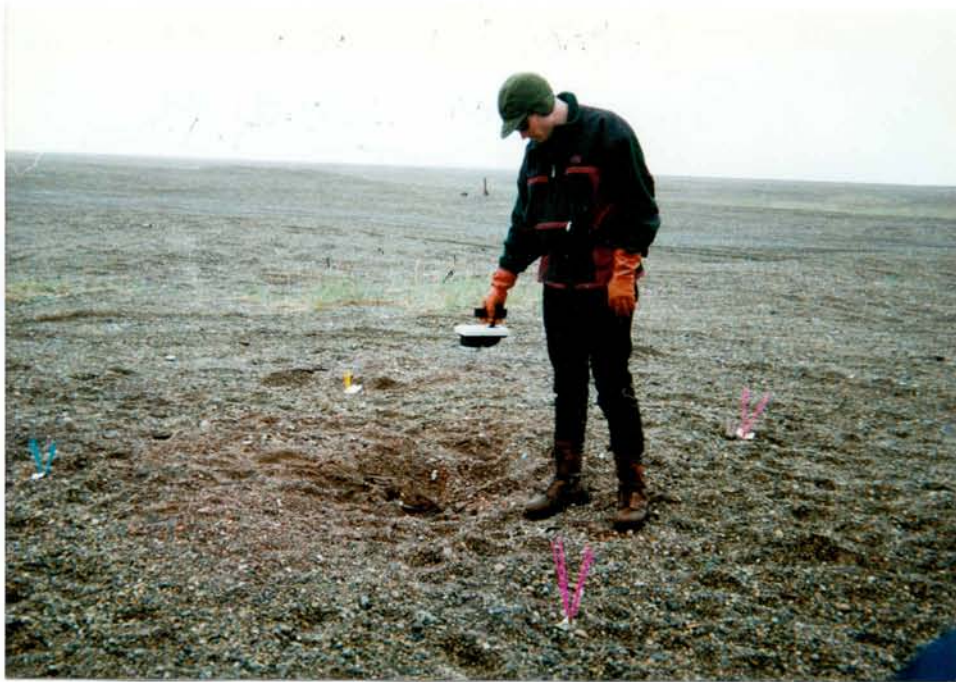
Radiological surveying at Site 2, stained area

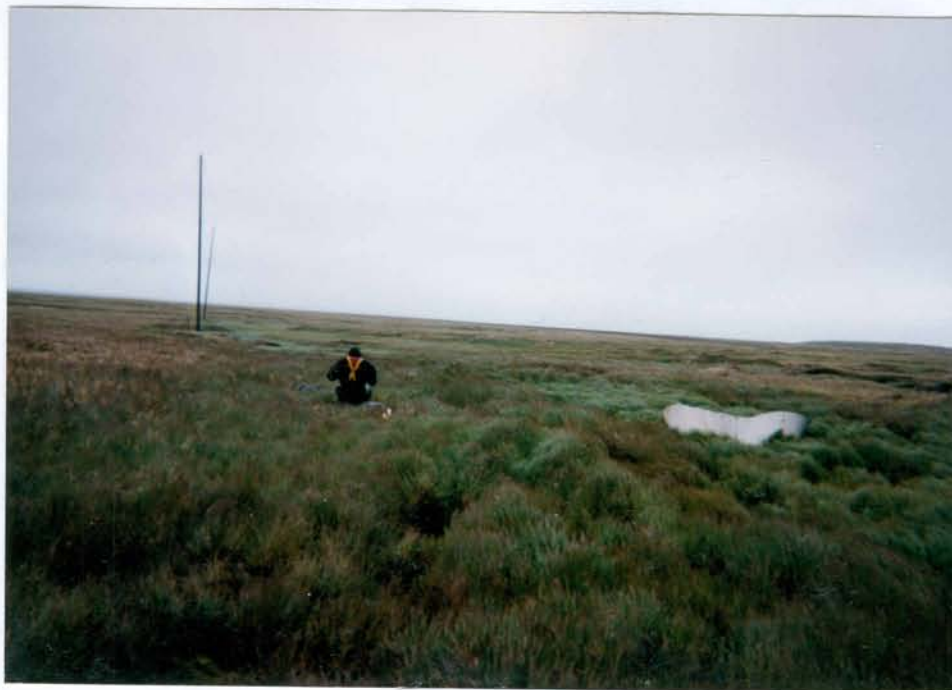
Drainage Basin, View from South, Pole 1 and 2 in foreground respectively
Note corrugated metal sheet; Doug Quist (Montgomery Watson)

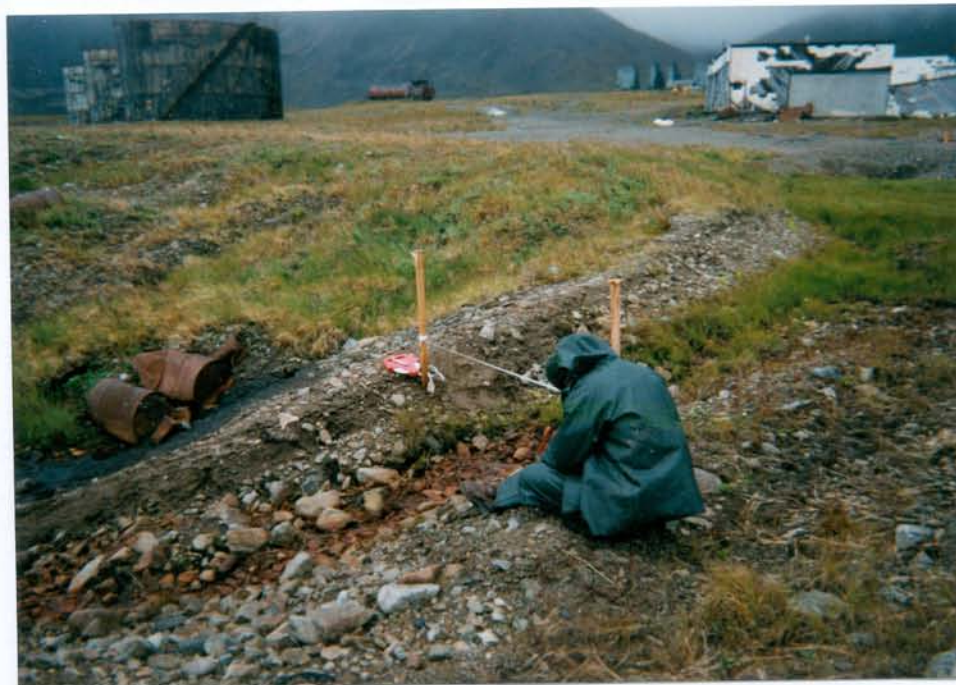
Stream Flow measurement #5

Drainage Basin; view from North, located just North of Site 27.

Note: drums and surface soil staining

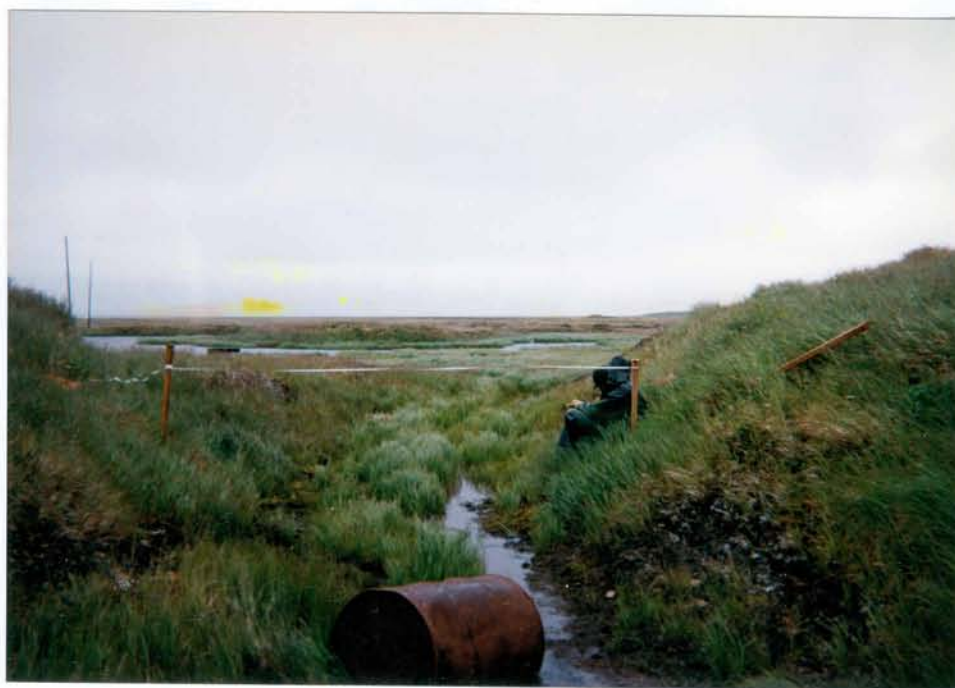
Drainage Basin; view from South, located just North of Site 27.
Stream Flow measurement #6
Note: 55 gal. drum (empty)
Doug Quist (Montgomery Watson)

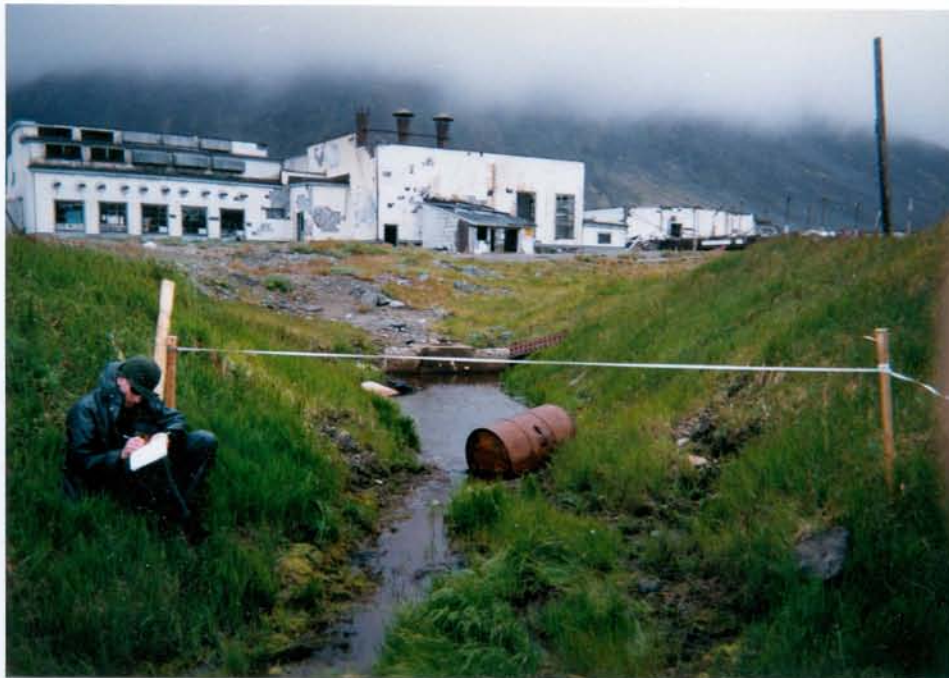
Stream Flow measurement #6

Drainage Basin; view from North, located just North of Site 27.

Note empty 55 gal. drum, manhole in center.

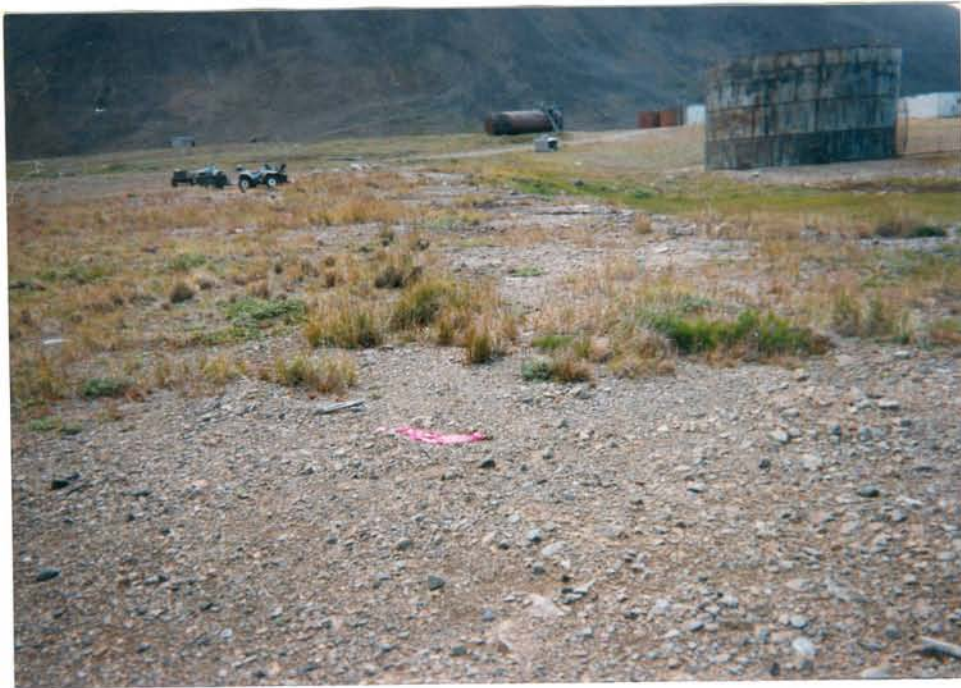
Site 10 - surface soil, Sample - SS106

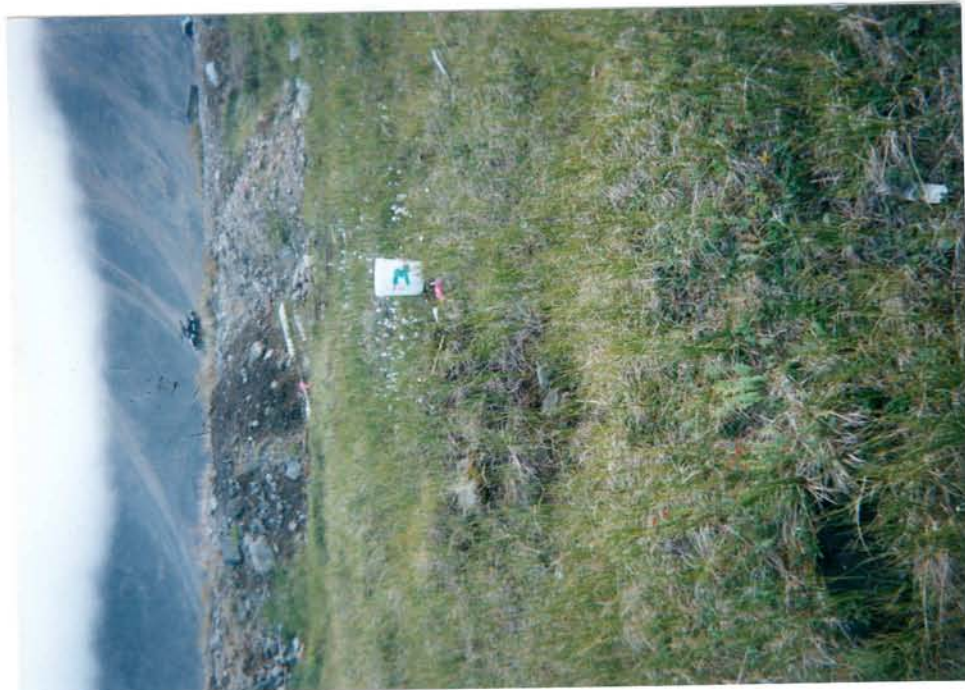
Site 10, Surface soil sample - SS107

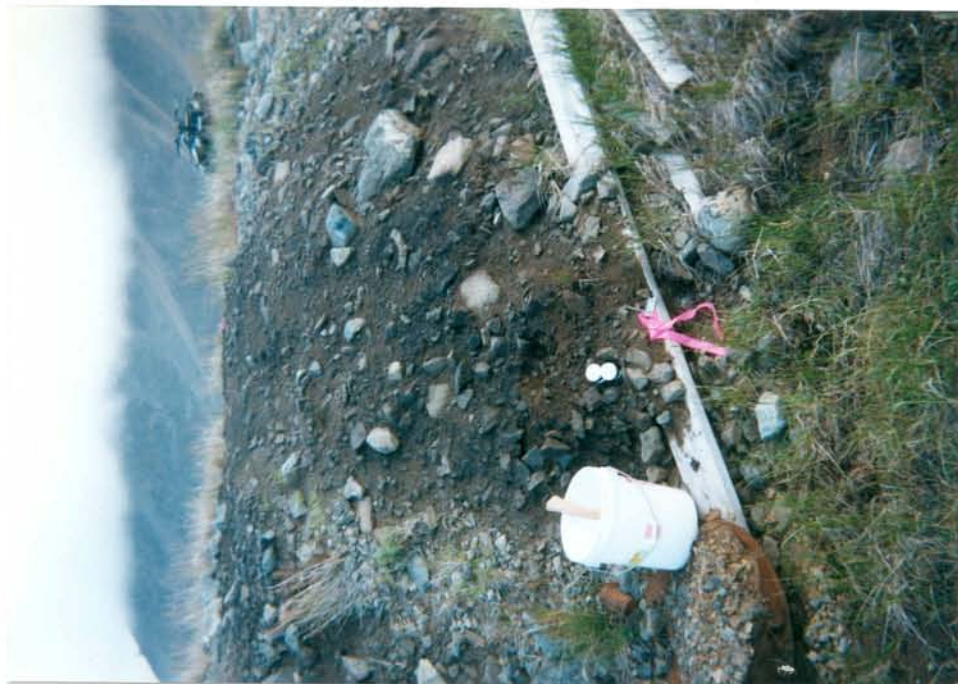
Site 10: Surface soil sample SS107 in background, SS108 in foreground

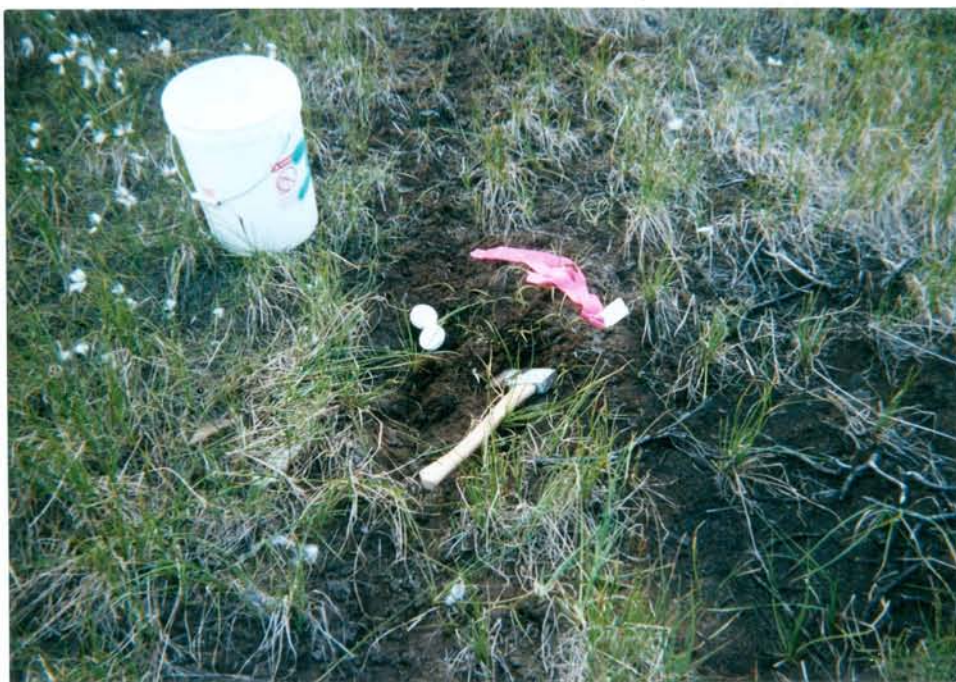
Site 10; Surface soil sample - SS108

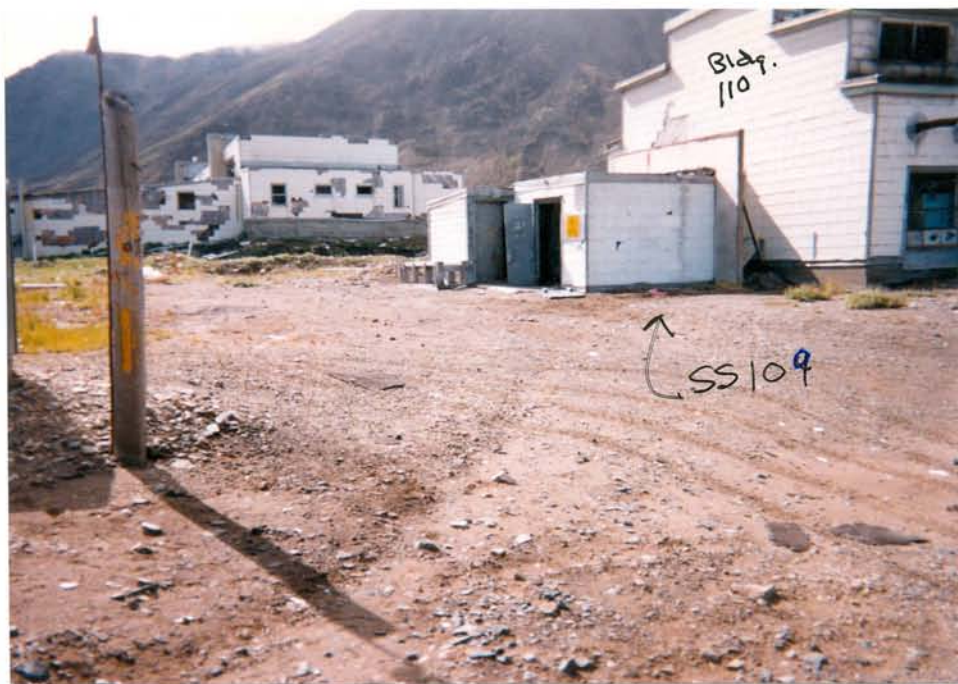
Site 13 Building 110, Surface Soil Sample - SS109

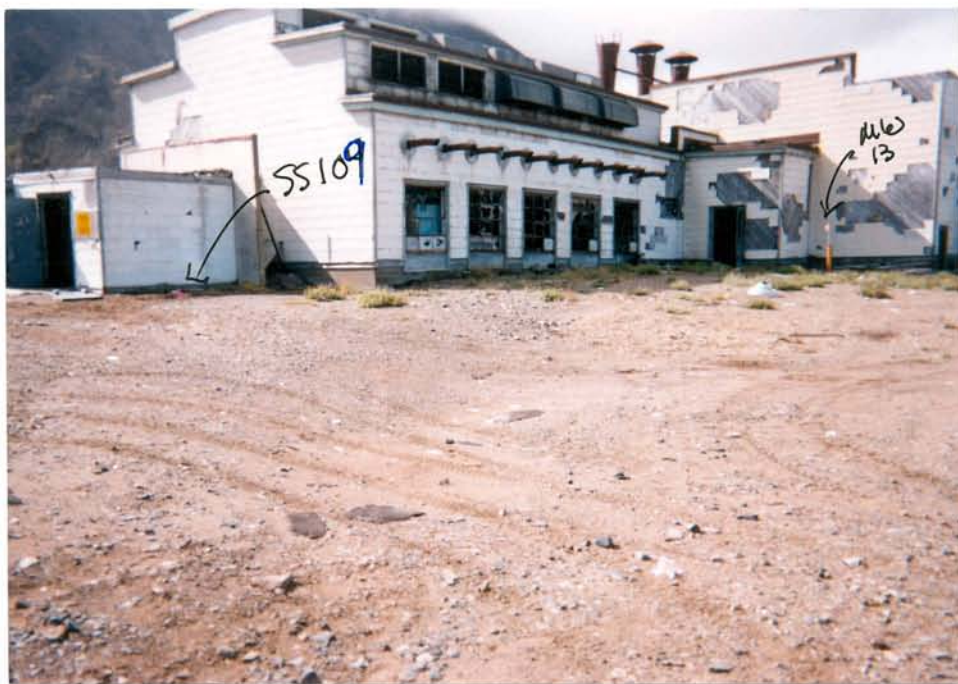
Site 13 Building 110, Surface Soil Sample - SS109
