**United States Army Corps of
Engineers, Alaska District**

**Phase II Remedial Investigation
Gambell,
St. Lawrence Island, Alaska**

Photographs - August, 1996

**Phase II Remedial Investigation
Northeast Cape,
St. Lawrence Island, Alaska**

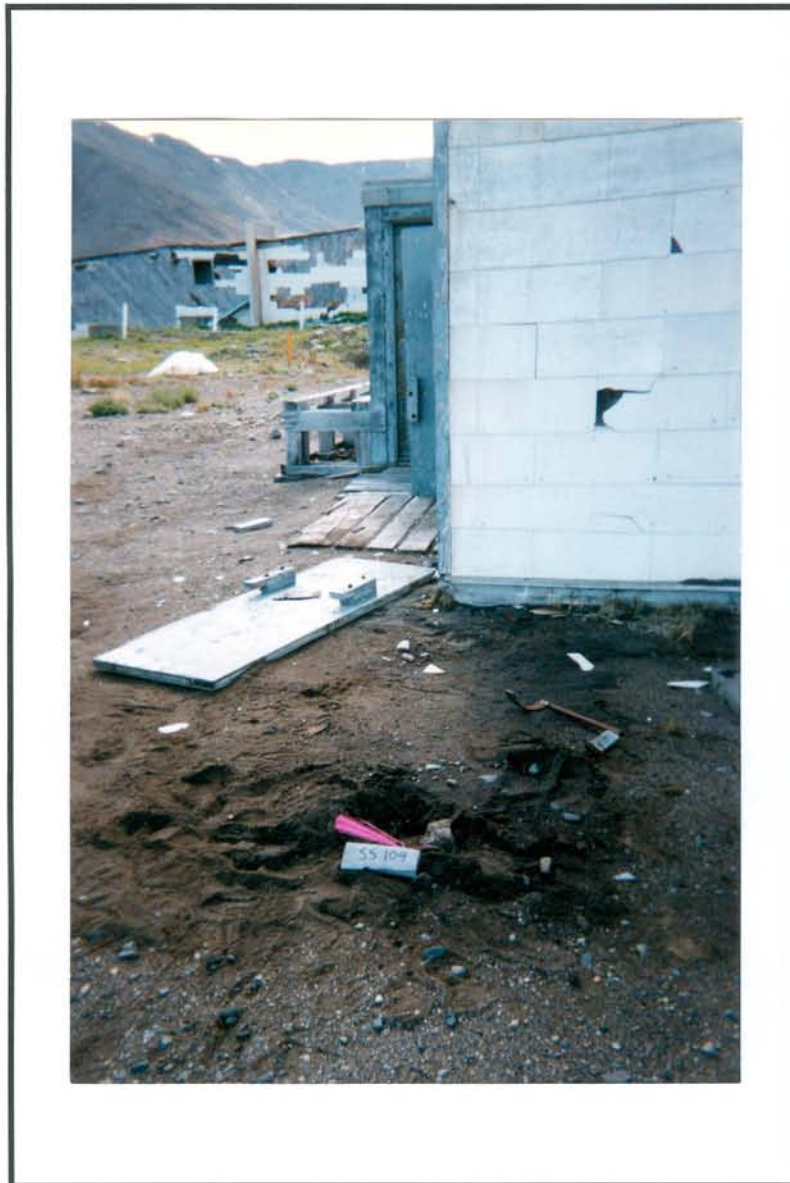
Site 13 Northeast corner, Surface Soil Sample - SS109

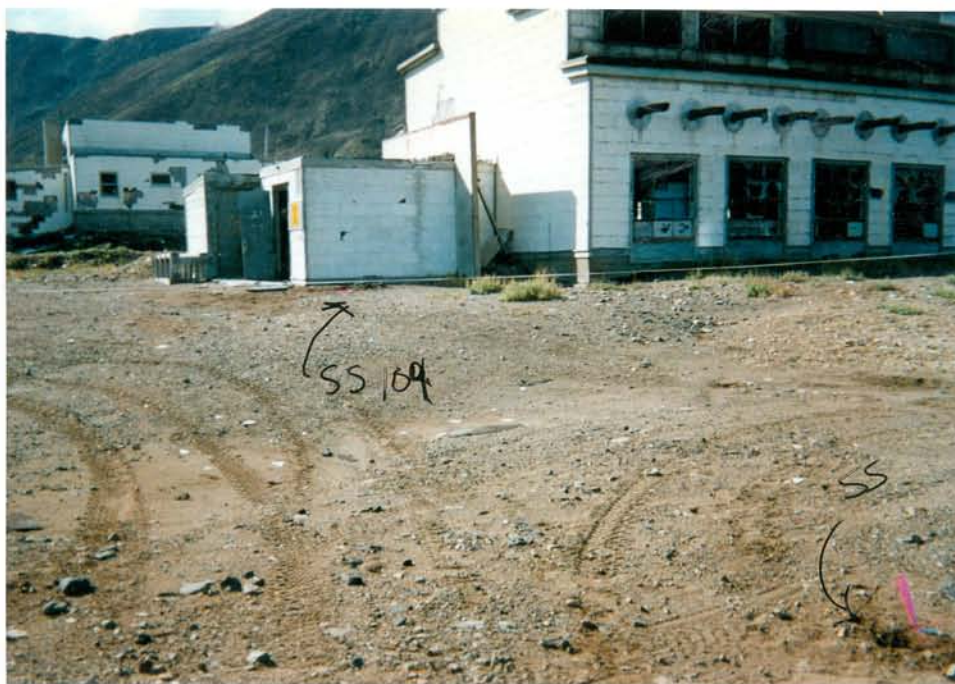
Site 13 Surface Soil Sample - SS109

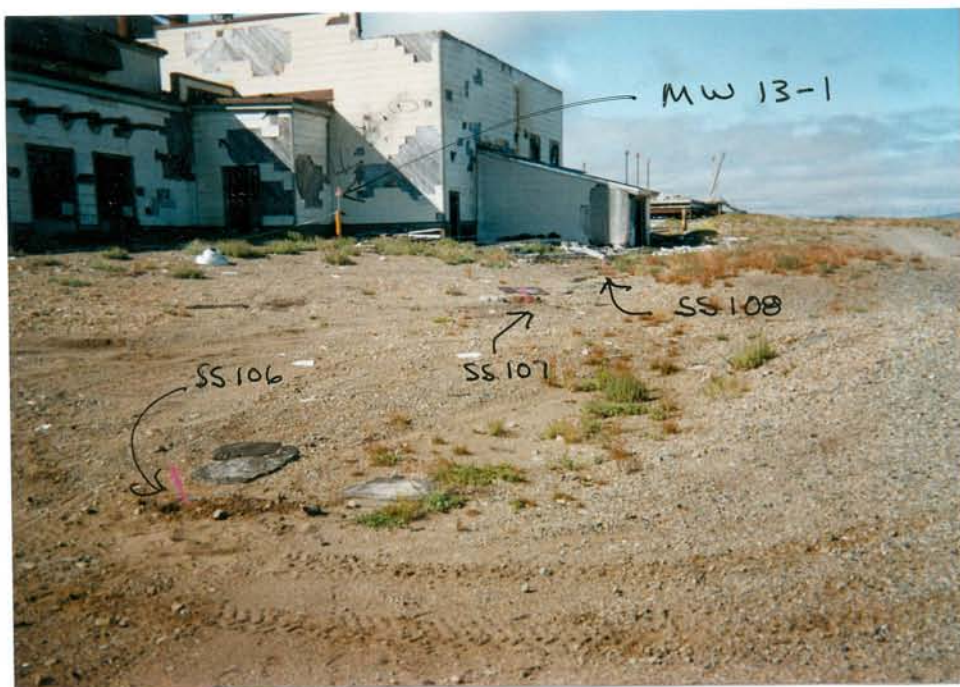
Site 13 Building 110, Surface Soil Samples - SS106, SS107, and SS108

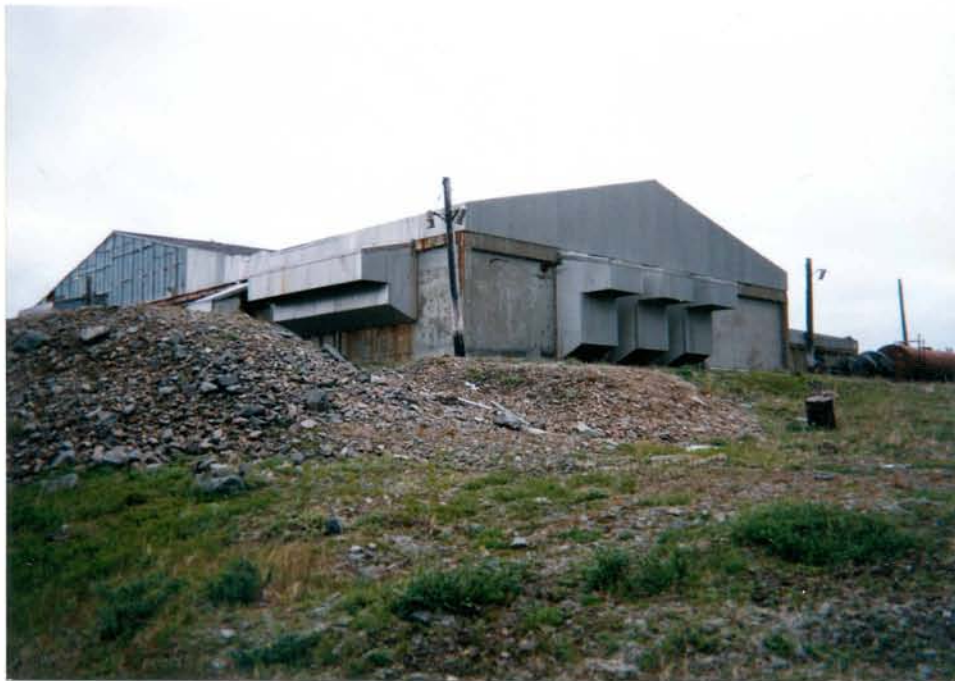
Site 14, view from Southwest. Emergency Heat and Electrical Building. Drum 14-2 in center (filled with antifreeze)

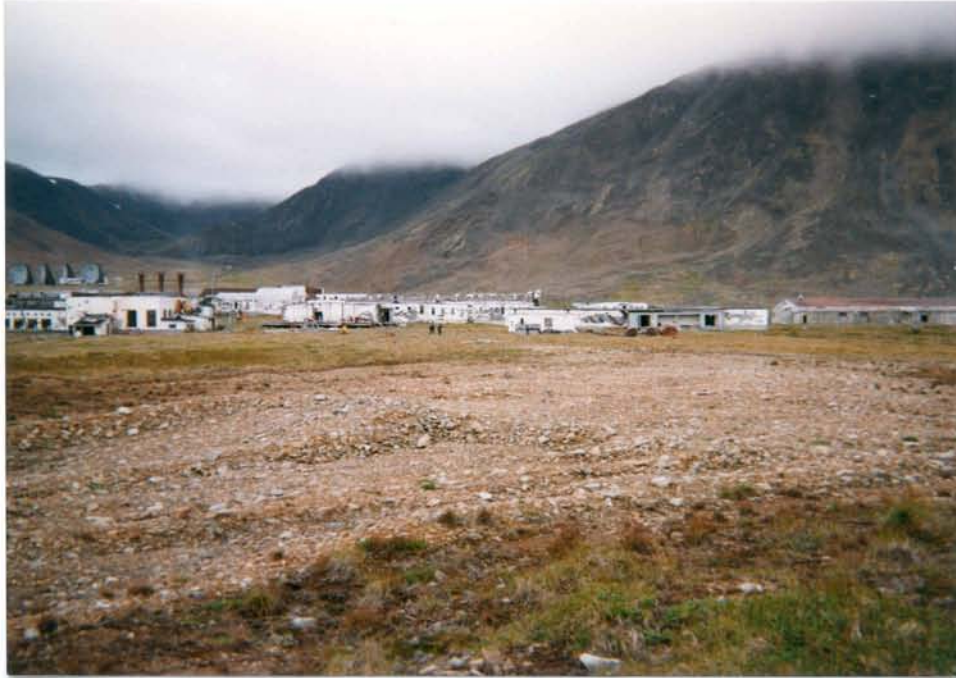
Site 16: Paint Dope Storage Building, View from North, Building in center background
Area of reported fuel burning (Toolic, 96) in foreground

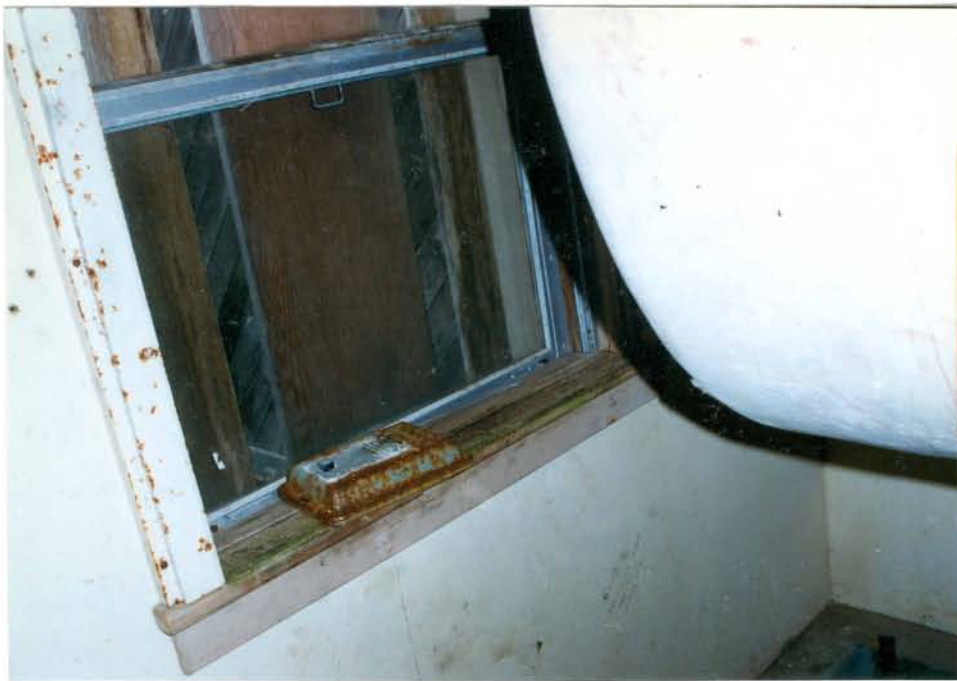
Site 18 Building 101 West: AST (500 gal.) ACM cover above opening to below ground plumbing room

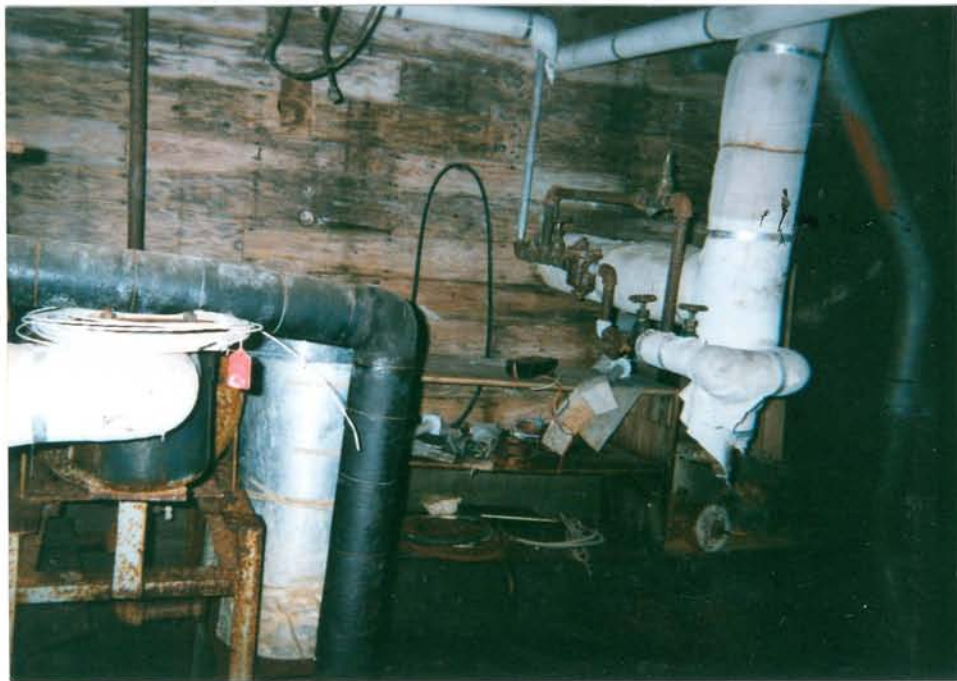
Site 18 Building 101 West - Below ground plumbing room. PACM on elbows

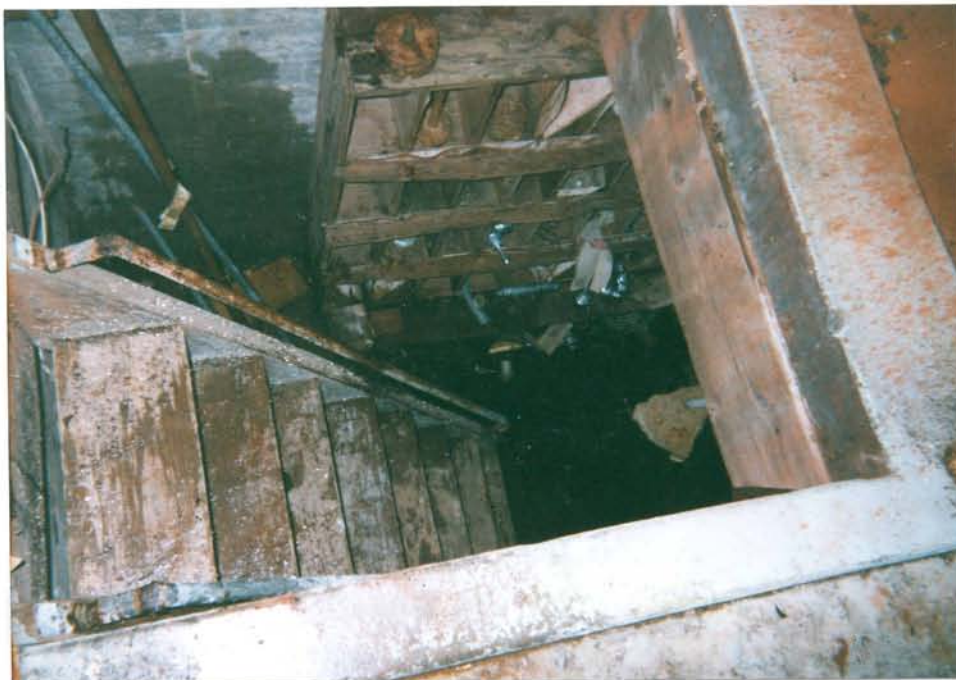
Basement water sampling at Building 101. 96NEC001SW, 96NEC011SW-Dupe, and 96NEC021SW-Split

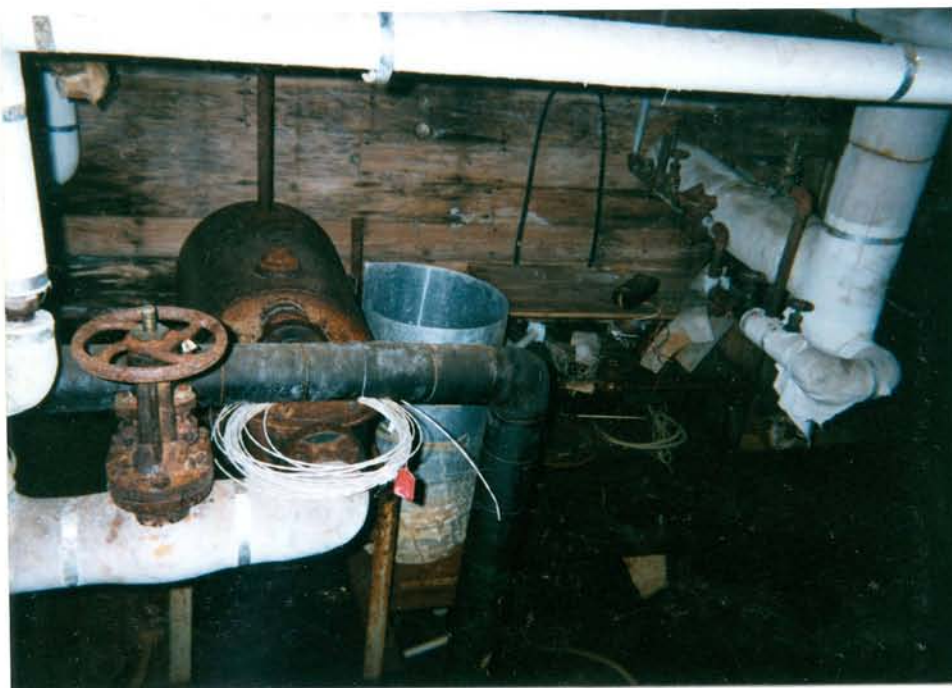
Site 18 Building 101 West: Below ground Plumbing Room, PACM on elbows.

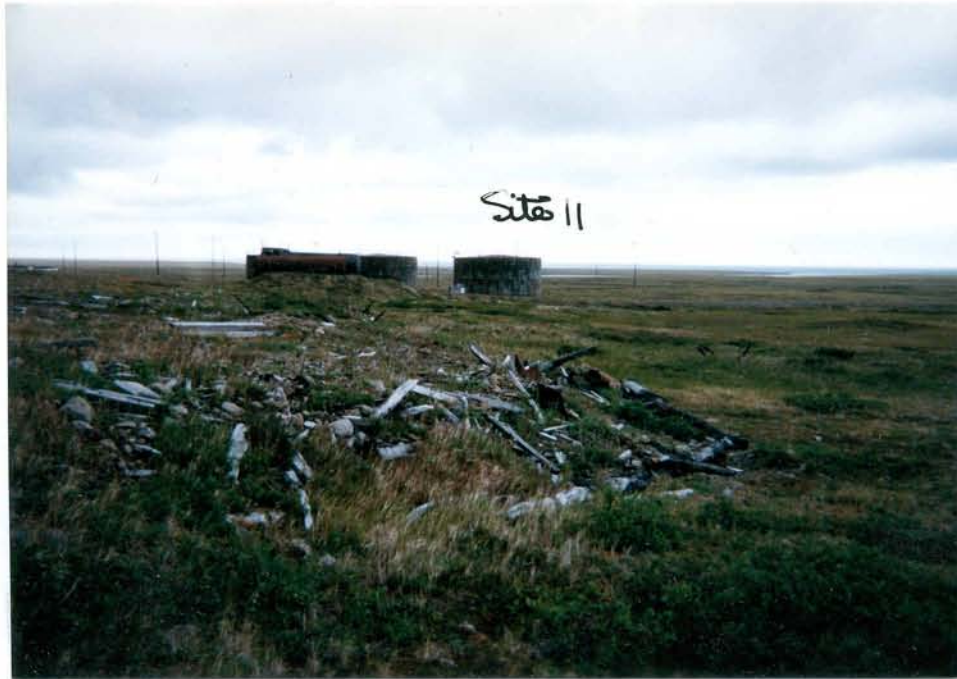
South of Site 18 & 22, Debris on gravel pad. Site 11 in background

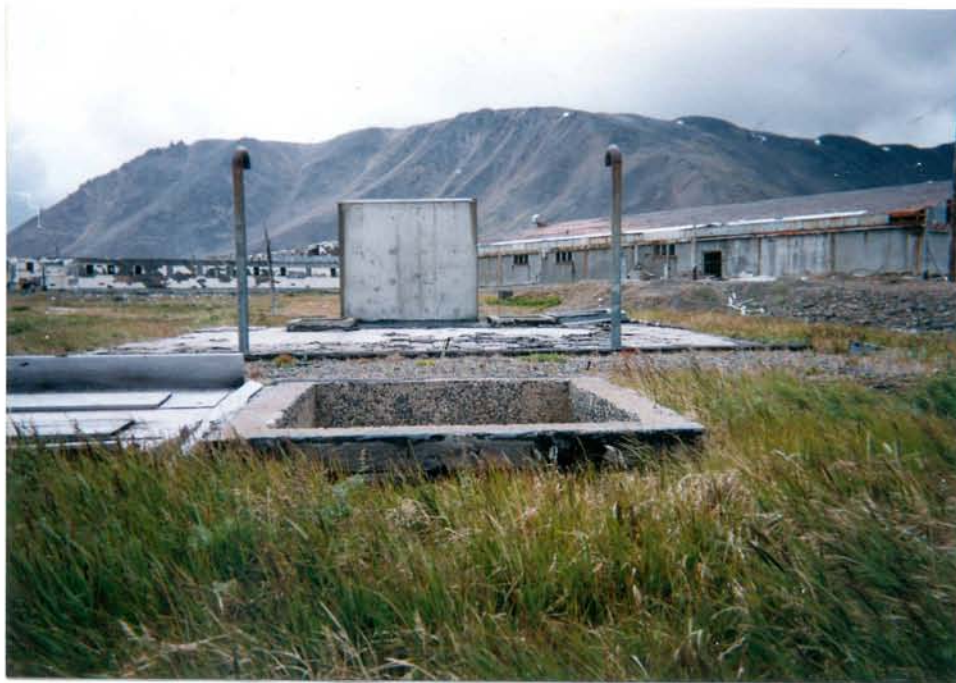
Site 21, view from Northwest. Wastewater Treatment Facility
Note: 3 open Cistern Hatches and 2 vent pipes

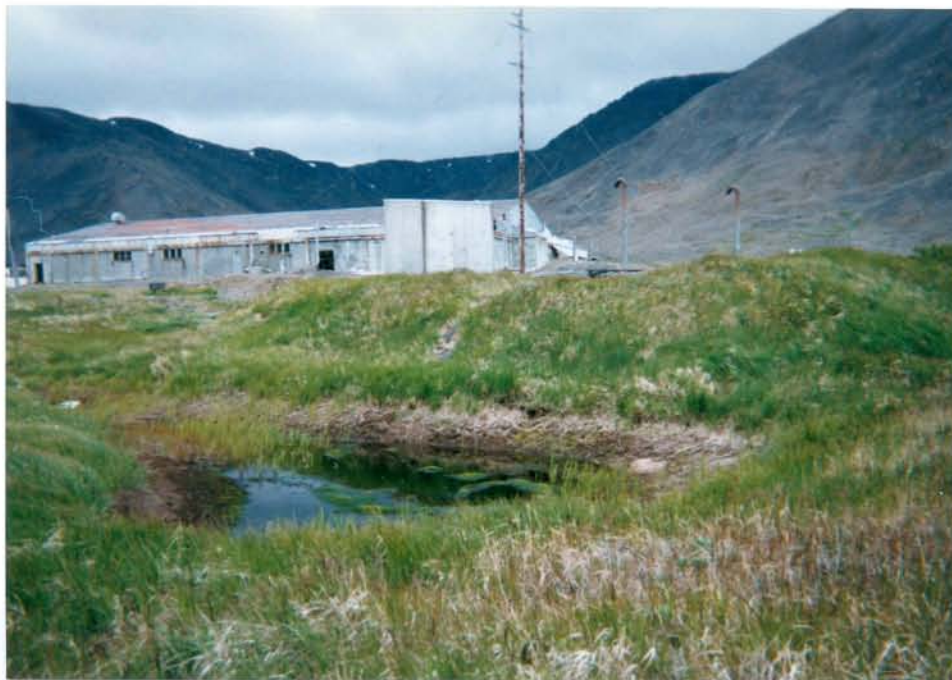
Site 21 Wastewater Treatment Facility, view from North Standing water North of cisterns. Site 14 in background

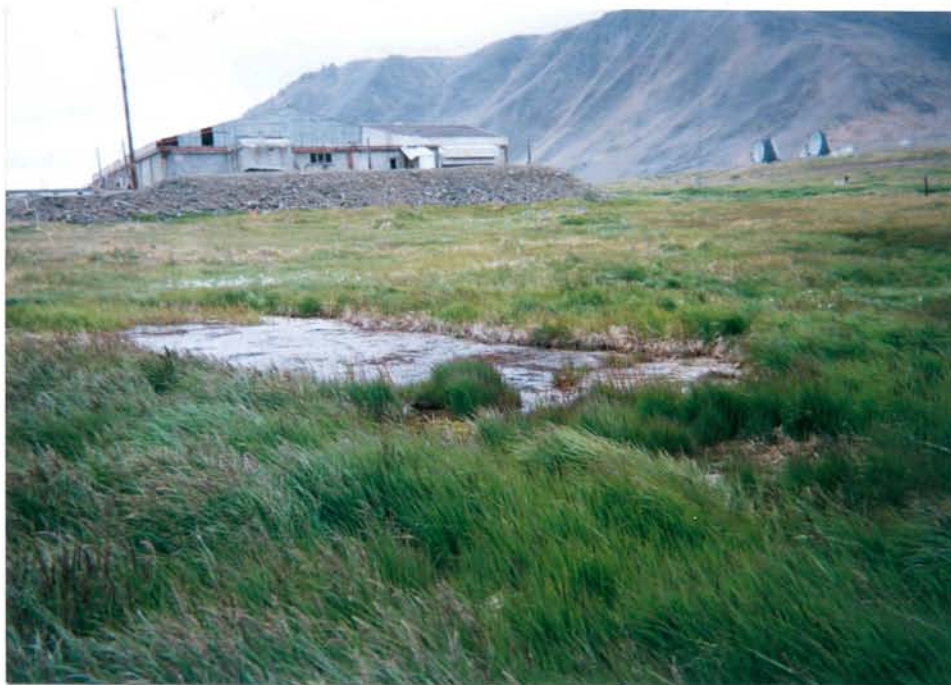
Site 21 Wastewater Treatment Facility, view from West. Site 14 in background. Standing water South of Outfall

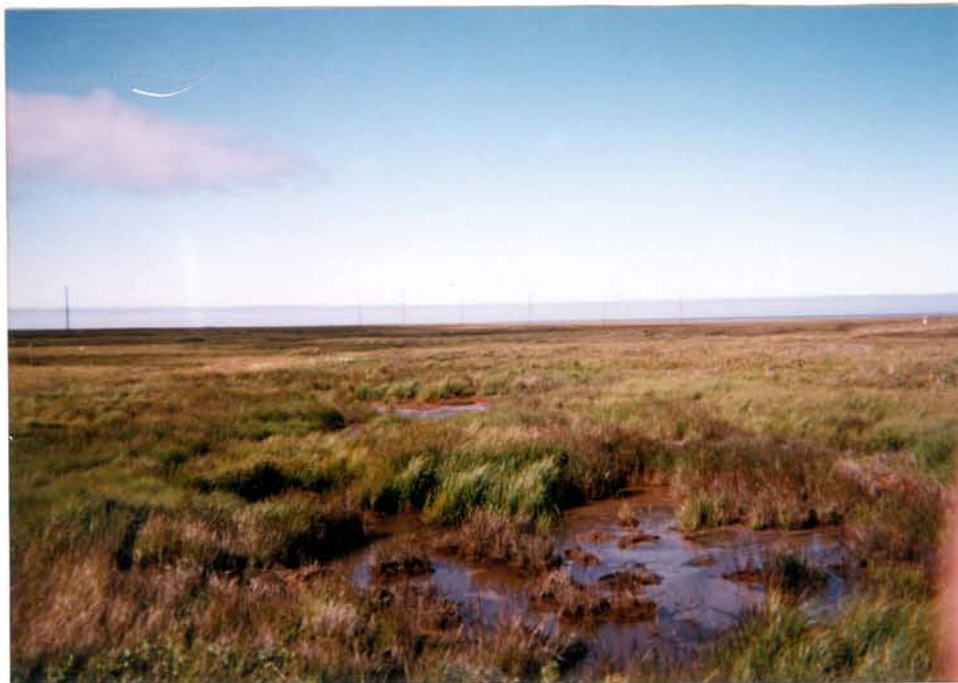
Northwest of Site 21, Standing water with floating organic material

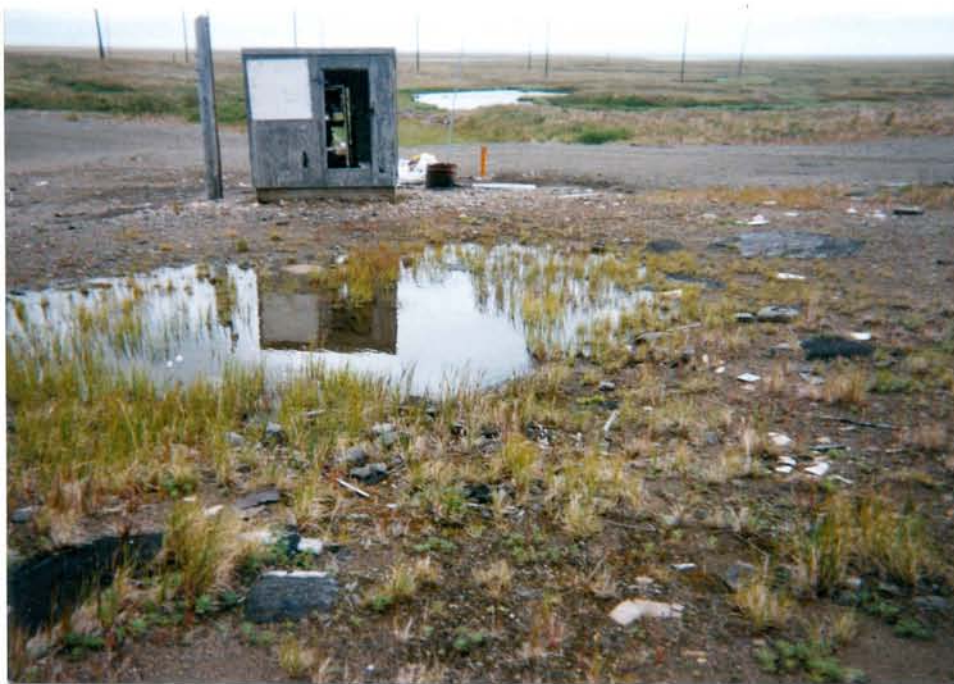
Site 27: Diesel Fuel Pump Island, looking North. Note: Standing water, no sheen seen

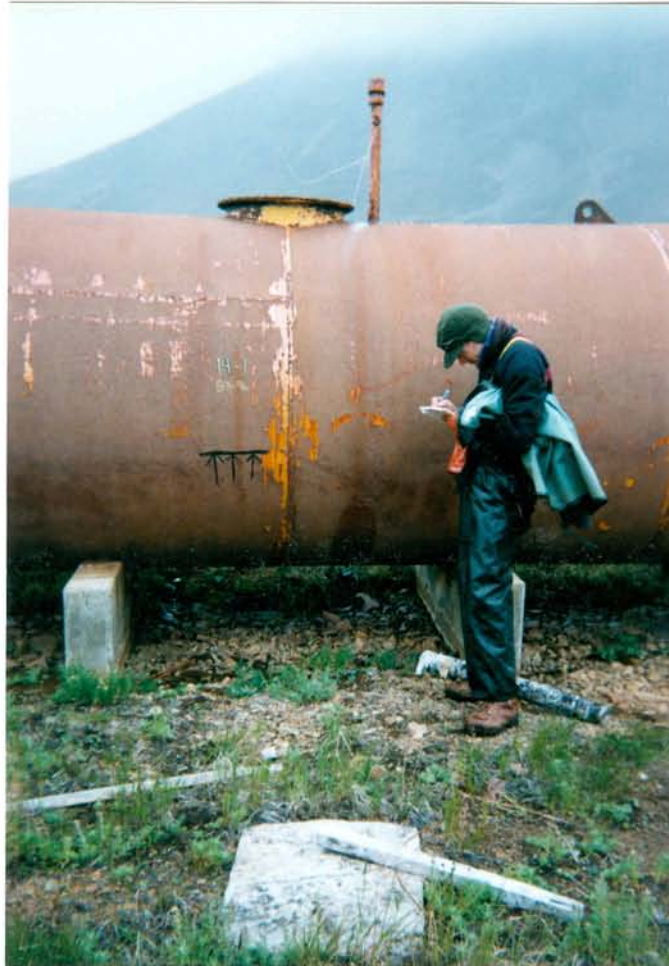
Site 14 Tank 14-1
Sampler Doug Quist (Montgomery Watson)
Note approximate fill level of rainwater (arrows)

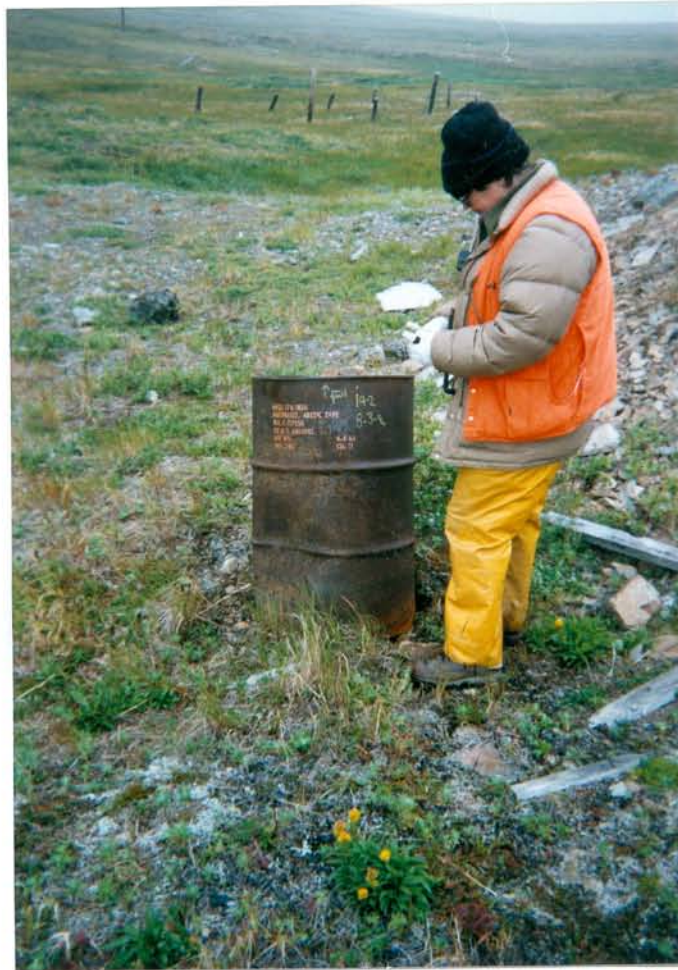
Site 14 Tank 14-2
55-Gal. drum full of antifreeze
Bonnie McLean (Montgomery Watson)

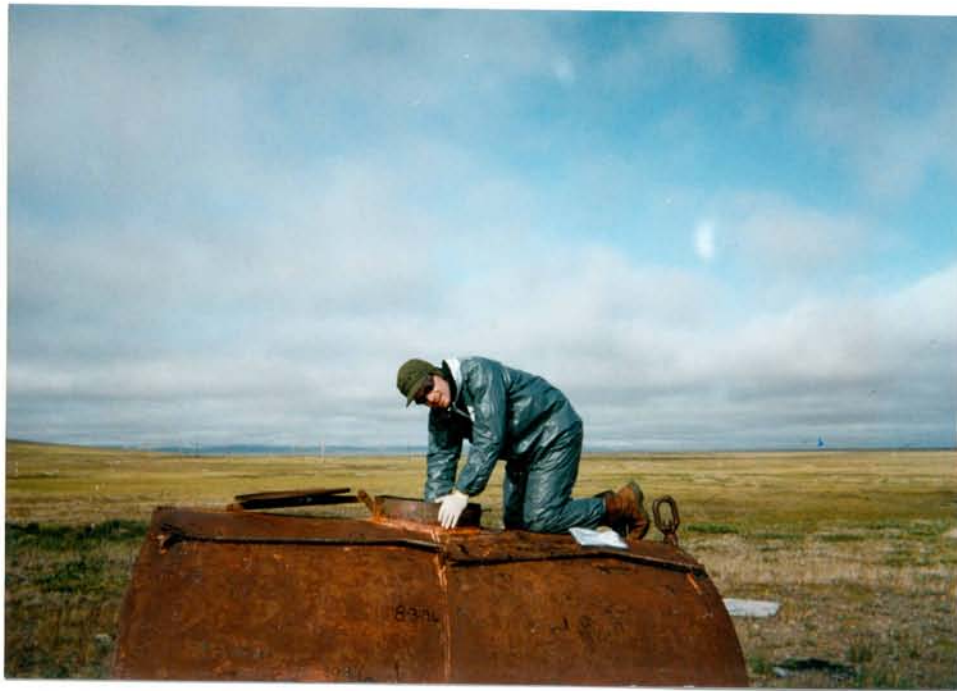
Site 16 Tank 16-1, Looking Northwest; Sampling by Doug Quist (Montgomery Watson)

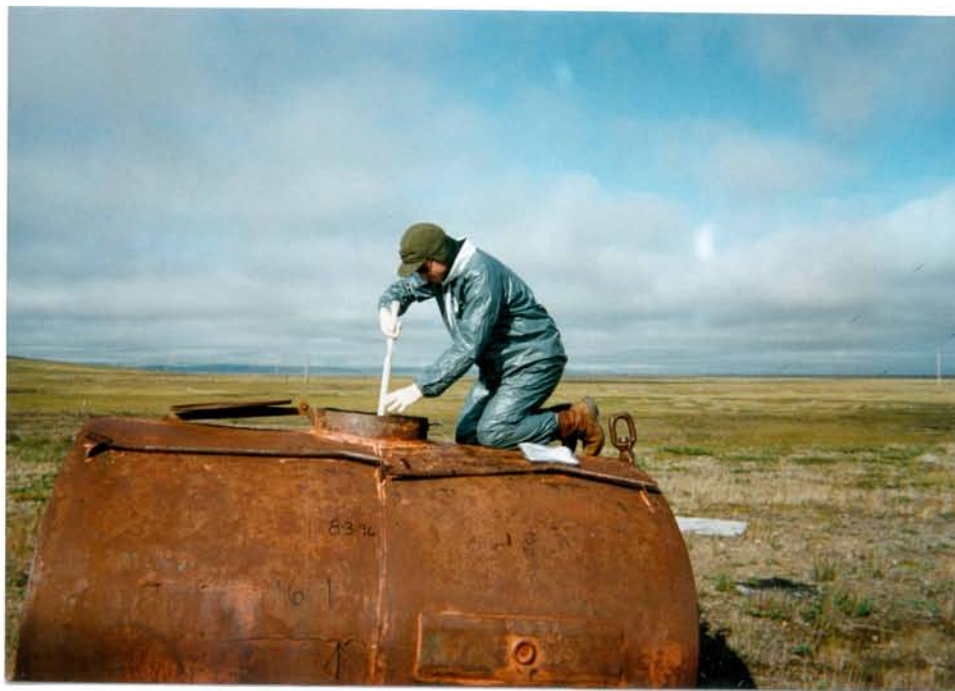
Site 16 Tank 16-1 Looking Northwest; Sampling by Doug Quist (Montgomery Watson)

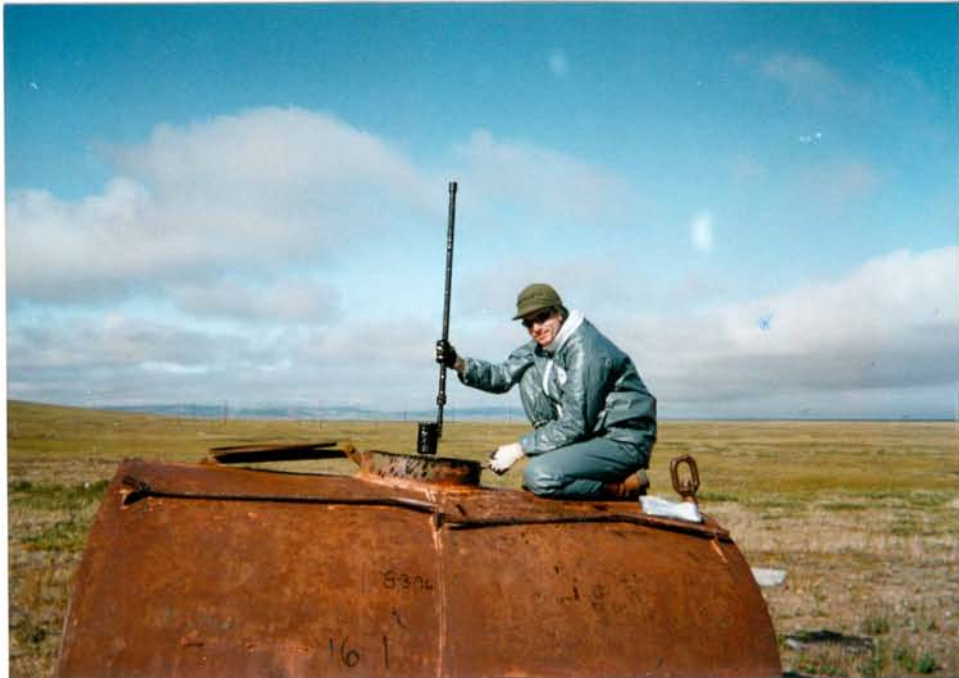
Site 16 Tank 16-1 Looking Northwest, Sampling by Doug Quist (Montgomery Watson)

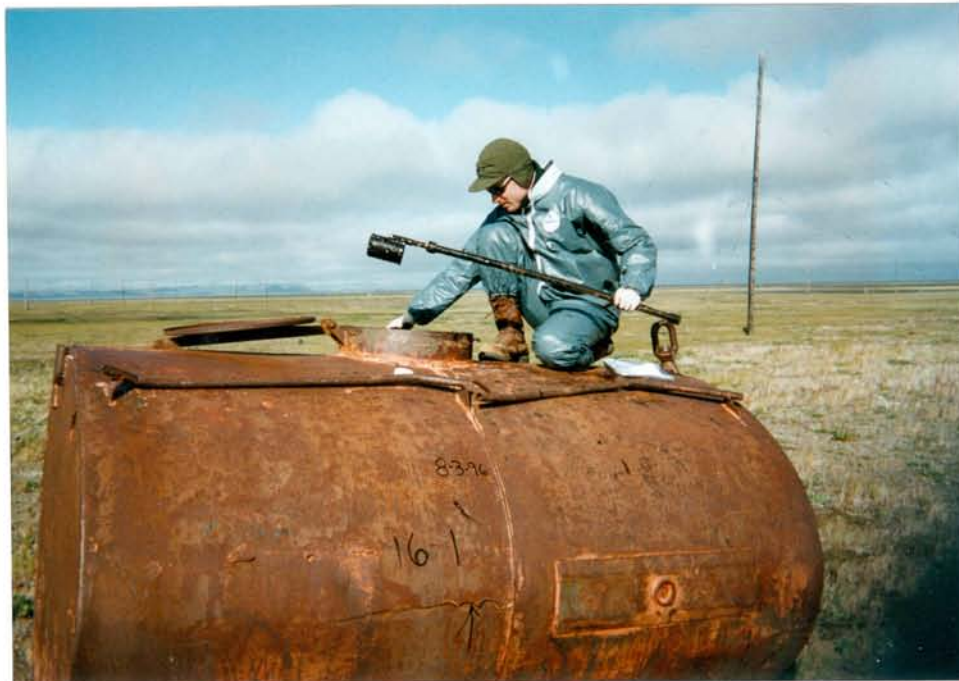
Site 16 Tank 16-1 Looking Northwest, Sampling by Doug Quist (Montgomery Watson)

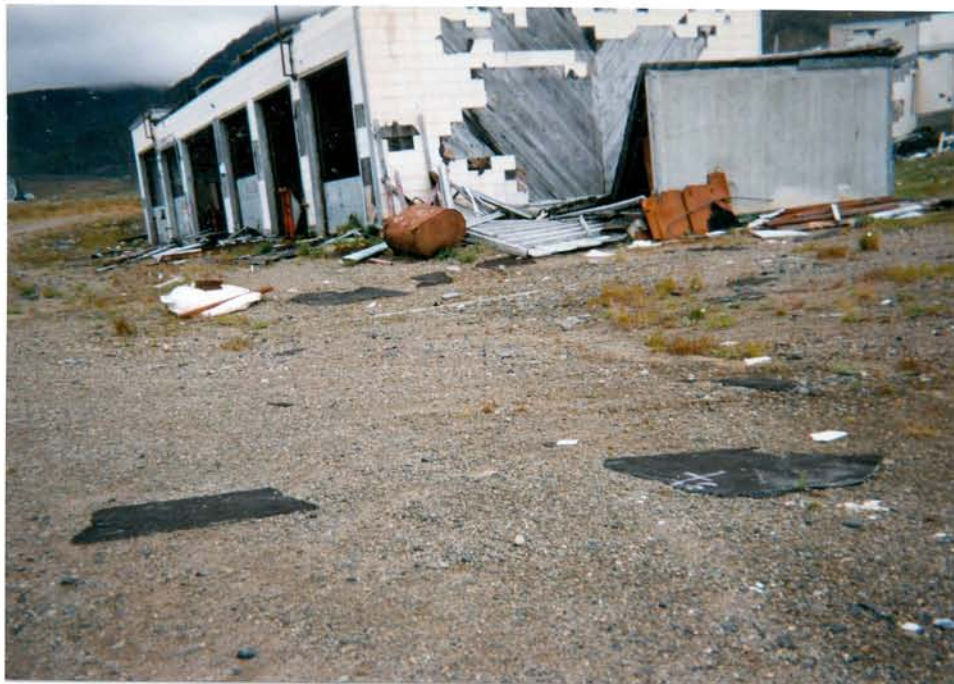
Site 19 Tank 19-1 North of Building 108

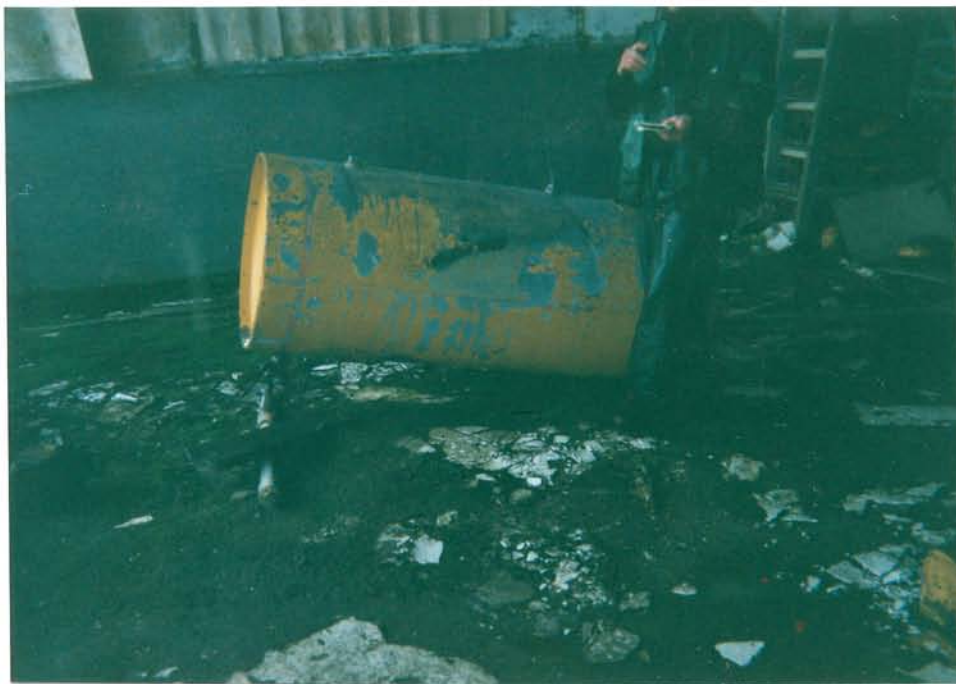
Site 19 Tank 19-2 (Empty)

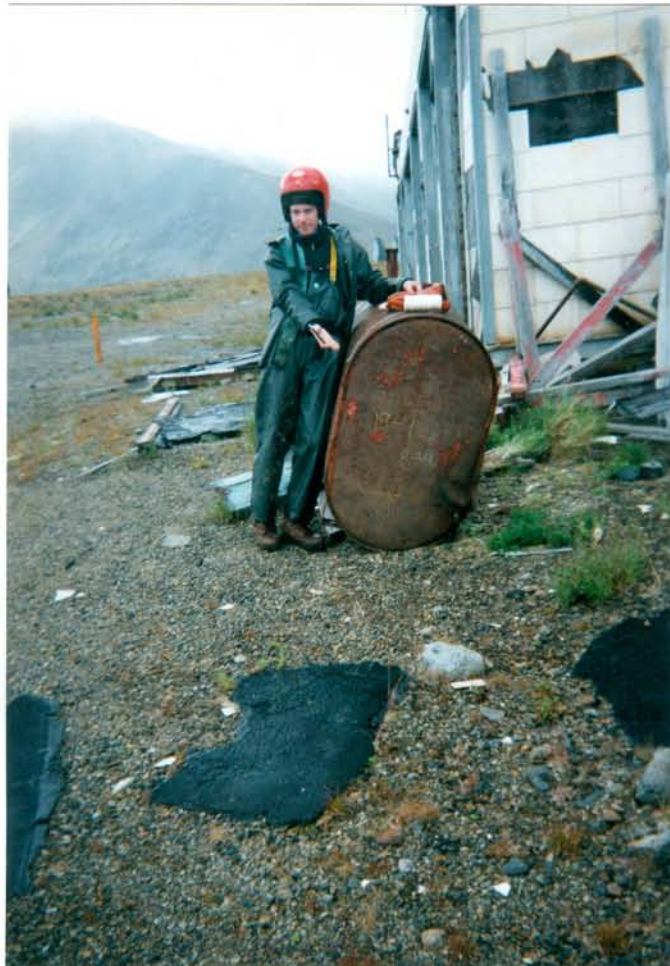
Site 19 Tank 19-1
Note fill line (arrows) Tank filled with antifreeze
Sampler Doug Quist (Montgomery Watson)

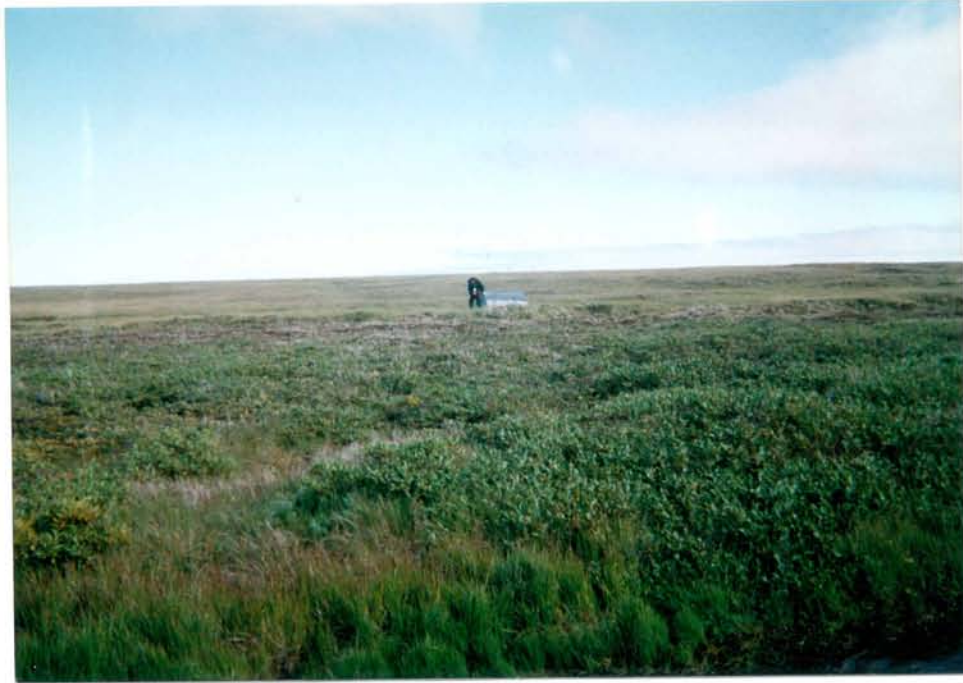
AST Tank located North of Main Camp, South of unnamed creek- Elmendorf AFB

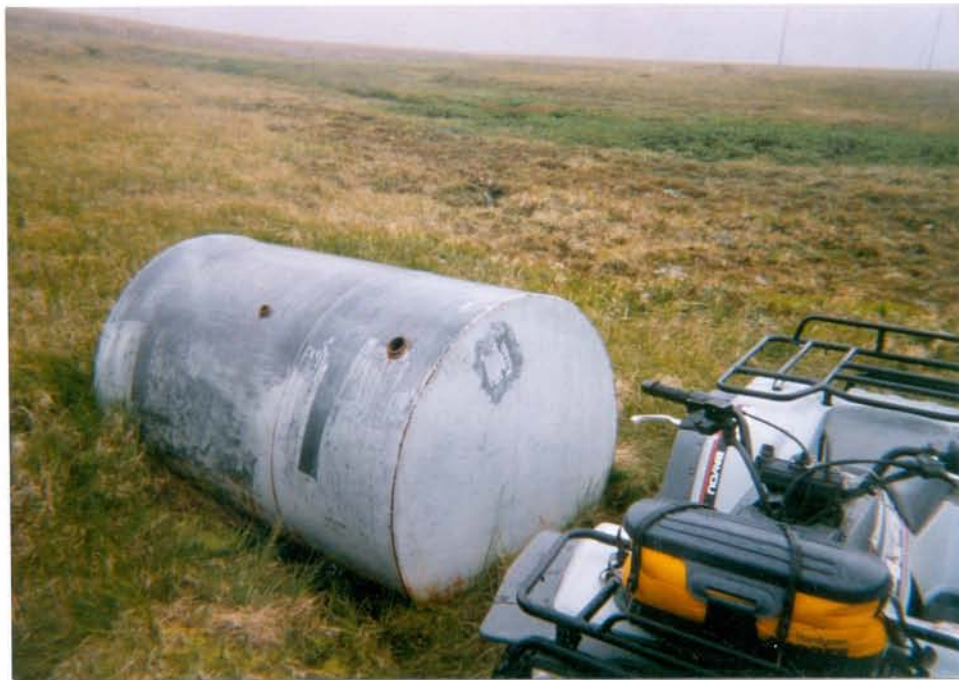
1,000 gal. AST tank (empty). Located East of unnamed creek towards Site 2

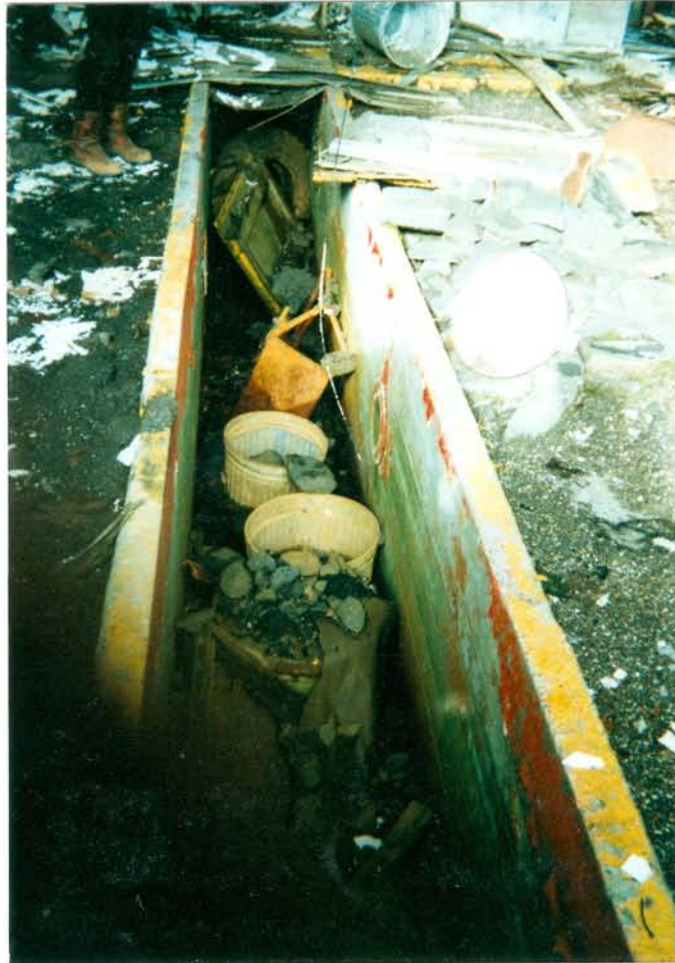
Site 19 Building 109, Mechanic Pit Sampling

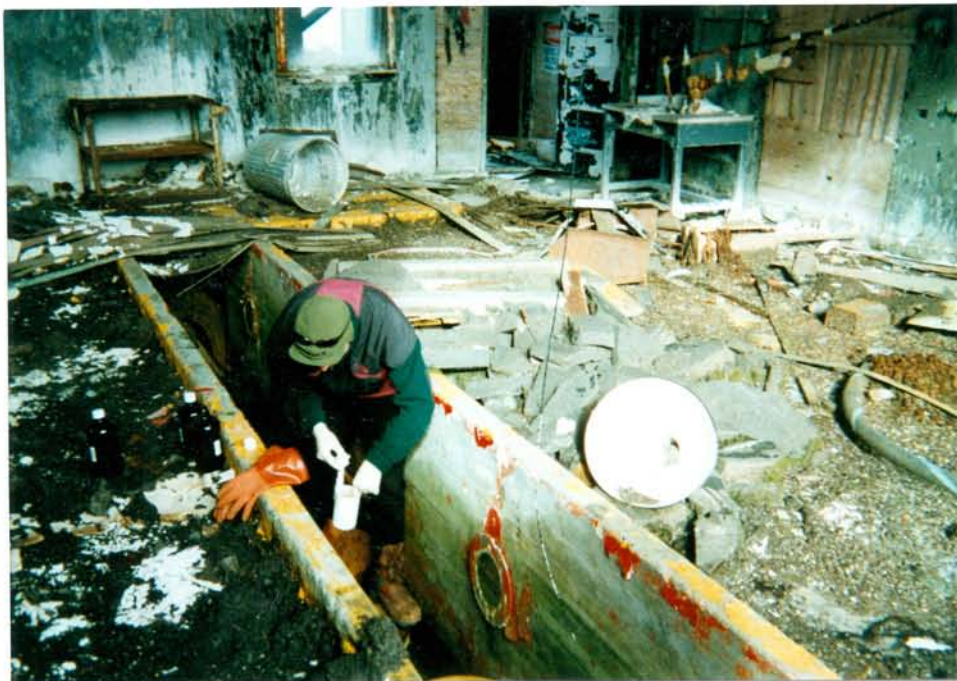
Site 19 Building 109, Mechanic Pit Sampling
Doug Quist (Montgomery Watson)

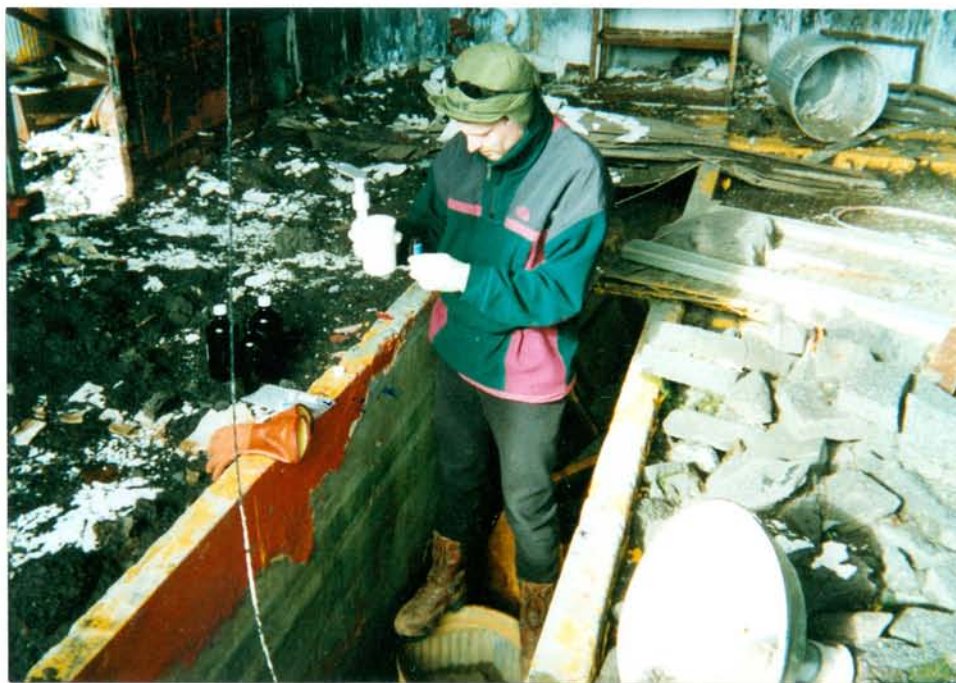
Site 19 Building 109, Mechanic Pit Sampling
Doug Quist (Montgomery Watson)

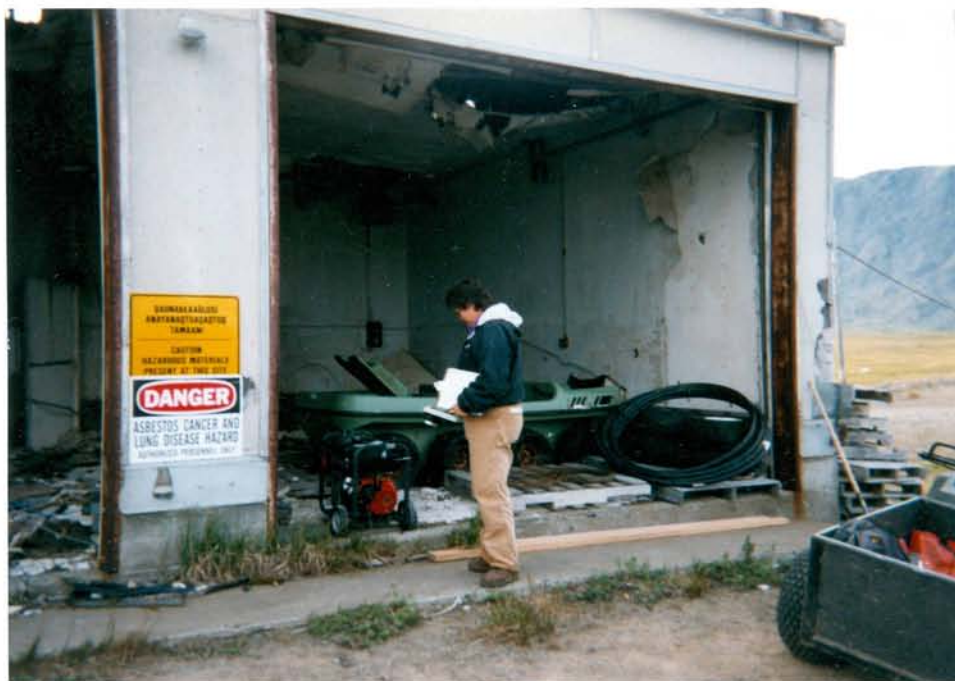
Site 2 North side of Terminal - Danger Asbestos Cancer Sign posting

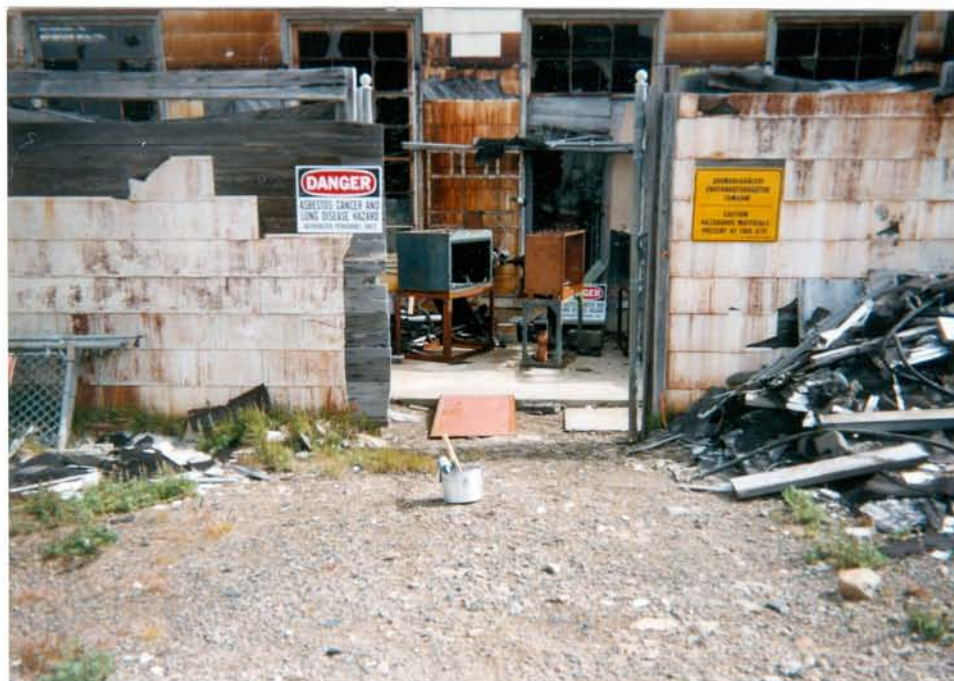
Site 13 Power Generation Building; Danger Asbestos Sign posting

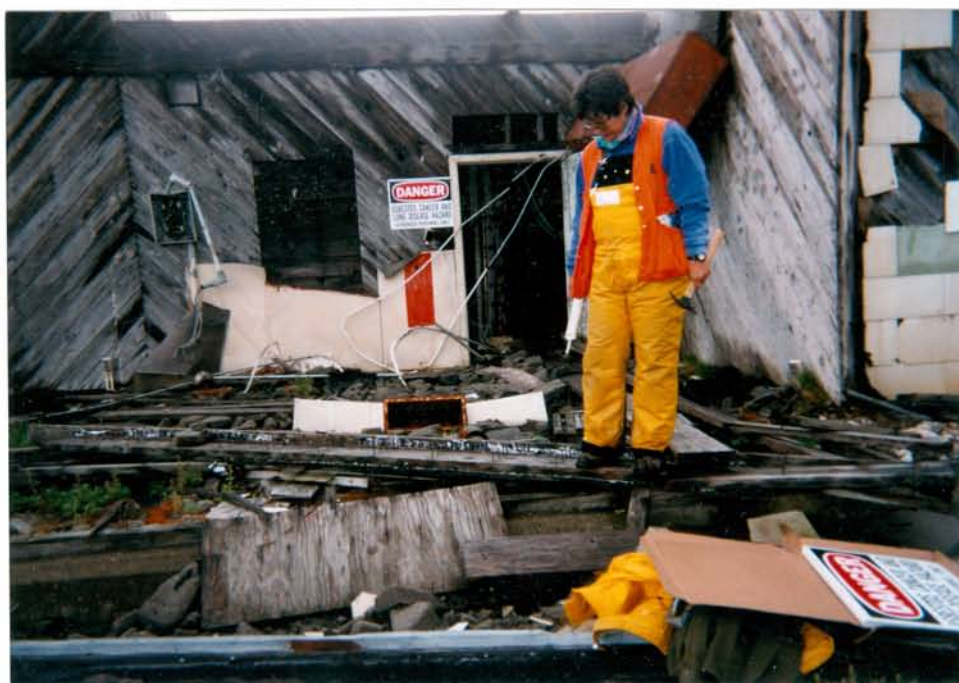
Site 13 Building 110 Power Plant North Dock, Danger Asbestos Sign posting

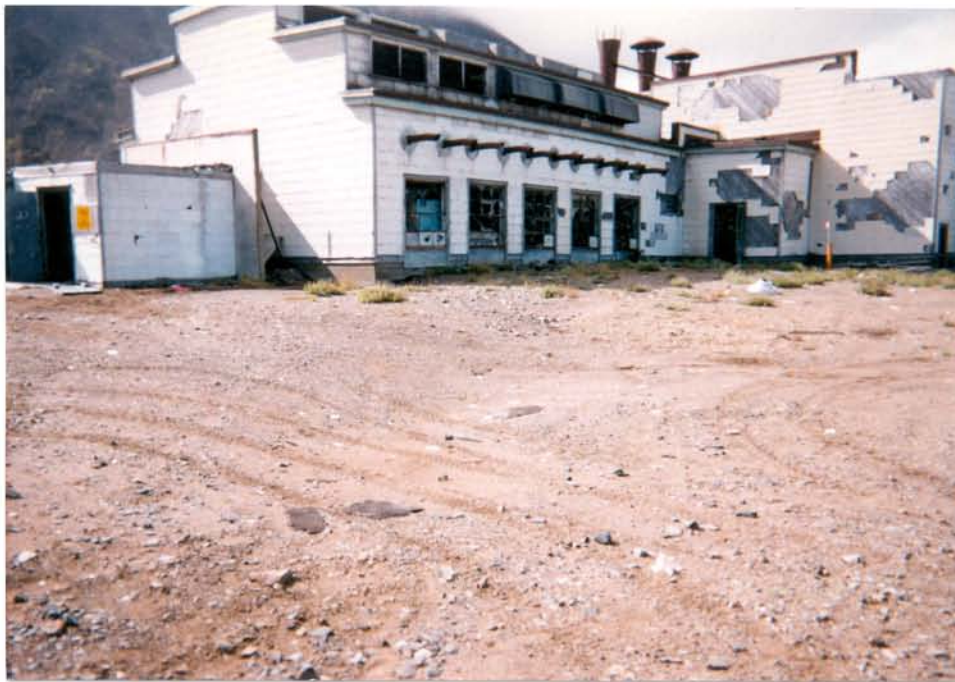
Site 13 Building 110, East entrance - Danger Sign Posting

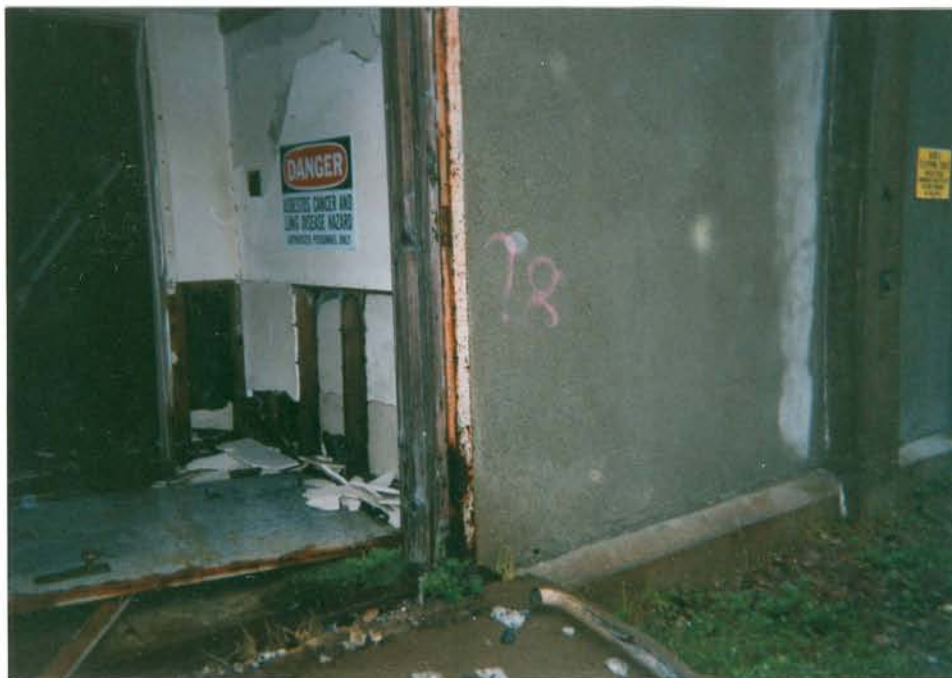
Site 14 Building 98, South Side West Door - Danger Sign Posting
