**United States Army Corps of
Engineers, Alaska District**

**Phase II Remedial Investigation
Gambell,
St. Lawrence Island, Alaska**

Photographs - August, 1996

**Phase II Remedial Investigation
Northeast Cape,
St. Lawrence Island, Alaska**

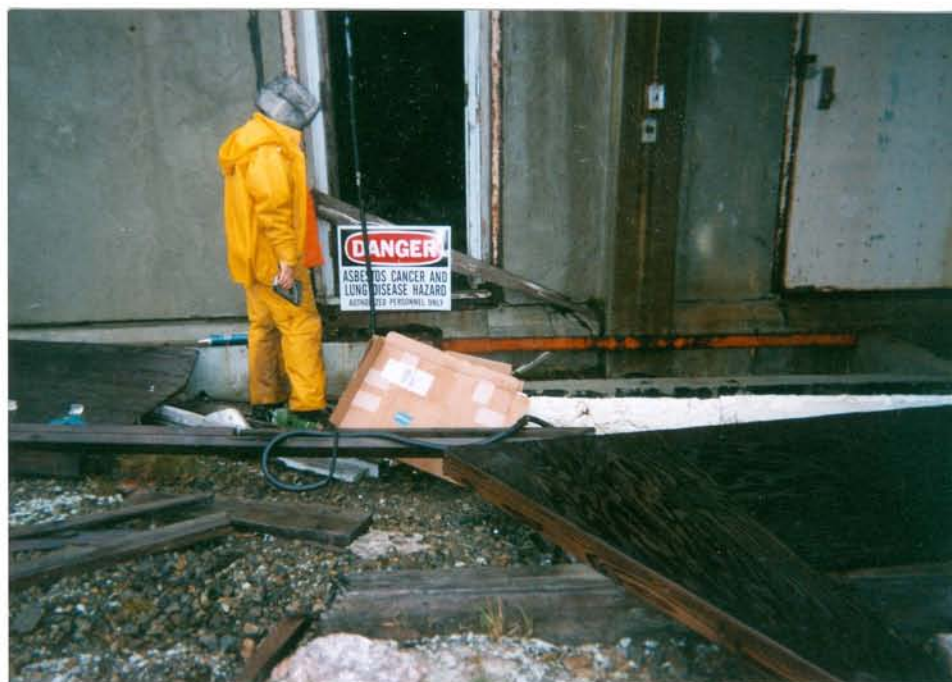
Site 14 Building 98 West Side, South Door - Danger Sign Posting

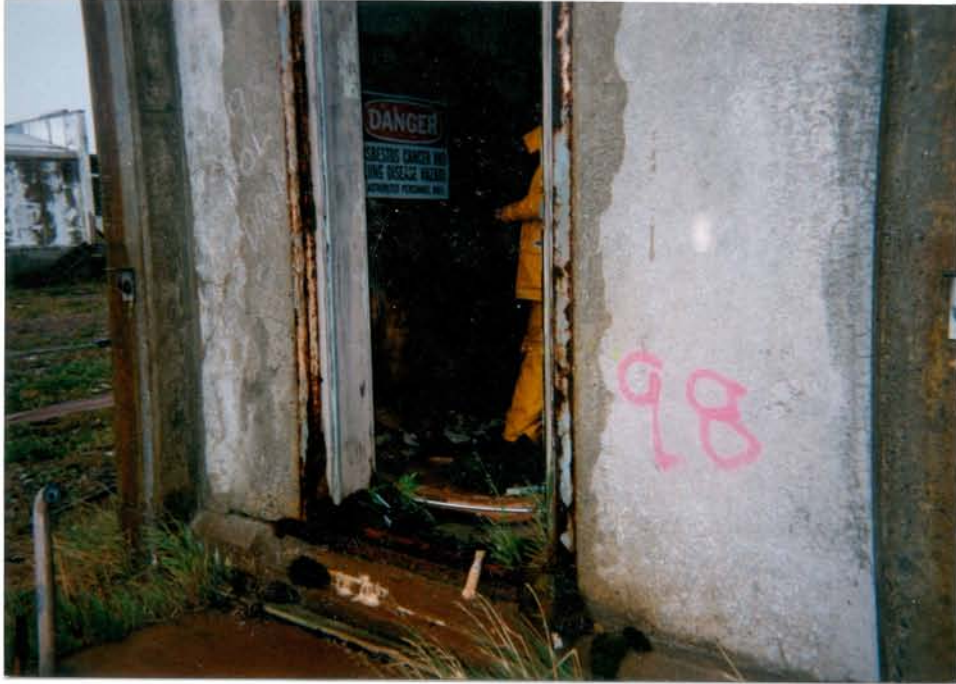
Site 14 Building 98, West Side South Door - Danger Sign Posting

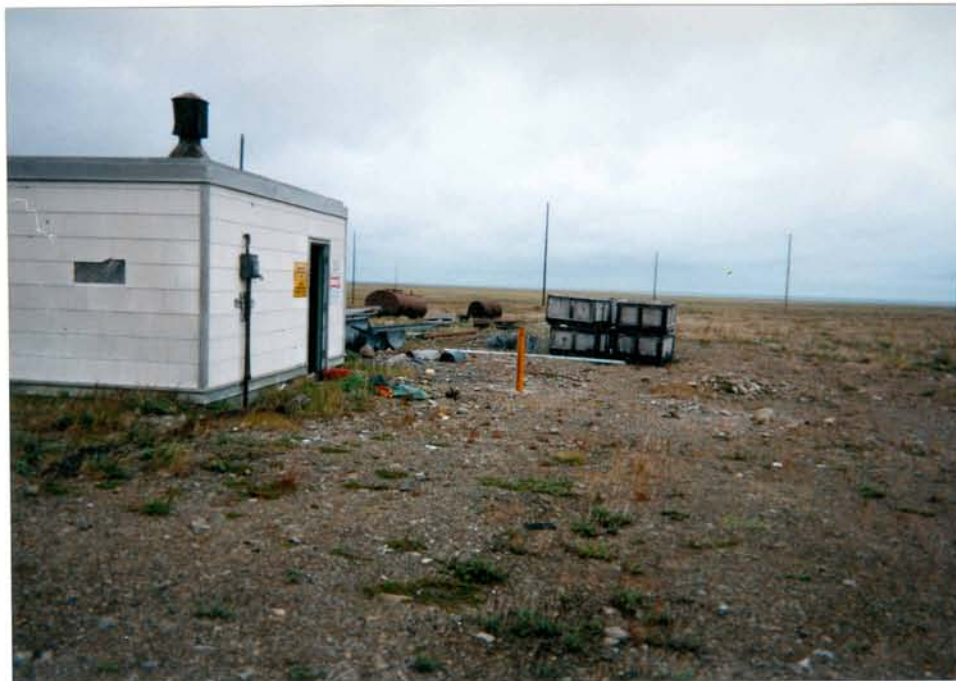
Site 16 Paint Storage Building, View from South - Danger Sign Posting
MW 16-1 in Foreground, AST 16-1 in Background

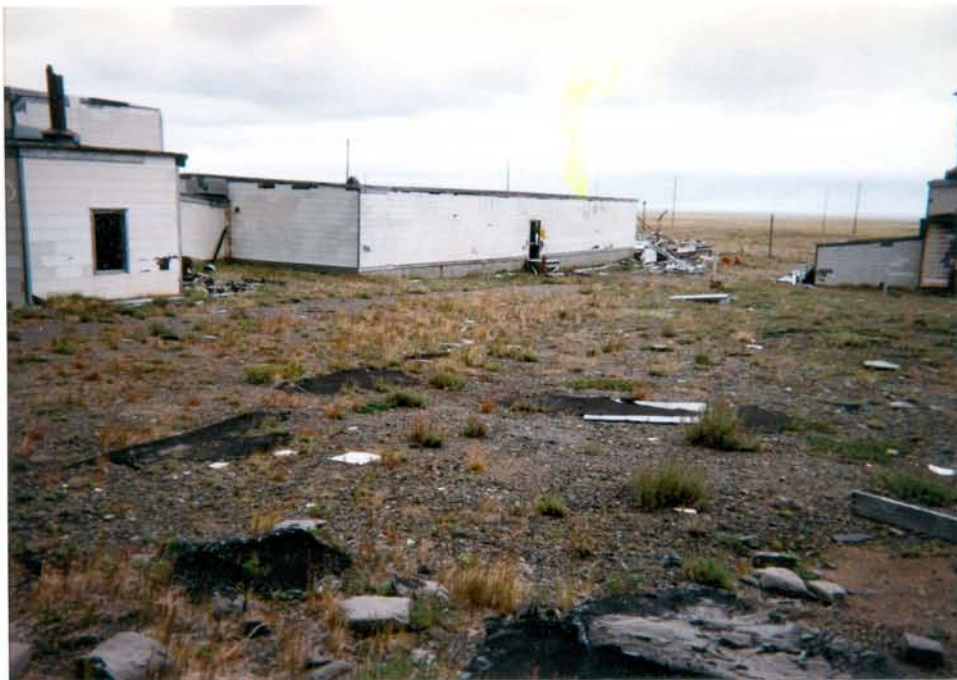
Site 17 Building 107, East Side Door - Danger Sign Posting

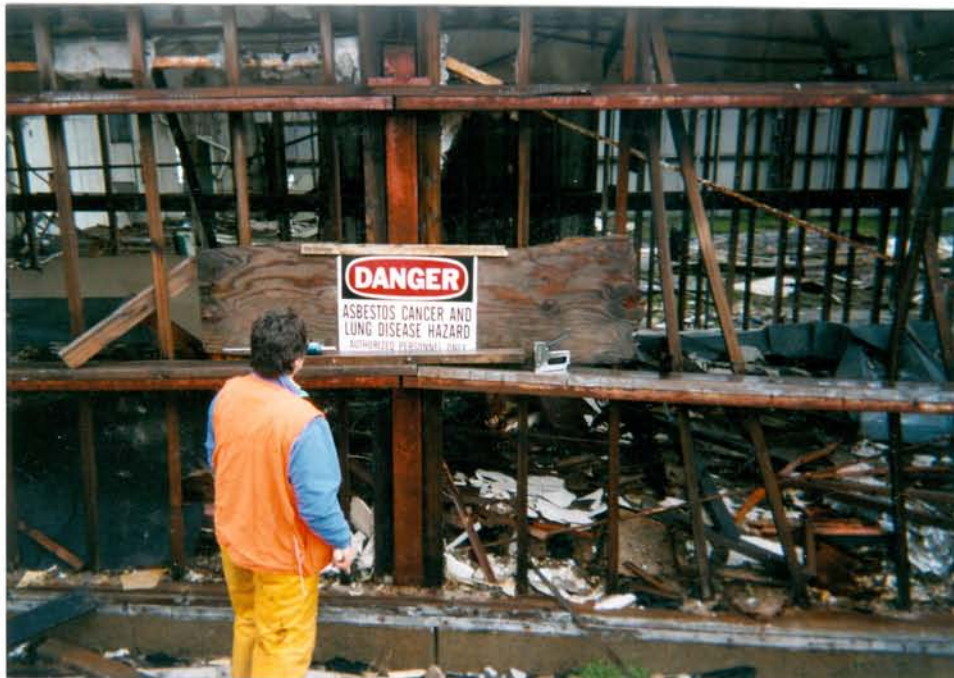
Site 18 Gym, South Side - Danger Sign Posting

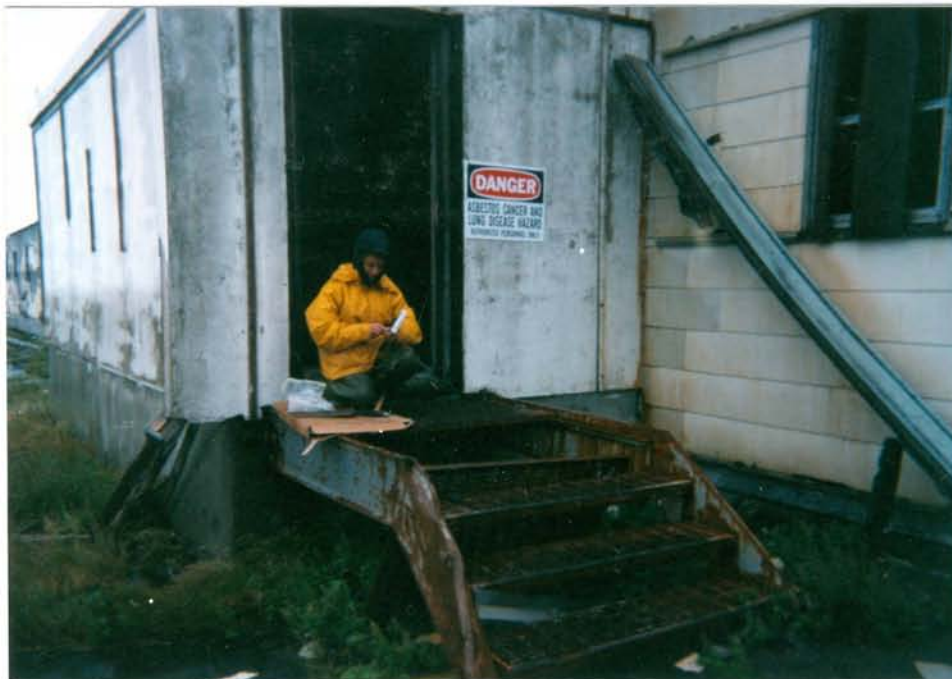
Site 18 Building 101 West, West Side Entrance - Danger Sign Posting

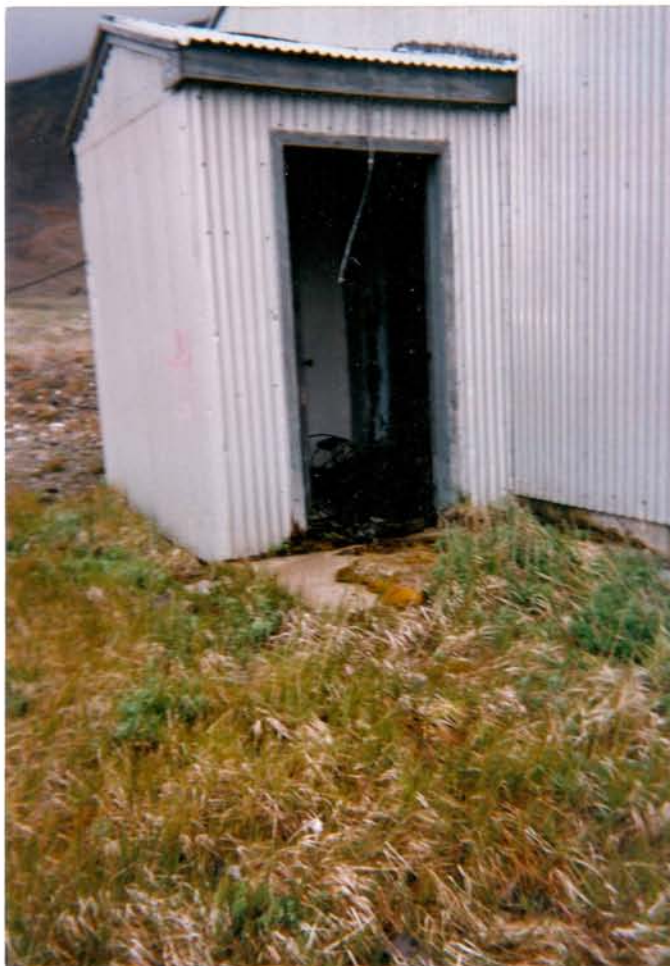
Site 18 Gym, East Door - Danger Sign Posting

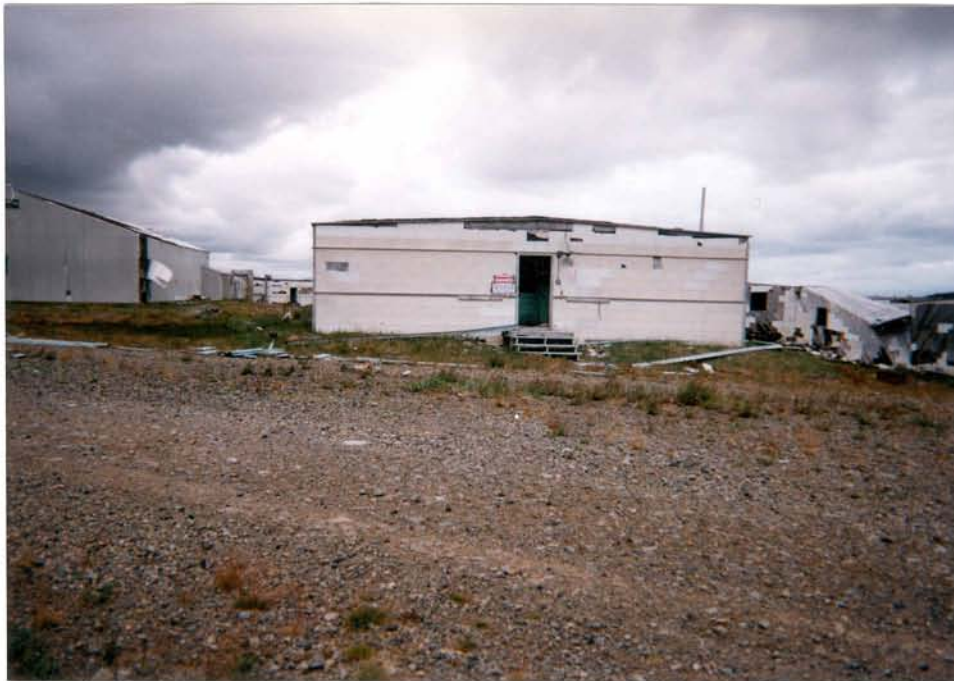
Site 18 Building 102, East Door- Danger Sign Posting

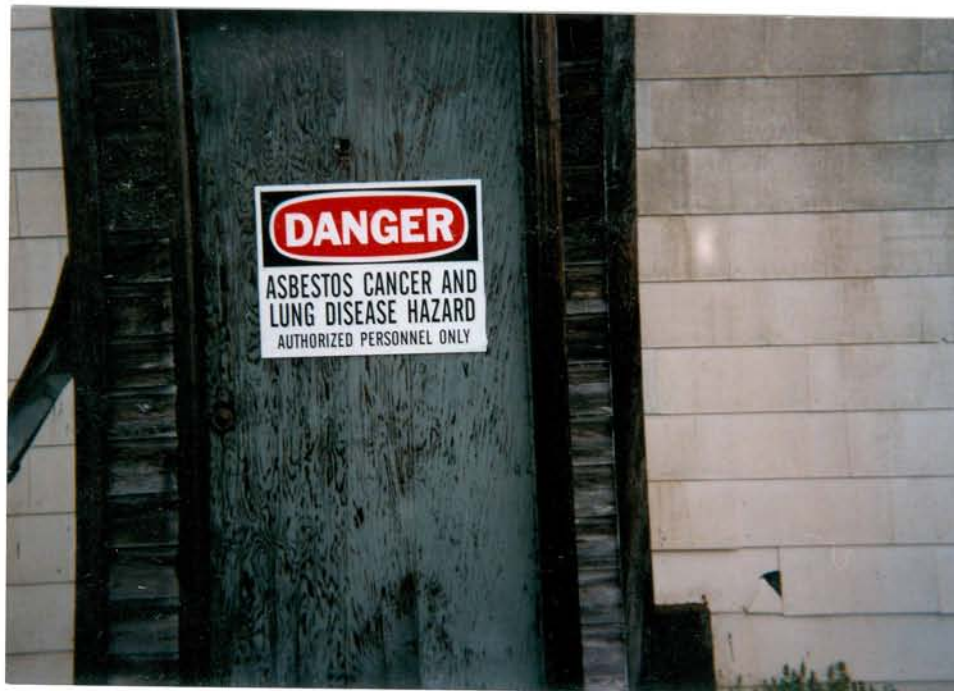
Site 18 Building 105, Rec. Building Danger Sign Posting

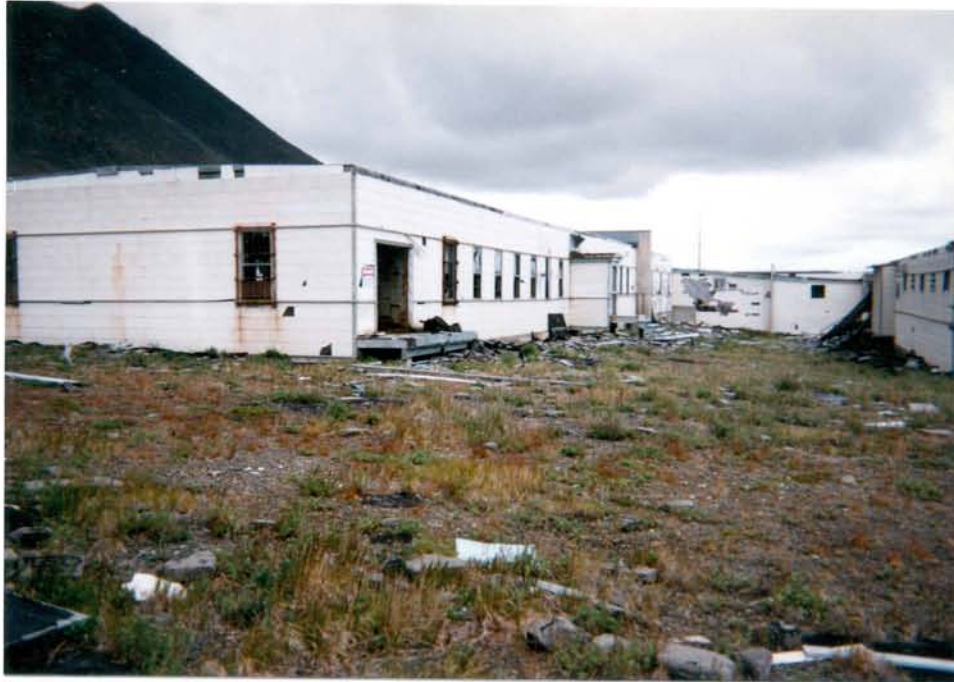
Site 18 Building 105, North Dock Door - Danger Sign Posting

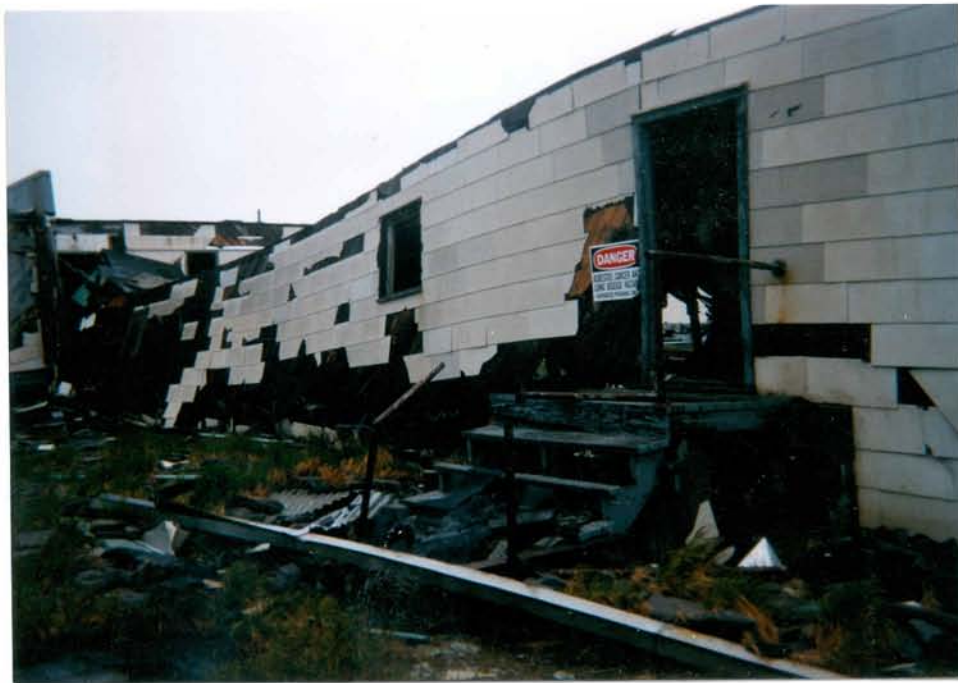
Site 18 Building 106 Walkway West Side, North Door - Danger Sign Posting

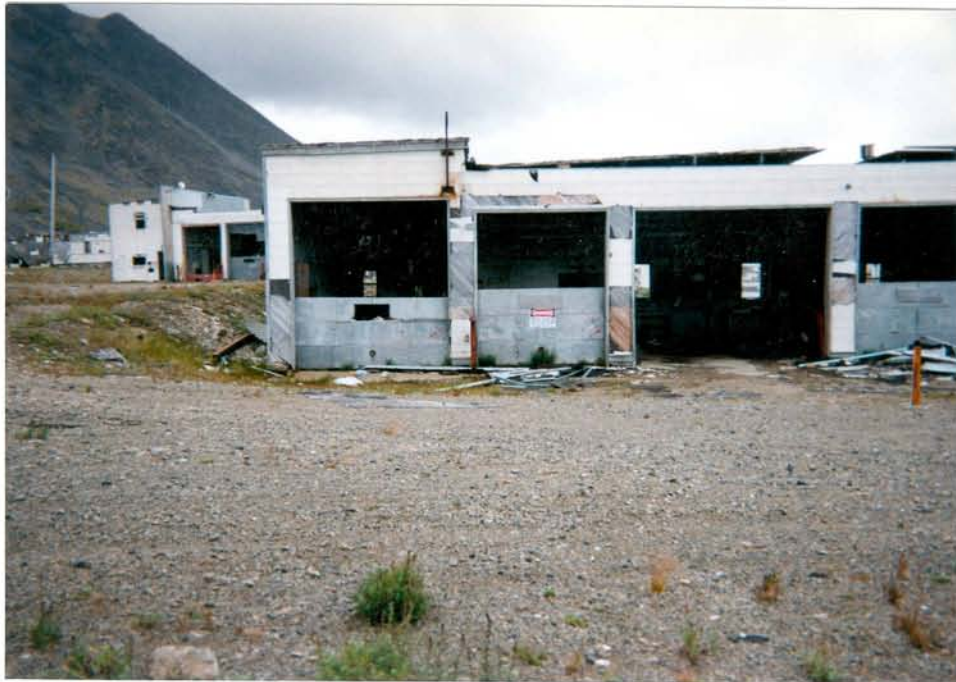
Site 19 Building 108, East Door - Danger Sign Posting

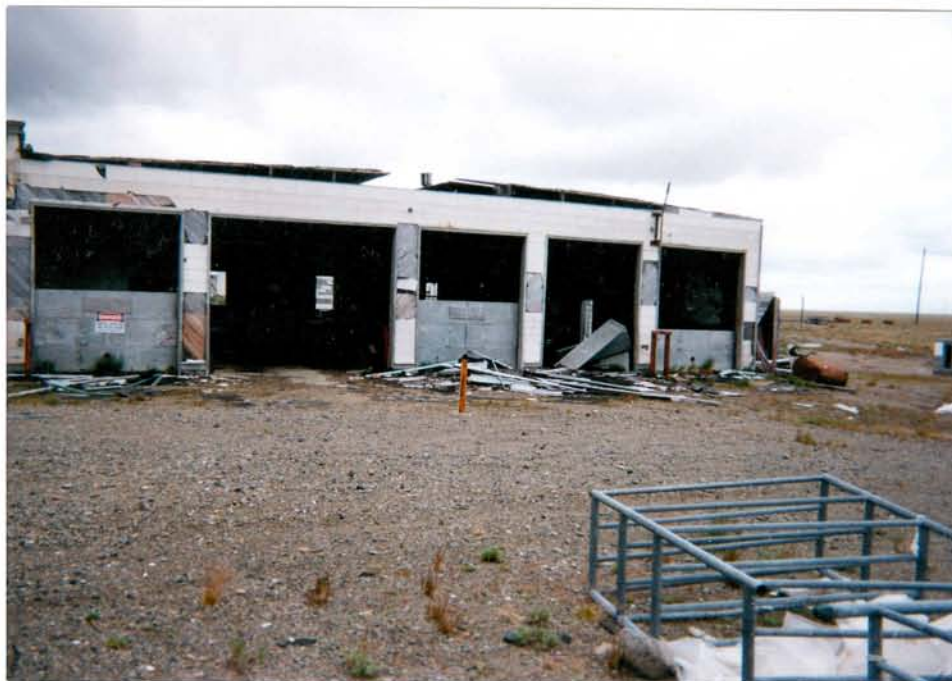
Site 19 Building 108 East Door - Danger Sign Posting

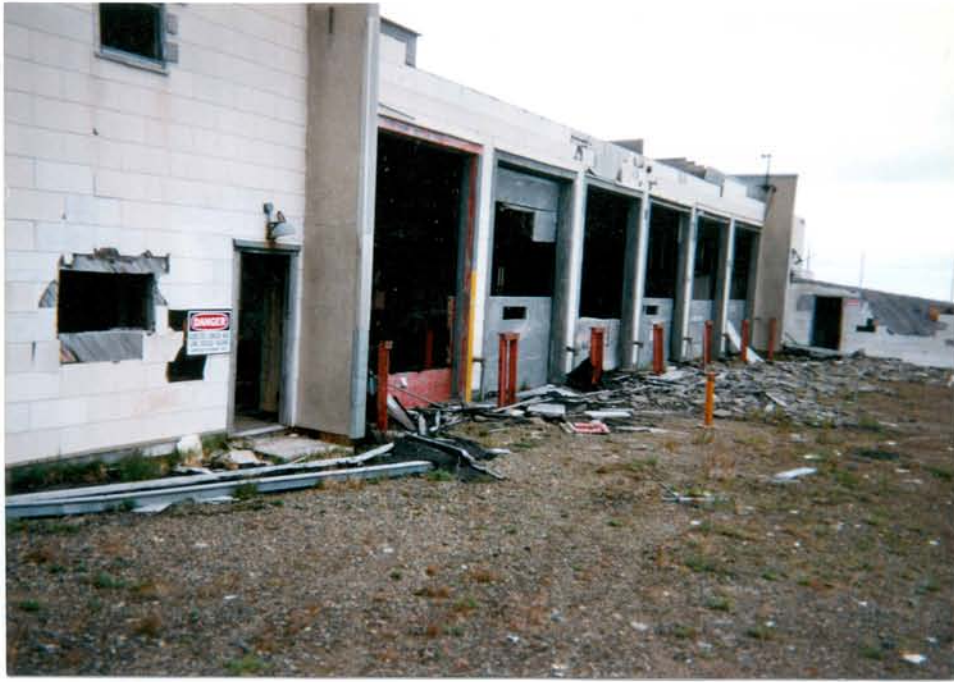
Site 19 Building 109, Southeast Entrance- Danger Sign Posting

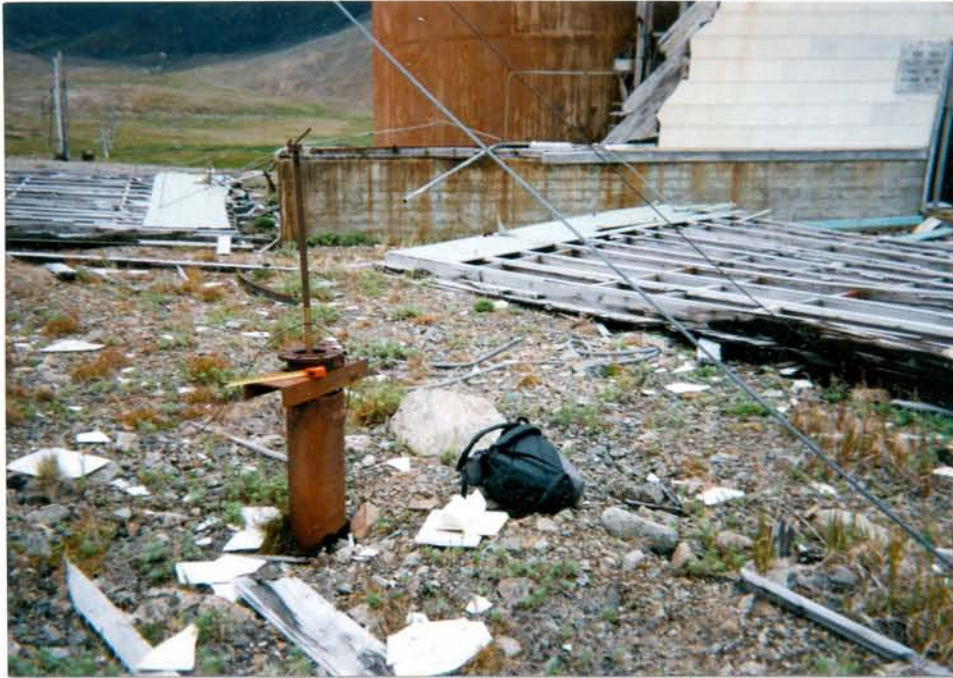
Site 22: Military Water Well #3

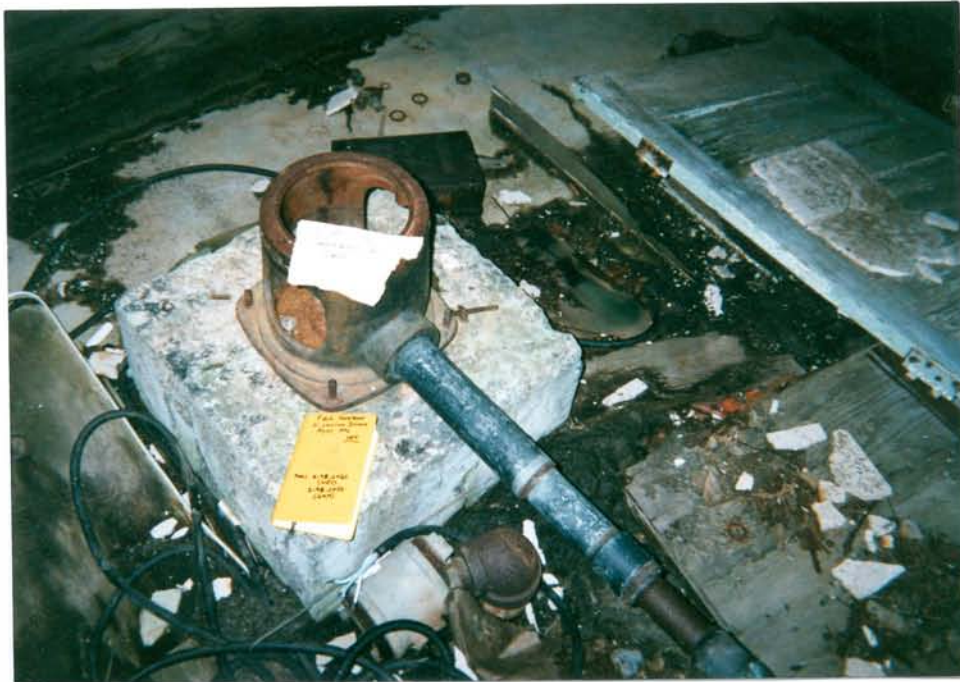
Site 22 Well #4, Military Water Southeast of Main Complex

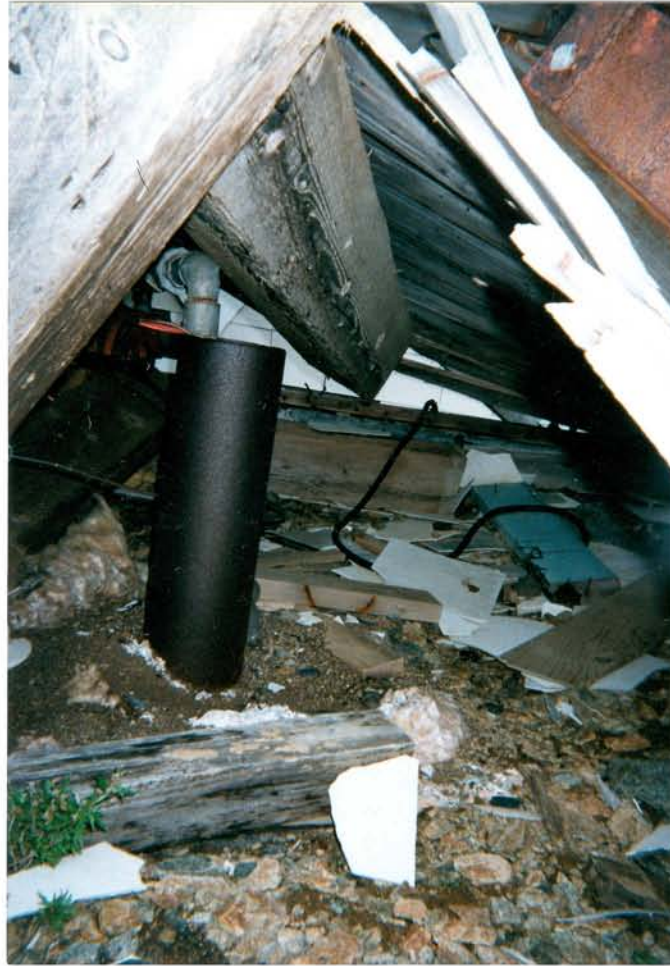
Site 22: Military Water Well #1

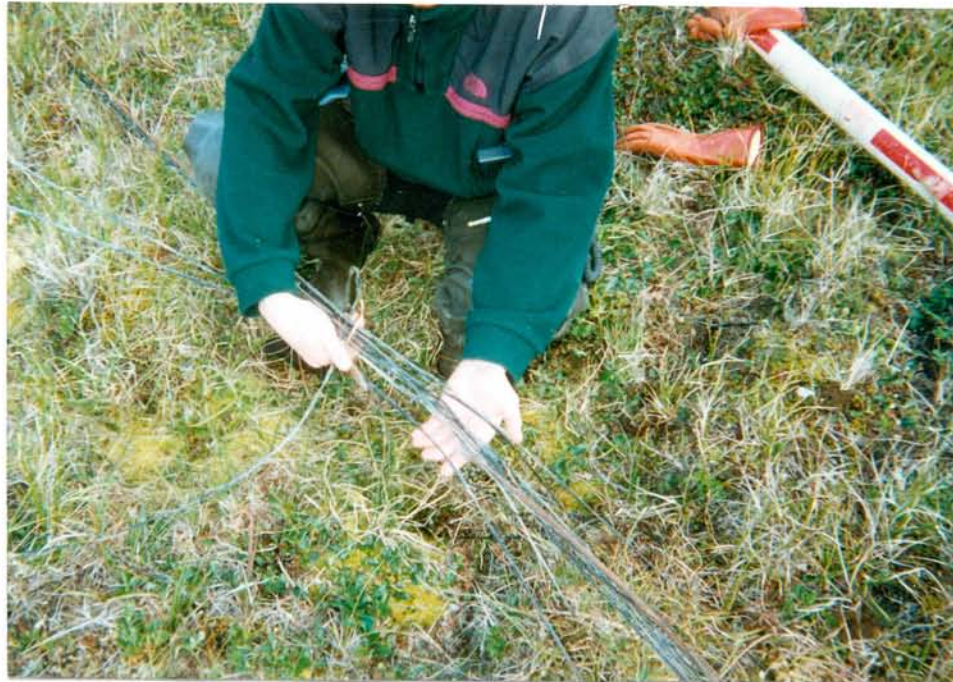
Examples of grounded braided copper wire

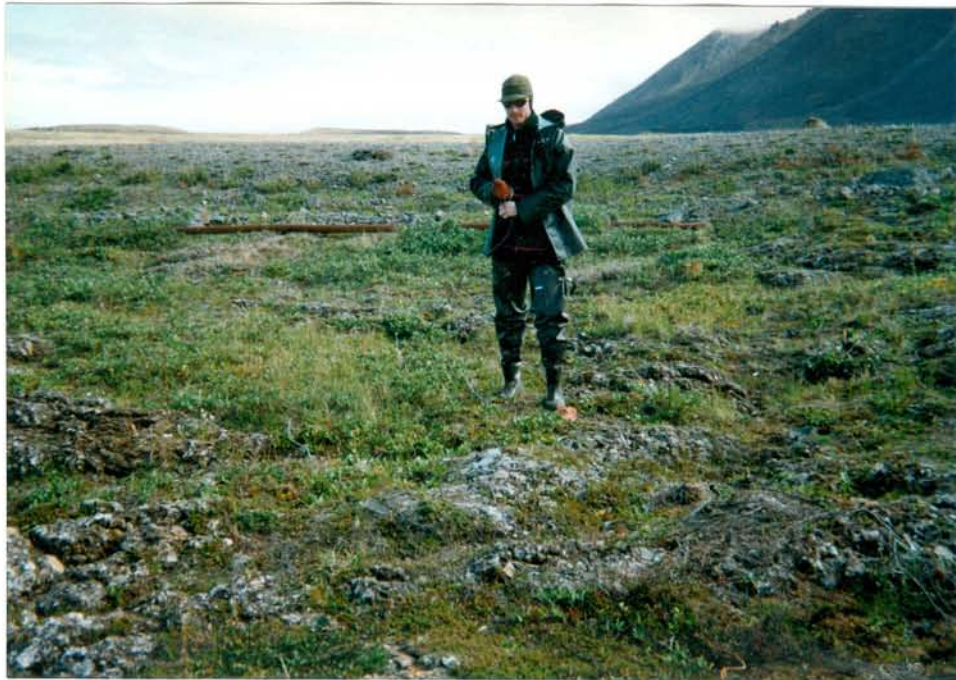
Examples of grounded braided copper wire

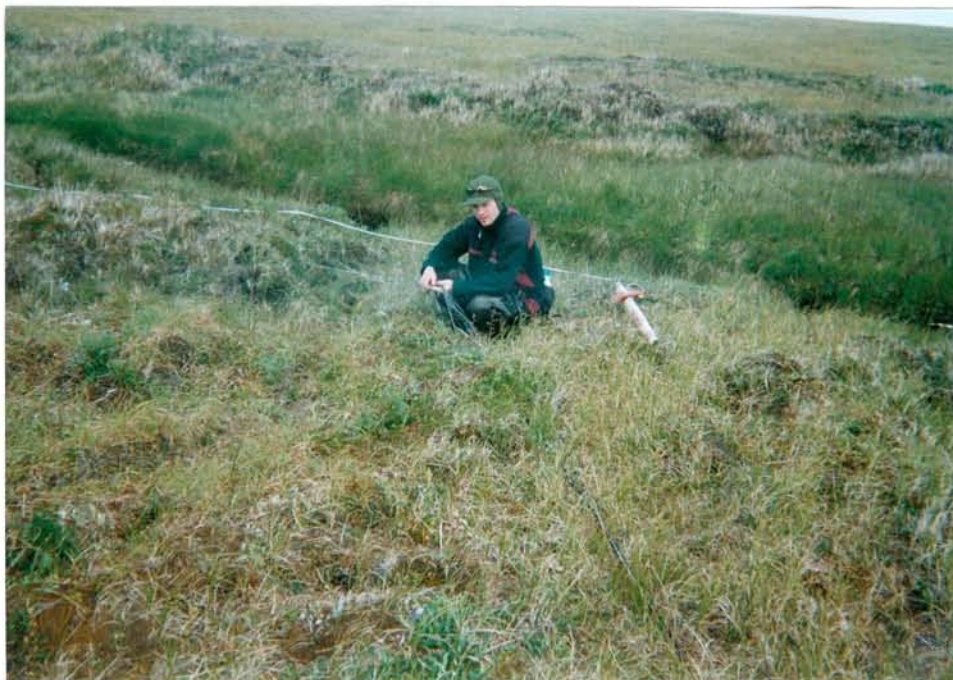
Examples of grounded braided copper wire

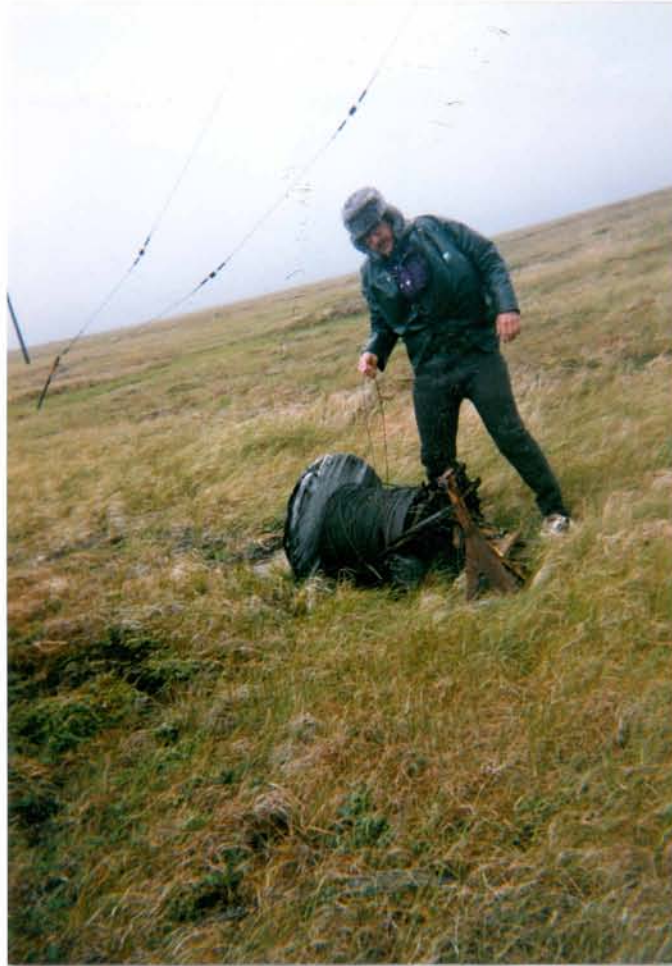
Examples of grounded braided copper wire

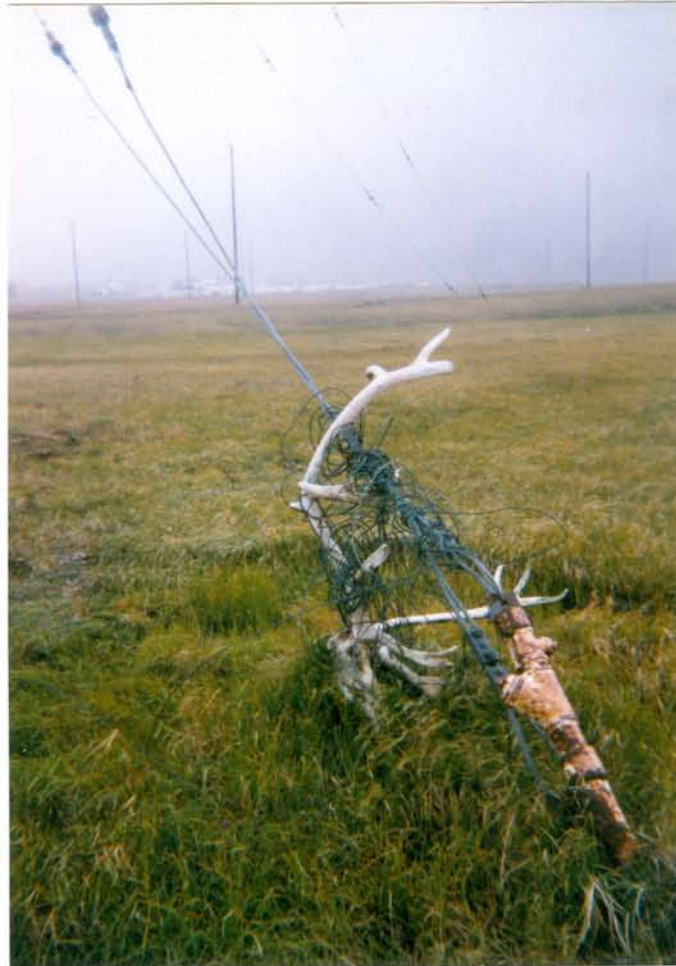
Wire Victims

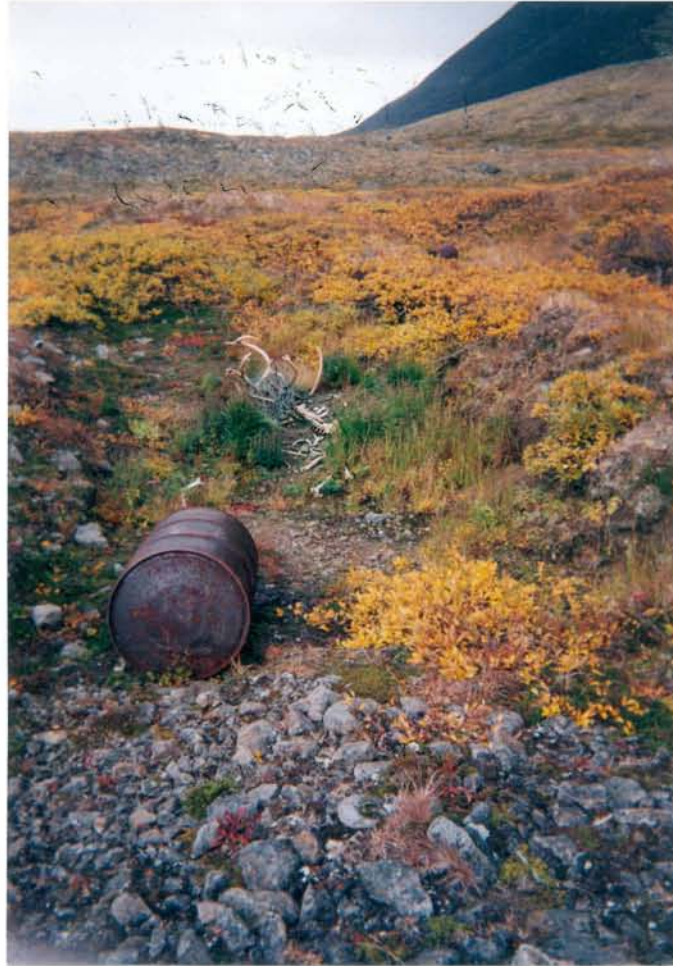
Wire Victims

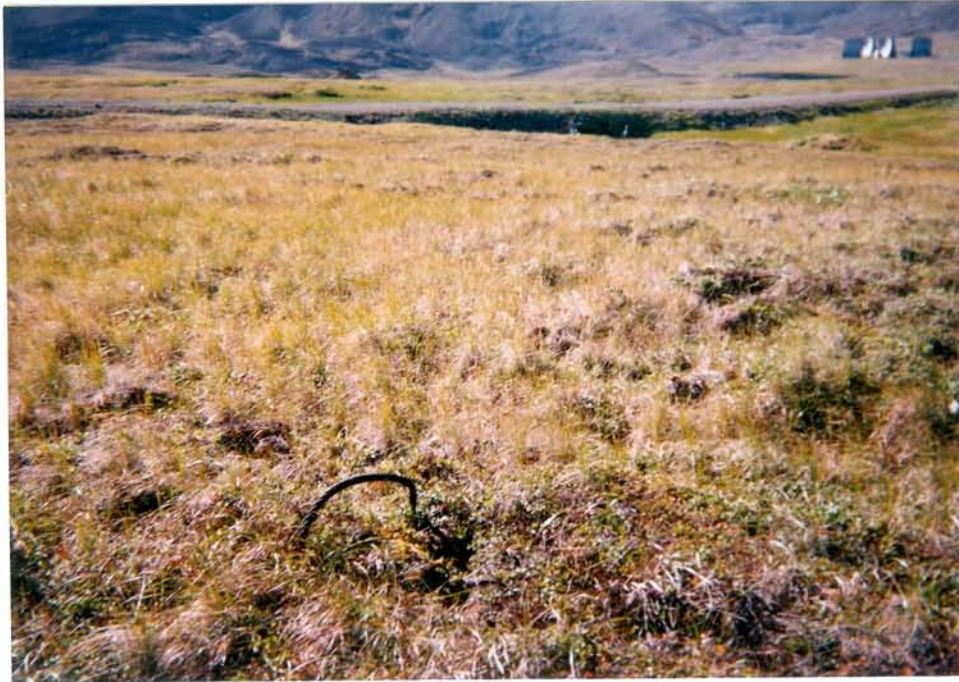
Other wire exposure

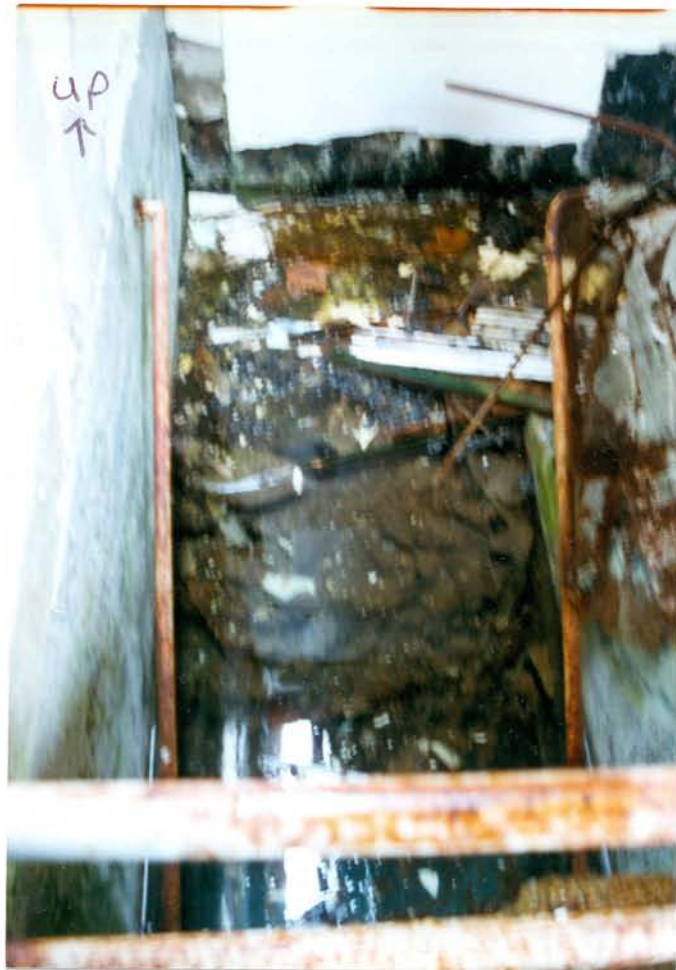
Site 14 Building 98, Debris littered Stairwell Leading to BUS Walkway
East to Building 101 West

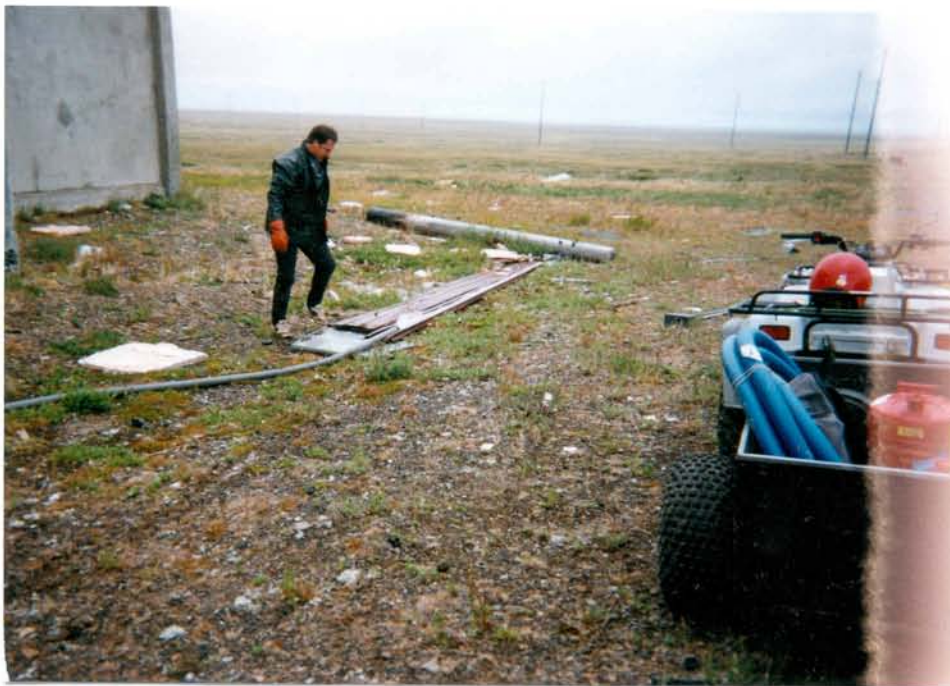
Site 14 Building 98, Effluent of water being pumped from flooded walkway

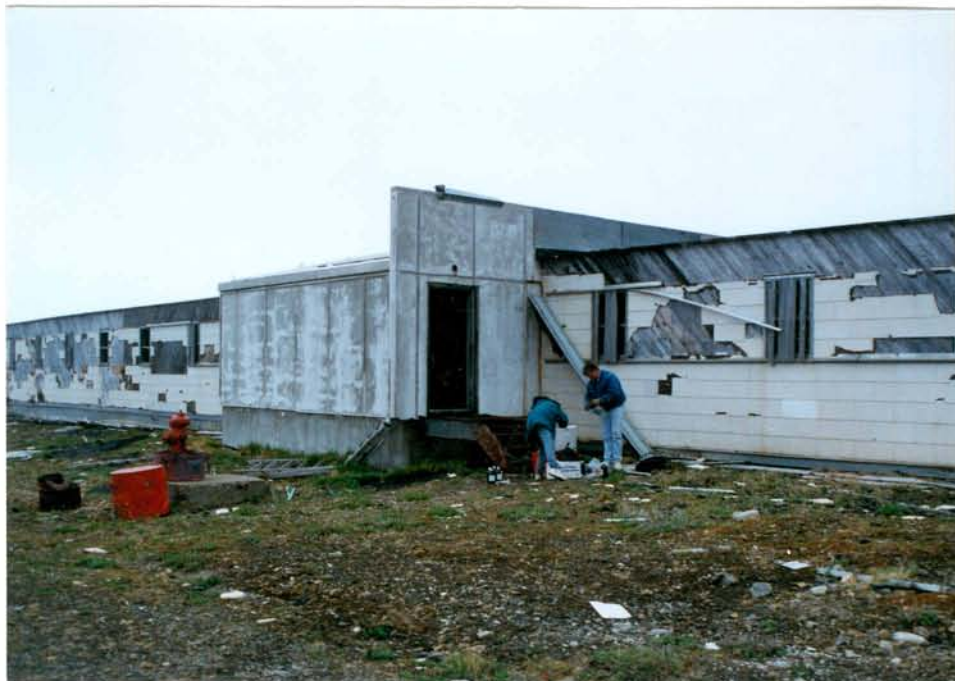
Site 18 Building 101, Preparing to sample sludge in "flooded" walkway to Building 98 (now pumped)

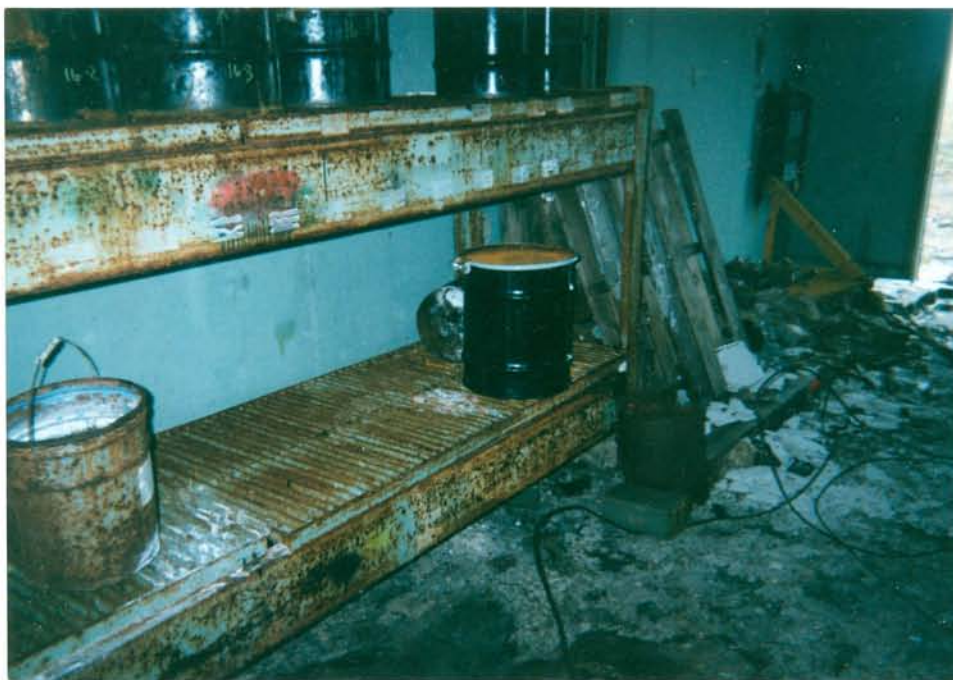
Site 16: Paint Dope Storage Building, Overpacks 16-2, 16-3, 16-4, 16-5, and 16-6. Unknown contents.

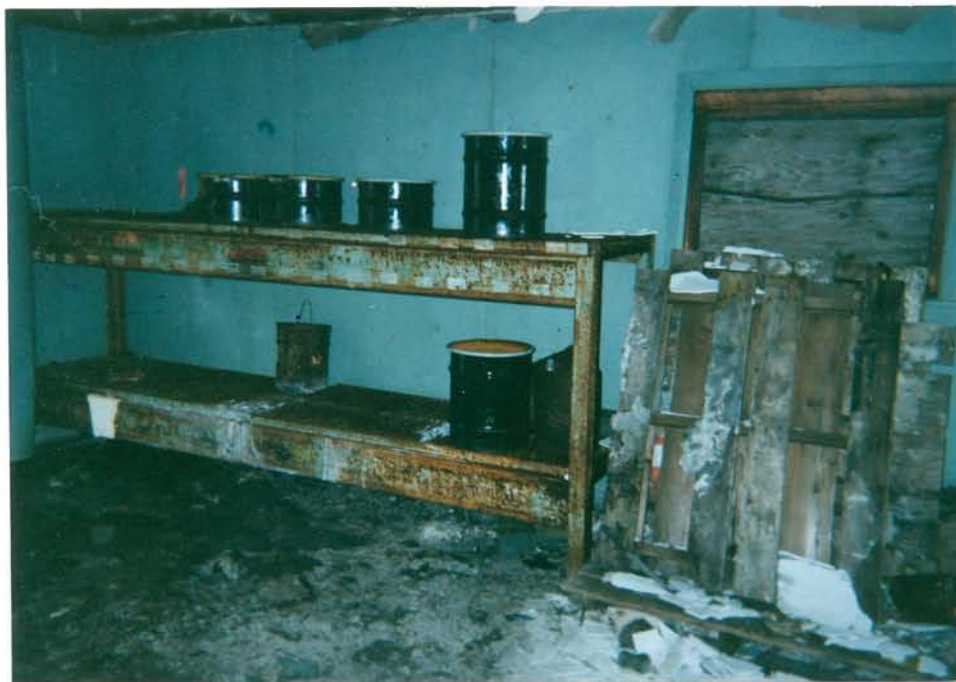
Site 16: Paint Dope Storage Building, Overpacks 16-2, 16-3, 16-4, 16-5, and 16-6. Unknown contents

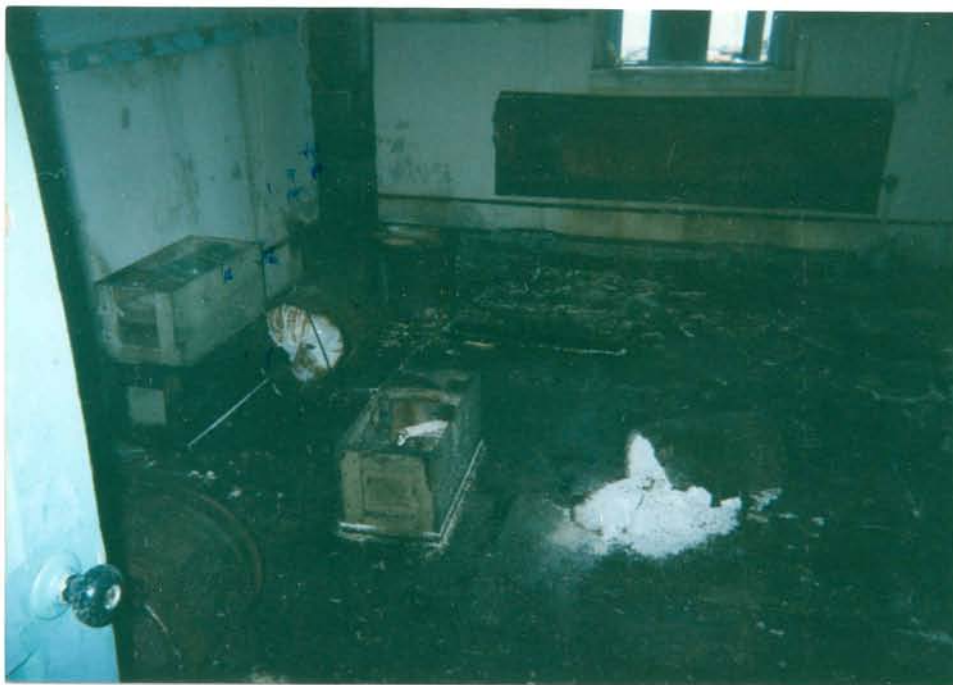
Site 18 Building 101 west, Military Decontamination Solution (Chemical agent) STB, DS2

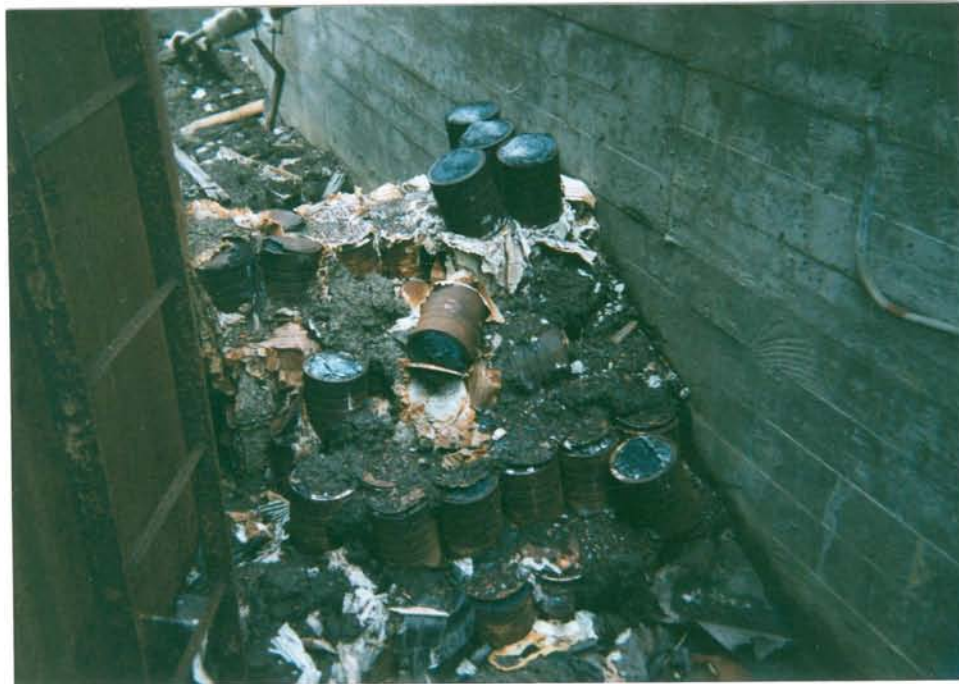
Site 22 Building 113, 150 gallon cans of asbestos paint

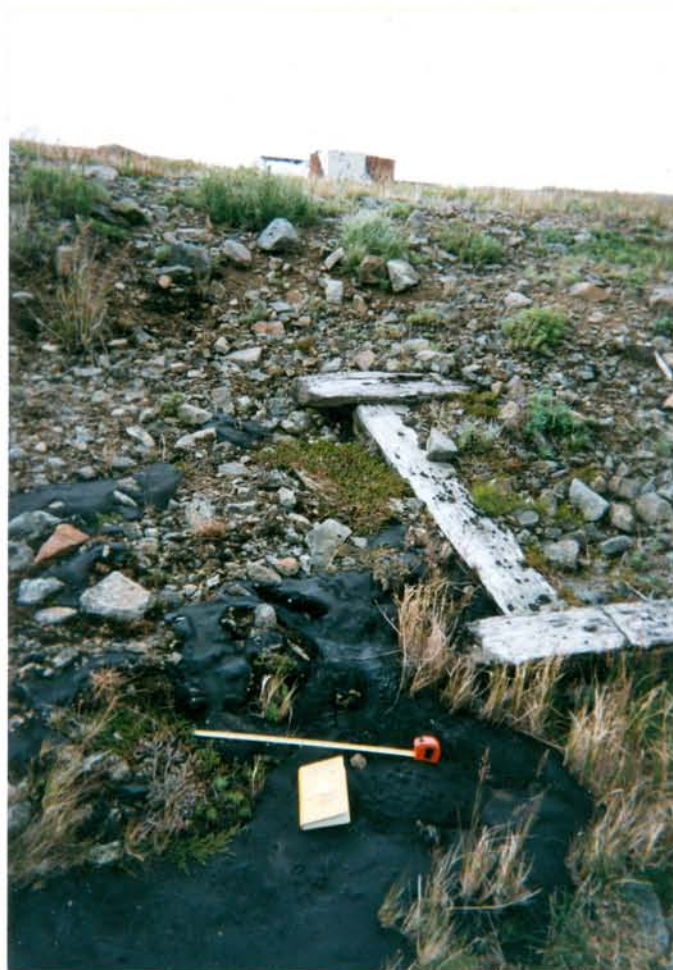
Tar Spill, South of Site 22, East side of Gravel Pad

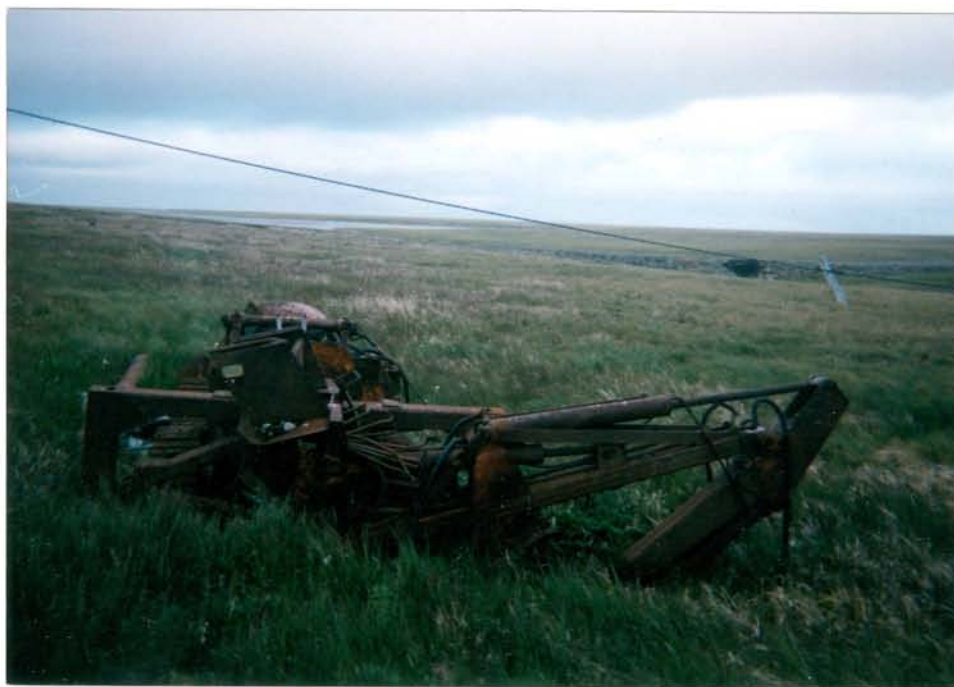
Tractor - South of Airstrip Gravel Pad, looking East.

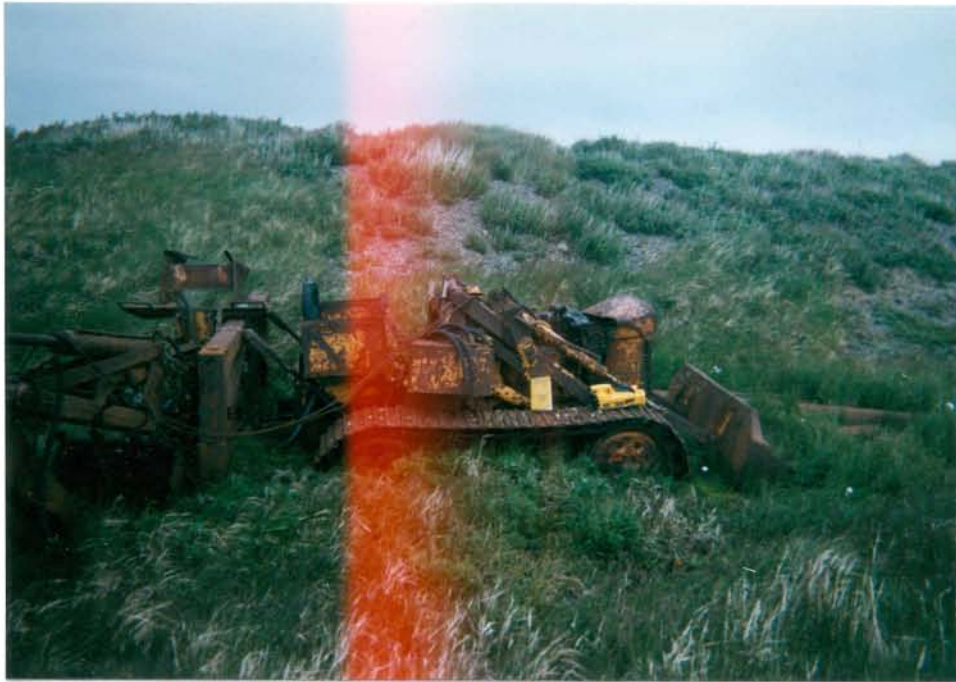
Tractor - South of Airstrip Gravel Pad, looking North
