**United States Army Corps of
Engineers, Alaska District**

**Phase II Remedial Investigation
Gambell,
St. Lawrence Island, Alaska**

Photographs - August, 1996

**Phase II Remedial Investigation
Northeast Cape,
St. Lawrence Island, Alaska**

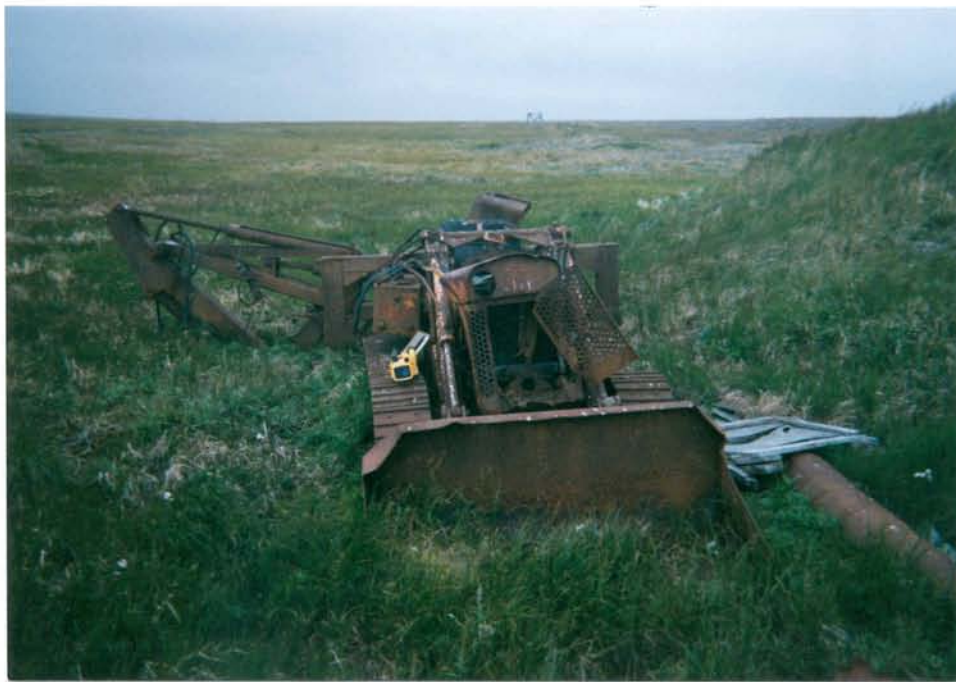
Tractor - South of Airstrip Gravel Pad, looking West
